## **Geotechnical Investigation and Slope Stability Risk Assessment**

**Proposed New Residence**

**Lot 03, 10 Fern Creek Road, Warriewood NSW**

**Report No. R22009.03.Rev0**

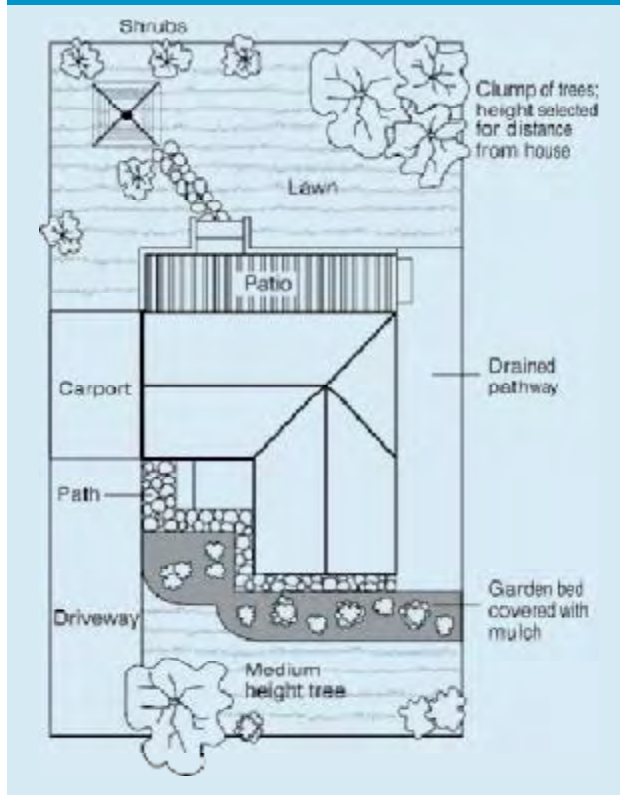
#### Gardens for a reactive site

should extend outwards a minimum of 900 mm (more in highly reactive soil) and should have a minimum fall away from the building of 1:60. The finished paving should be no less than 100 mm below brick vent bases.
