## Preliminary Geotechnical Assessment

**Project:** Alterations & Additions  
9 Tyalla Avenue, Frenchs Forest NSW

**Ref:** AG 22494  
21 November 2022

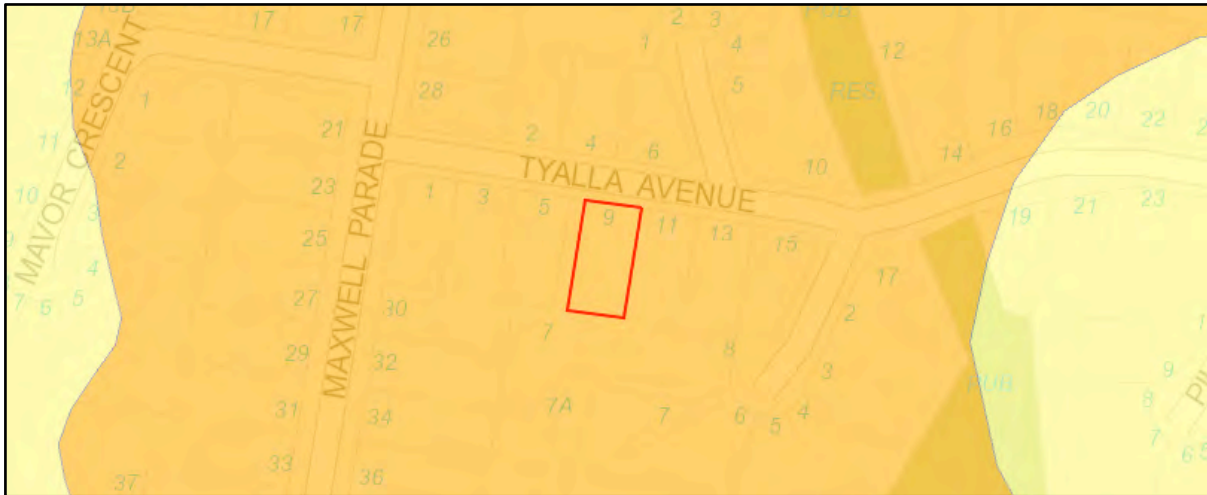
The site is mapped as **Area B** subject to specific landslip risk/geotechnical hazard mapping with reference to the Warringah (WLEP) Landslip Risk Map, Northern Beaches Council (**Image 1**).

**Image 1.** Warringah Landslip Risk Map:  
9 Tyalla Avenue, Frenchs Forest NSW (© NBC Maps)
