Geotechnical Assessment

Project: Alterations and Additions
13 Quinlan Parade, Manly Vale NSW.

REF: AG 19049B
19th June, 2020

For Alterations and Additions at
13 Quinlan Parade, Manly Vale, NSW

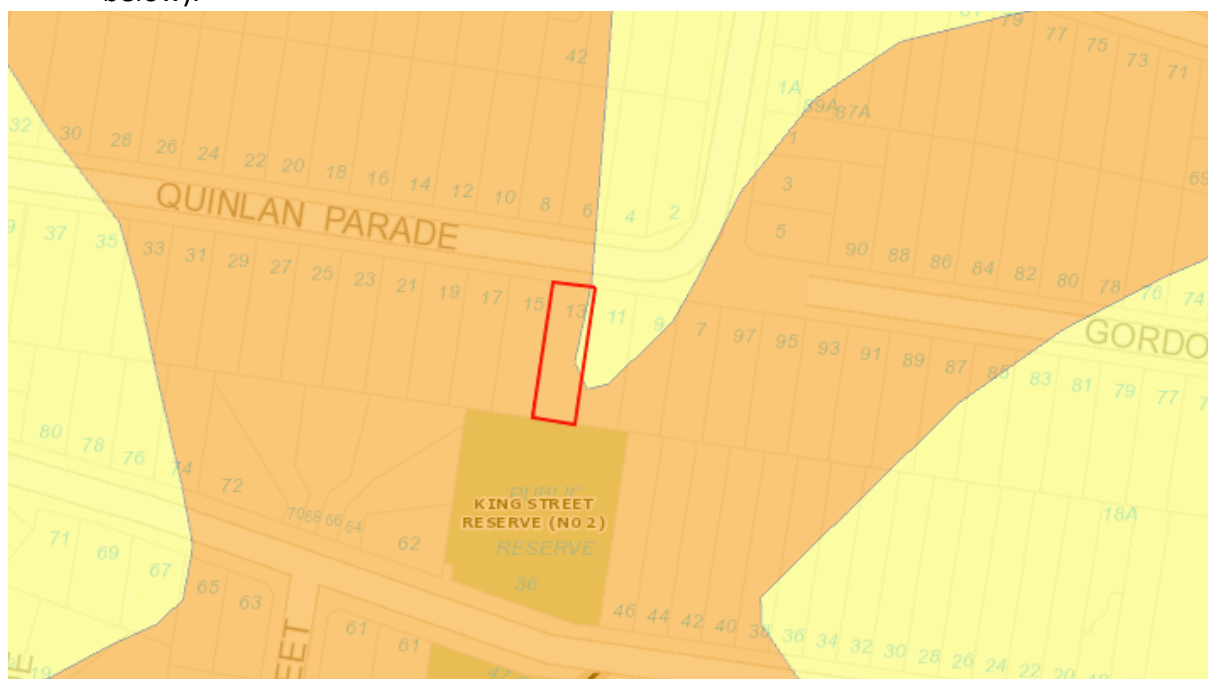
WARRINGAH LANDSLIP RISK MAP

- Area A - Slope less than 5 degrees
- Area B - Flanking Slopes from 5 to 25 degrees
- Area C - Slopes more than 25 degrees
- Area D - Collaroy Plateau Area Flanking Slopes 5 to 15 degrees
- Area E - Collaroy Plateau Area Slopes more than 15 degrees

- No evidence of significant soil creep, tension cracks or other indicators of slope instability were identified at the time of our inspection.
- The existing structures including retaining walls displayed no evidence of significant cracking or settlement that could be attributed to slope instability.
- The property is classified as **Area A & Area B** with reference to Northern Beaches Council WLEP Landslip Risk Map Sheet LSR_008 (WLEP Landslip Risk Map **Image 2** below).

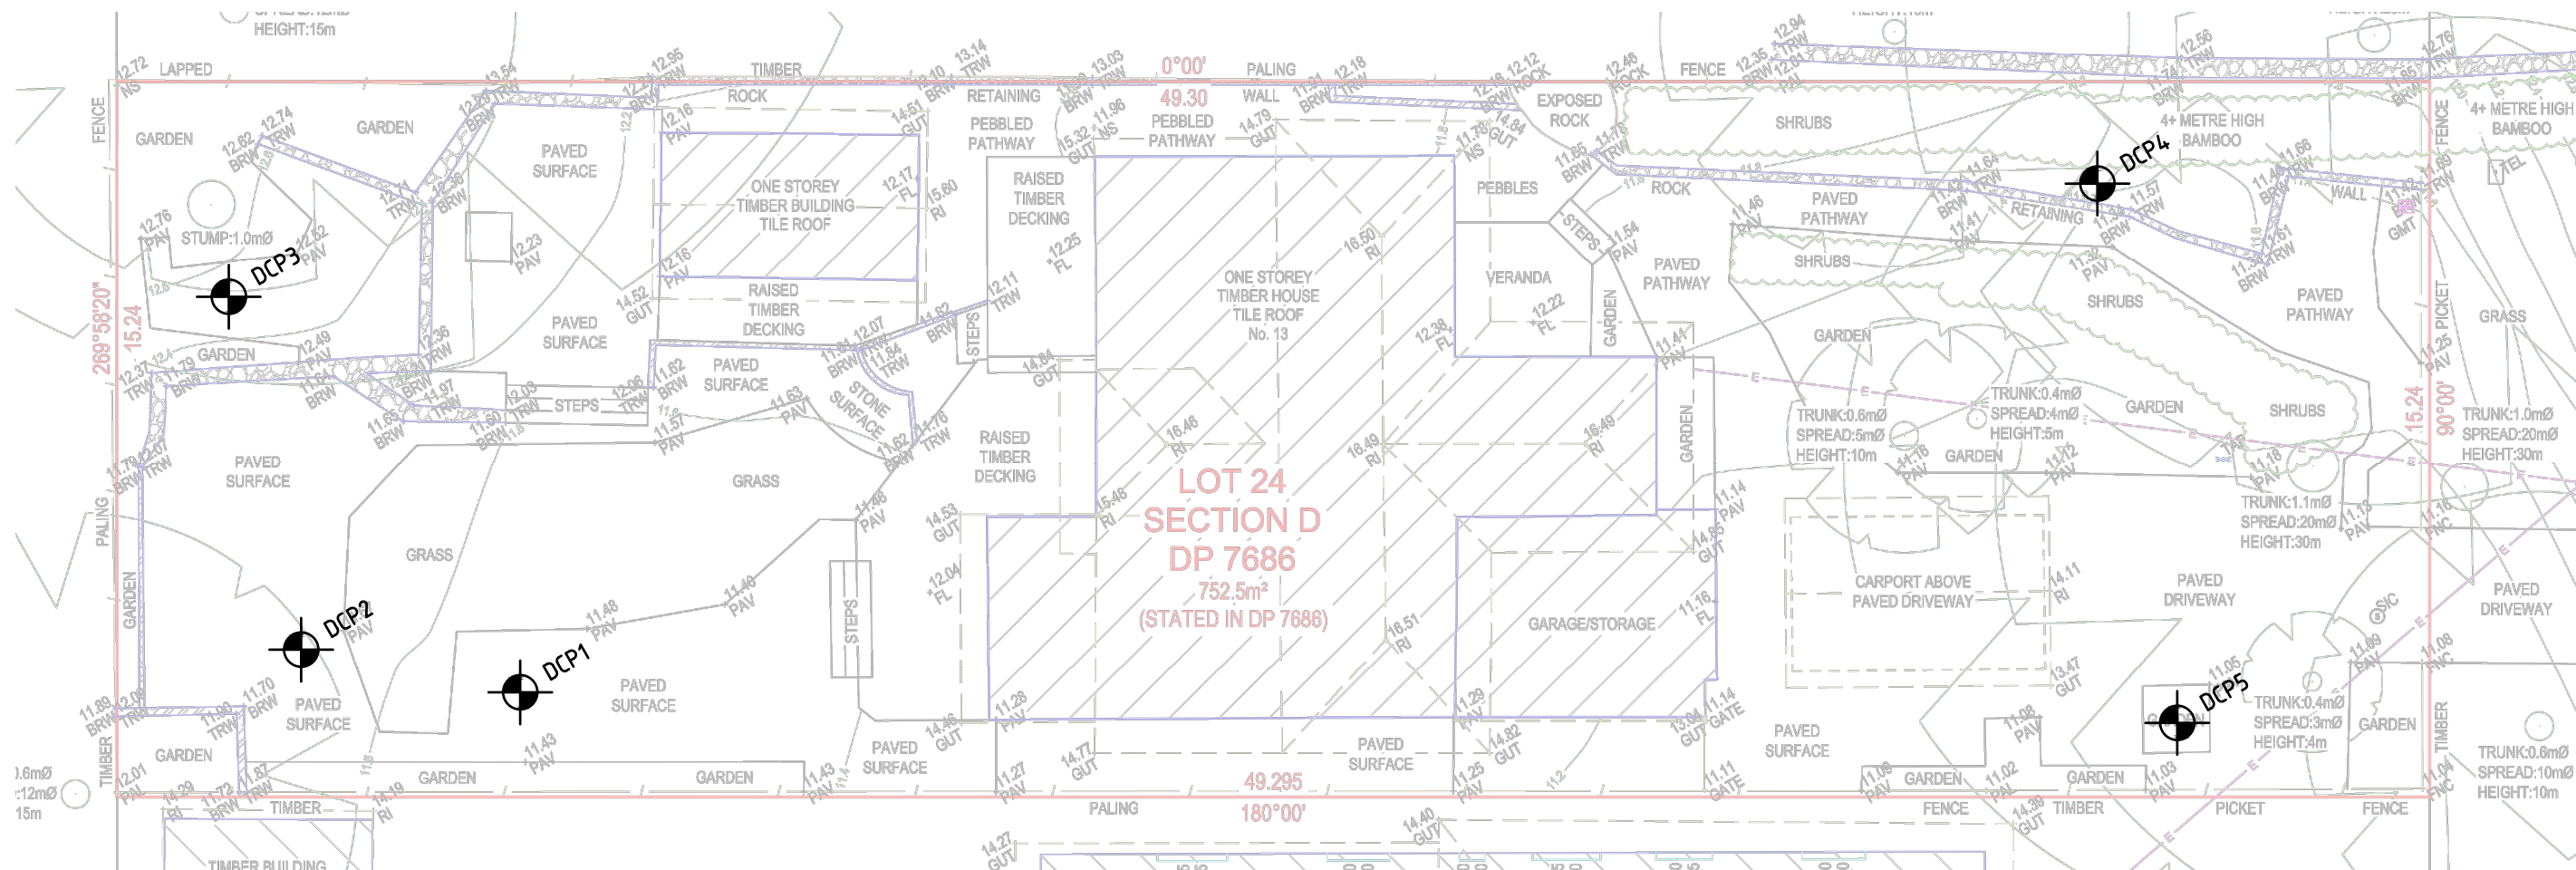
SITE PLAN/GROUND TEST LOCATIONS

DATE:	20/03/2019
SCALE:	AS SHOWN @ A3
DRAWING TITLE:	SITE PLAN
DRAWING NO:	AG 19049- S1

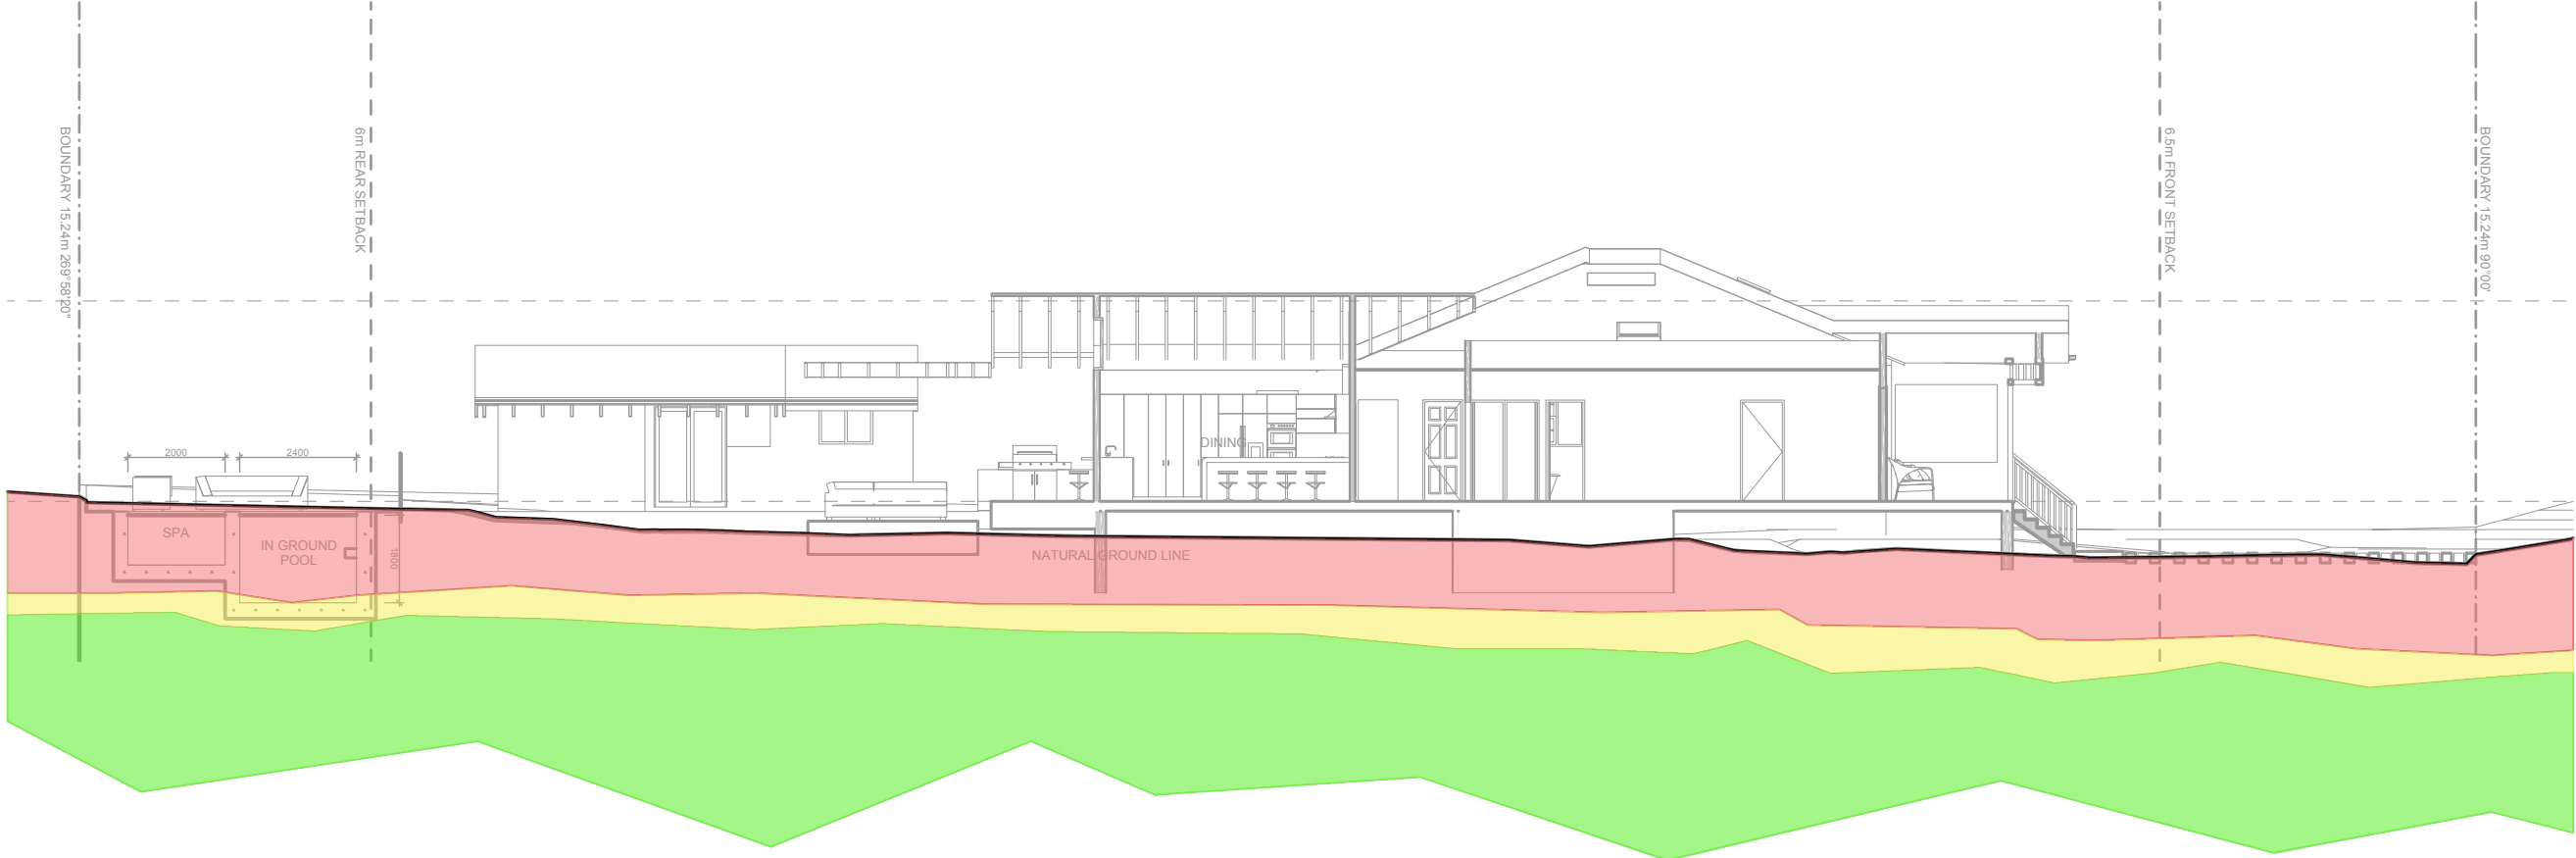
INFERRED GEOLOGICAL SECTION

INTERPRETED SUBSURFACE SECTION ONLY.
ACTUAL GROUND CONDITIONS MAY VARY.
