## Preliminary Geotechnical Assessment

For Alterations and Additions at  
**3 Wyadra Avenue, Freshwater, NSW**

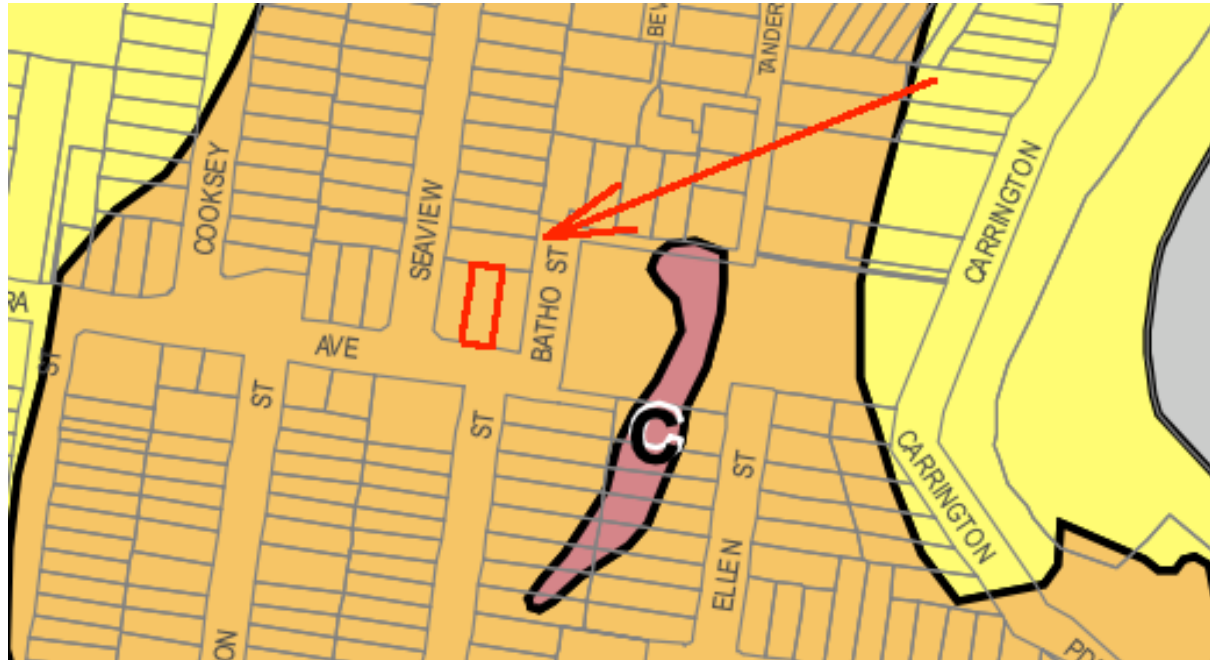
The site is mapped as **Area B** on the Landslip Risk Map LSR\_010 (**Image 1**, below).

**WARRINGAH LANDSLIP RISK MAP**
