**GEOTECHNICAL RISK MANAGEMENT POLICY FOR PITTWATER  
FORM NO. 1 – To be submitted with Development Application**

Development Application for	<u>Ben Dyball</u>
	Name of Applicant
Address of site	<u>20 York Terrace, Bilgola Plateau</u>

The site is mapped as Geotechnical Hazard **H2** on the Geotechnical Hazard Map GTH\_017 (**Image 1**, below).

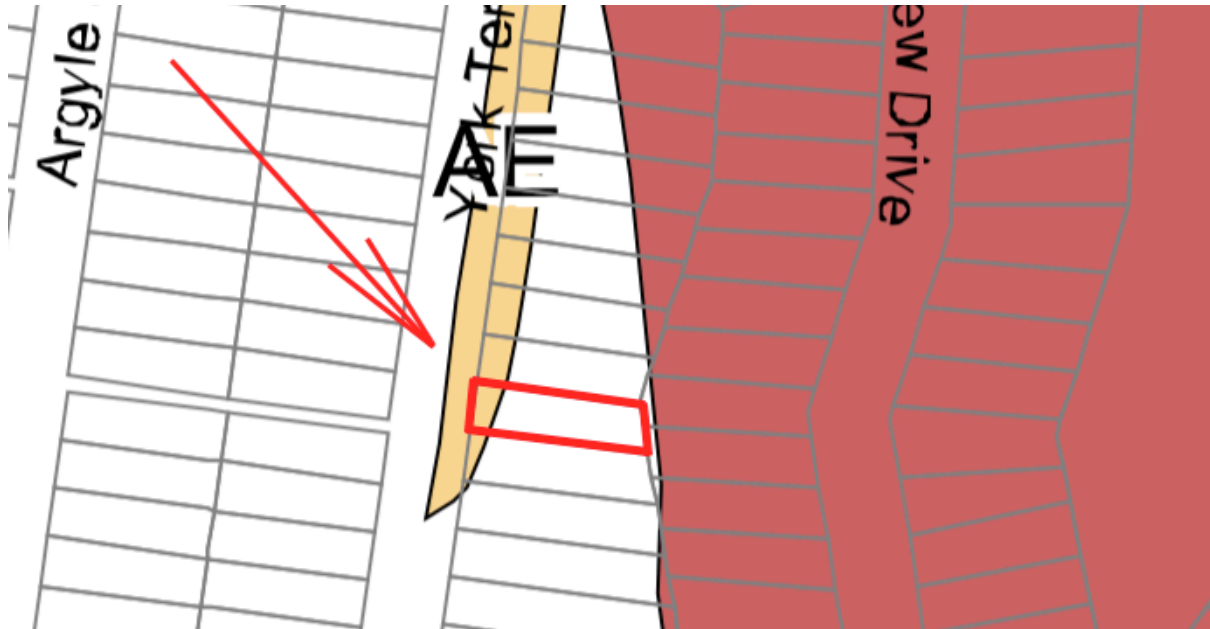
**Geotechnical Hazard**

W	Geotechnical Hazard H1
AE	Geotechnical Hazard H2
