Preliminary Geotechnical Assessment

Project: Alterations & Additions
9 Linkmead Avenue, Clontarf NSW

Ref: AG 24518
21 November 2024

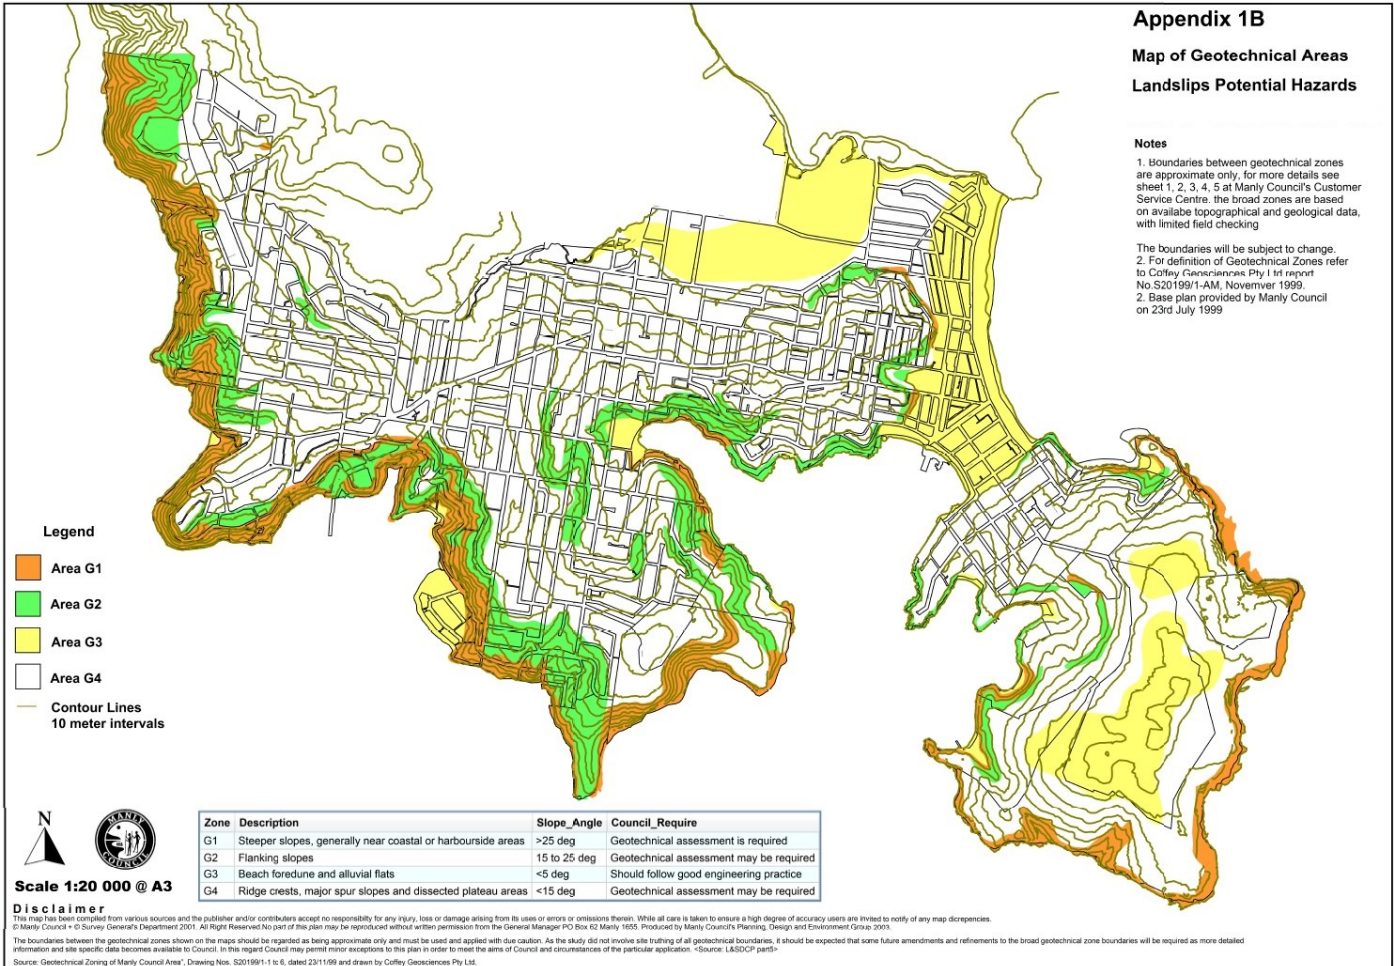
Potential Geotechnical Landslip Hazard Areas
Northern Beaches Council | Manly DCP Schedule 1 Map C

Notes
 1. Boundaries between geotechnical zones are approximate only, for more details see sheet 1, 2, 3, 4, 5 at Manly Council's Customer Service Centre, the broad zones are based on available topographical and geological data, with limited field checking

The site is mapped as **G1 & G2** landslide risk/geotechnical hazard with reference to Schedule 1 – Map C – Potential Geotechnical Landslip Hazard Areas, Manly DCP, Northern Beaches Council (**Appendix B**).
