Geotechnical Assessment

Project: New Inclined Lift
53-55 Annam Road, Bayview NSW

Ref: AG 22124
11 April 2022

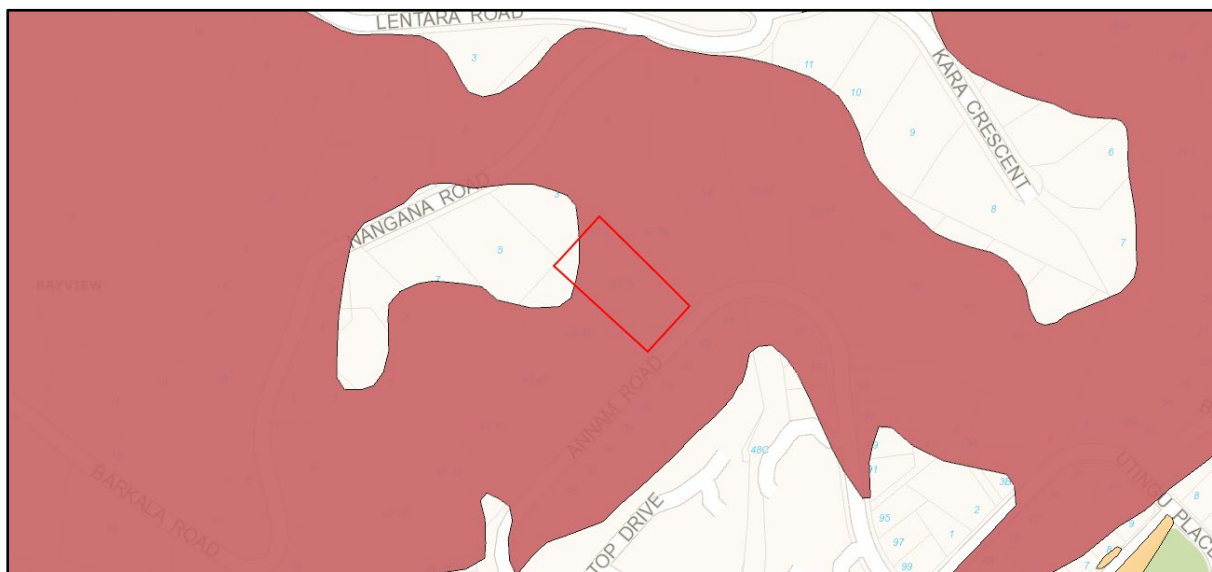
Image 2. PLEP Geotechnical Hazard Map
– 53-55 Annam Road, Bayview NSW

LEGEND
Pittwater Geotechnical Hazard Map
■ Geotechnical Hazard H1
■ Geotechnical Hazard H2

- No evidence of significant soil creep, tension cracks or landslip instability were identified across the site or on adjacent properties as viewed from the subject site at the time of our inspection.
- Based on reference to the plan entitled “Geotechnical Hazard Mapping” (Ref. P21DCP-BC-MDCP2002, dated 2007) prepared by GHD LONGMAC on behalf of Pittwater Council, the site is mapped as a **Geotechnical Hazard H1** zone.

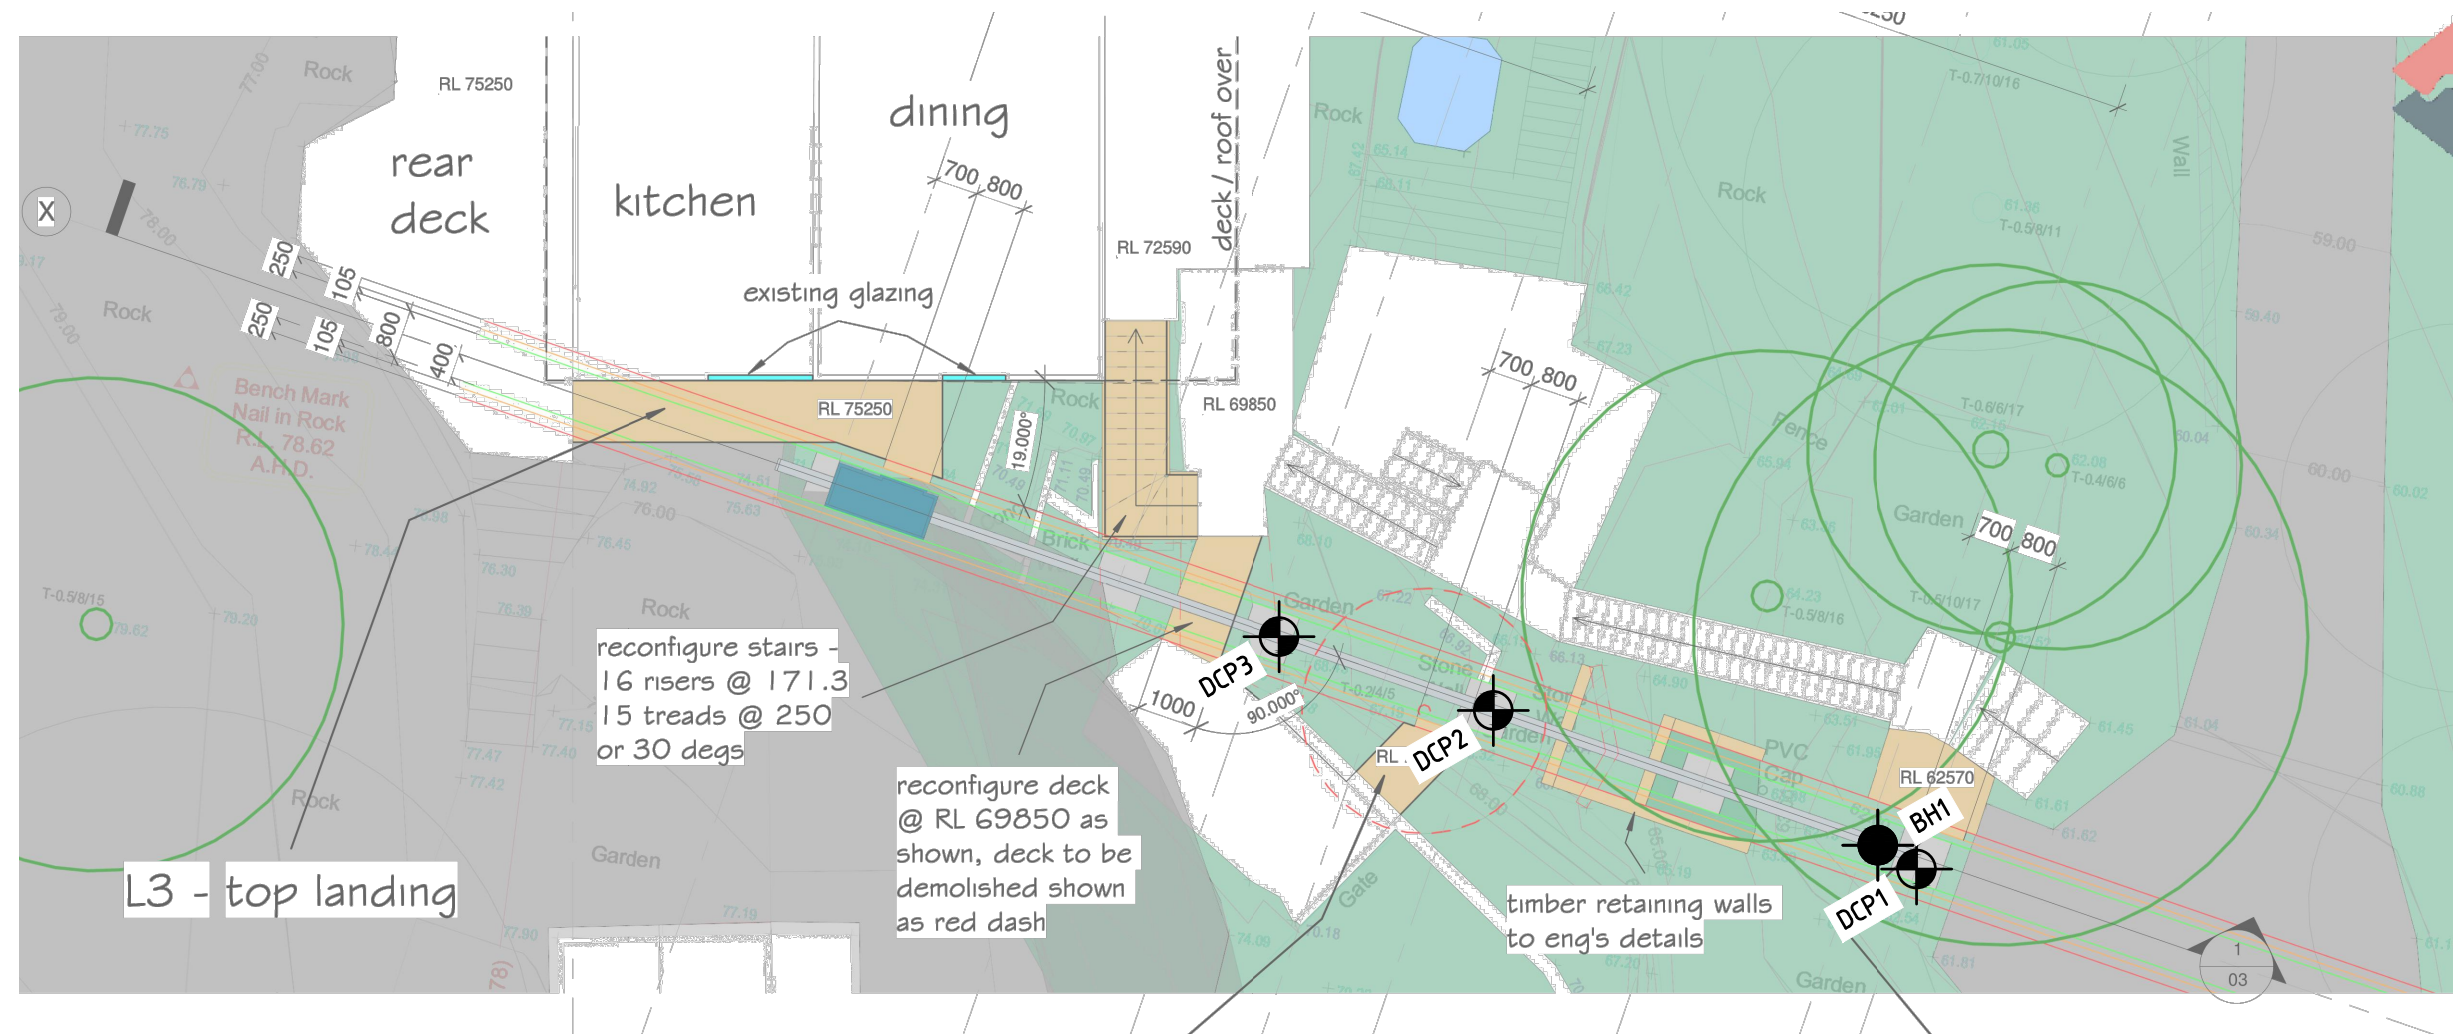
SITE PLAN/GROUND TEST LOCATIONS
SCALE NTS

DCP LOCATIONS

BOREHOLE LOCATION

DATE:	11/04/2022
SCALE:	AS SHOWN @ A3
DRAWING TITLE:	SITE PLAN
DRAWING NO:	AG 22124- S1

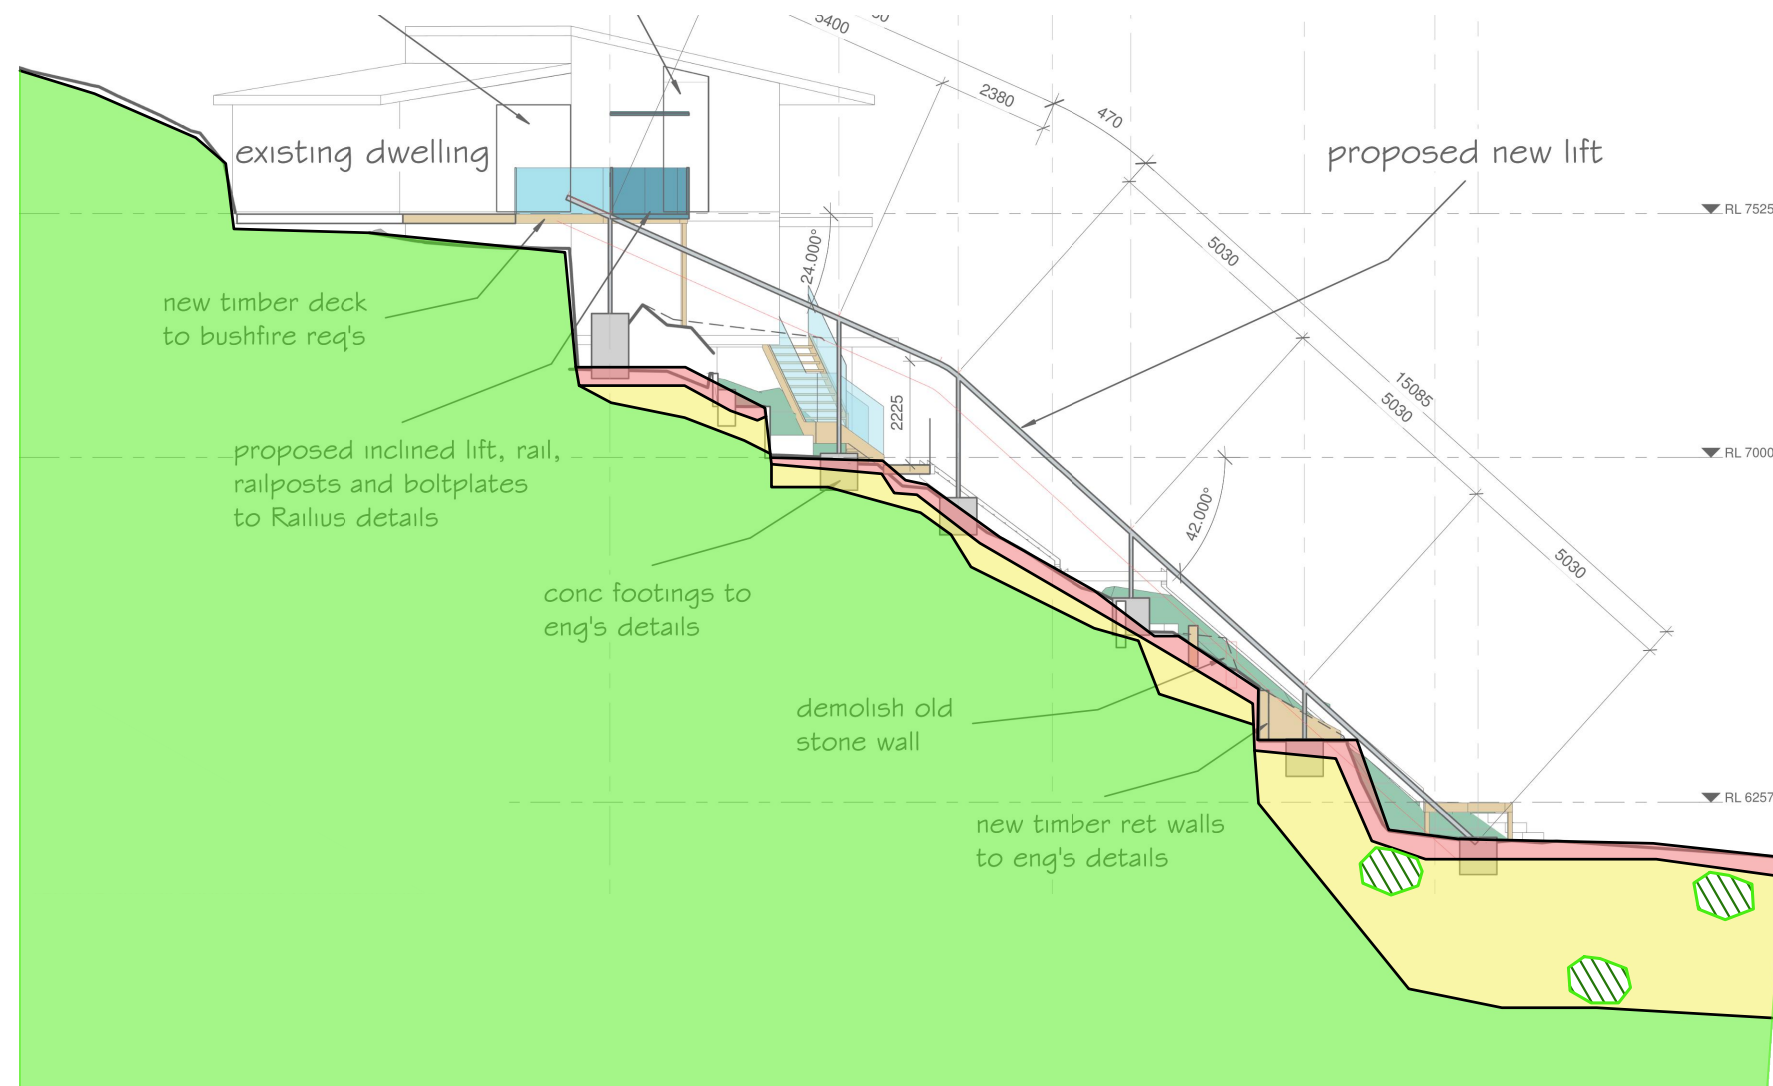
INFERRED GEOLOGICAL SECTION
SCALE NTS

INTERPRETED SUBSURFACE SECTION ONLY.
ACTUAL GROUND CONDITIONS MAY VARY.

- FILL/SILTY SAND
- SILTY SAND
- HAWKESBURY SANDSTONE
- POSSIBLE SANDSTONE FLOATERS IN THE UPPER PROFILE

ABN: 71 621 428 402 www.ascentgeo.com.au	CLIENT: CAROLE AND LEO HOKKE	INFERRED GEOLOGICAL SECTION AT 53-55 ANNAM ROAD BAYVIEW NSW	DATE: 11/04/2022
						(02) 9913 3179 admin@ascentgeo.com.au			SCALE: AS SHOWN @ A3
						1457 Pittwater Road North Narrabeen NSW 2101	COPYRIGHT: THE INFORMATION CONTAINED IN THIS DOCUMENT IS THE PROPERTY OF ASCENT GEOTECHNICAL CONSULTING. COPYING OF THIS MATERIAL IN WHOLE OR IN PART WITHOUT THE WRITTEN PERMISSION OF ASCENT GEOTECHNICAL CONSULTING CONSTITUTES AN INFRINGEMENT OF COPYRIGHT LAWS.		DRAWING TITLE: SECTION
A	11.04.22	PRELIMINARY ISSUE	VT	BM					DRAWING NO: AG 22124- S2
REV	DATE	REVISION DESCRIPTION	REV BY	CHCKD

The soil profile consists of sandy topsoil (O & A Horizons) and weathered bedrock (C Horizon) with the potential for large sandstone floaters. Based on our observations and the results of testing on site, we would expect weathered sandstone bedrock to be found within 0.00 to 2.25 metres below current surface levels across the area of the proposed works.
