PRELIMINARY GEOTECHNICAL ASSESSMENT: **50 Grandview Grove, Seaforth**

1.0 Proposed Development

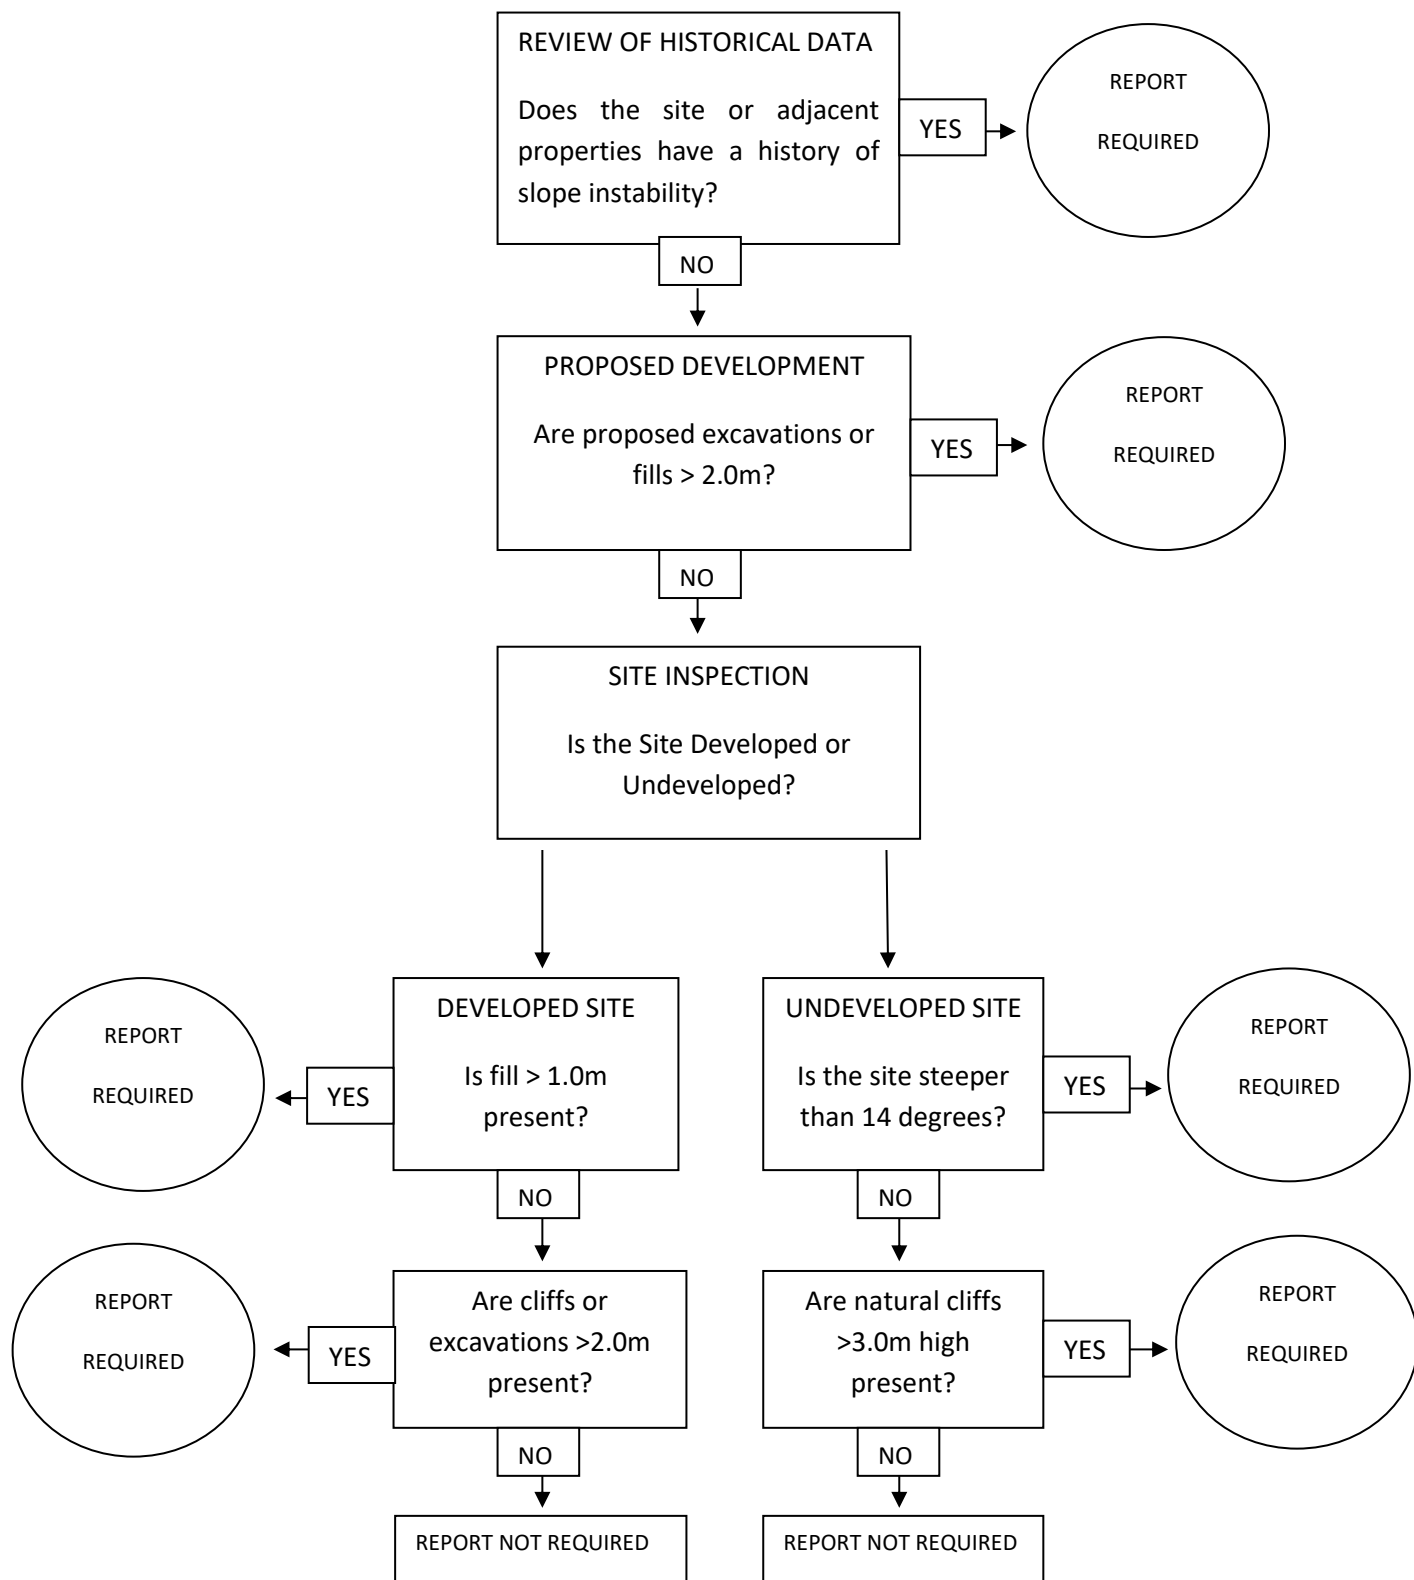
Preliminary Assessment Flow Chart – Northern Beaches Council (Manly)

The proposed development and site conditions were considered and applied to the Council Flow Chart.
