Ref: SRE/481/FF/19

RE: - PRELIMINARY GEOTECHNICAL ASSESSMENT FOR PROPOSED ALTERATIONS AND ADDITIONS AT 52 Tallowood Way, Frenchs Forest, NSW 2086 - PRELIMINARY GEOTECHNICAL ASSESSMENT

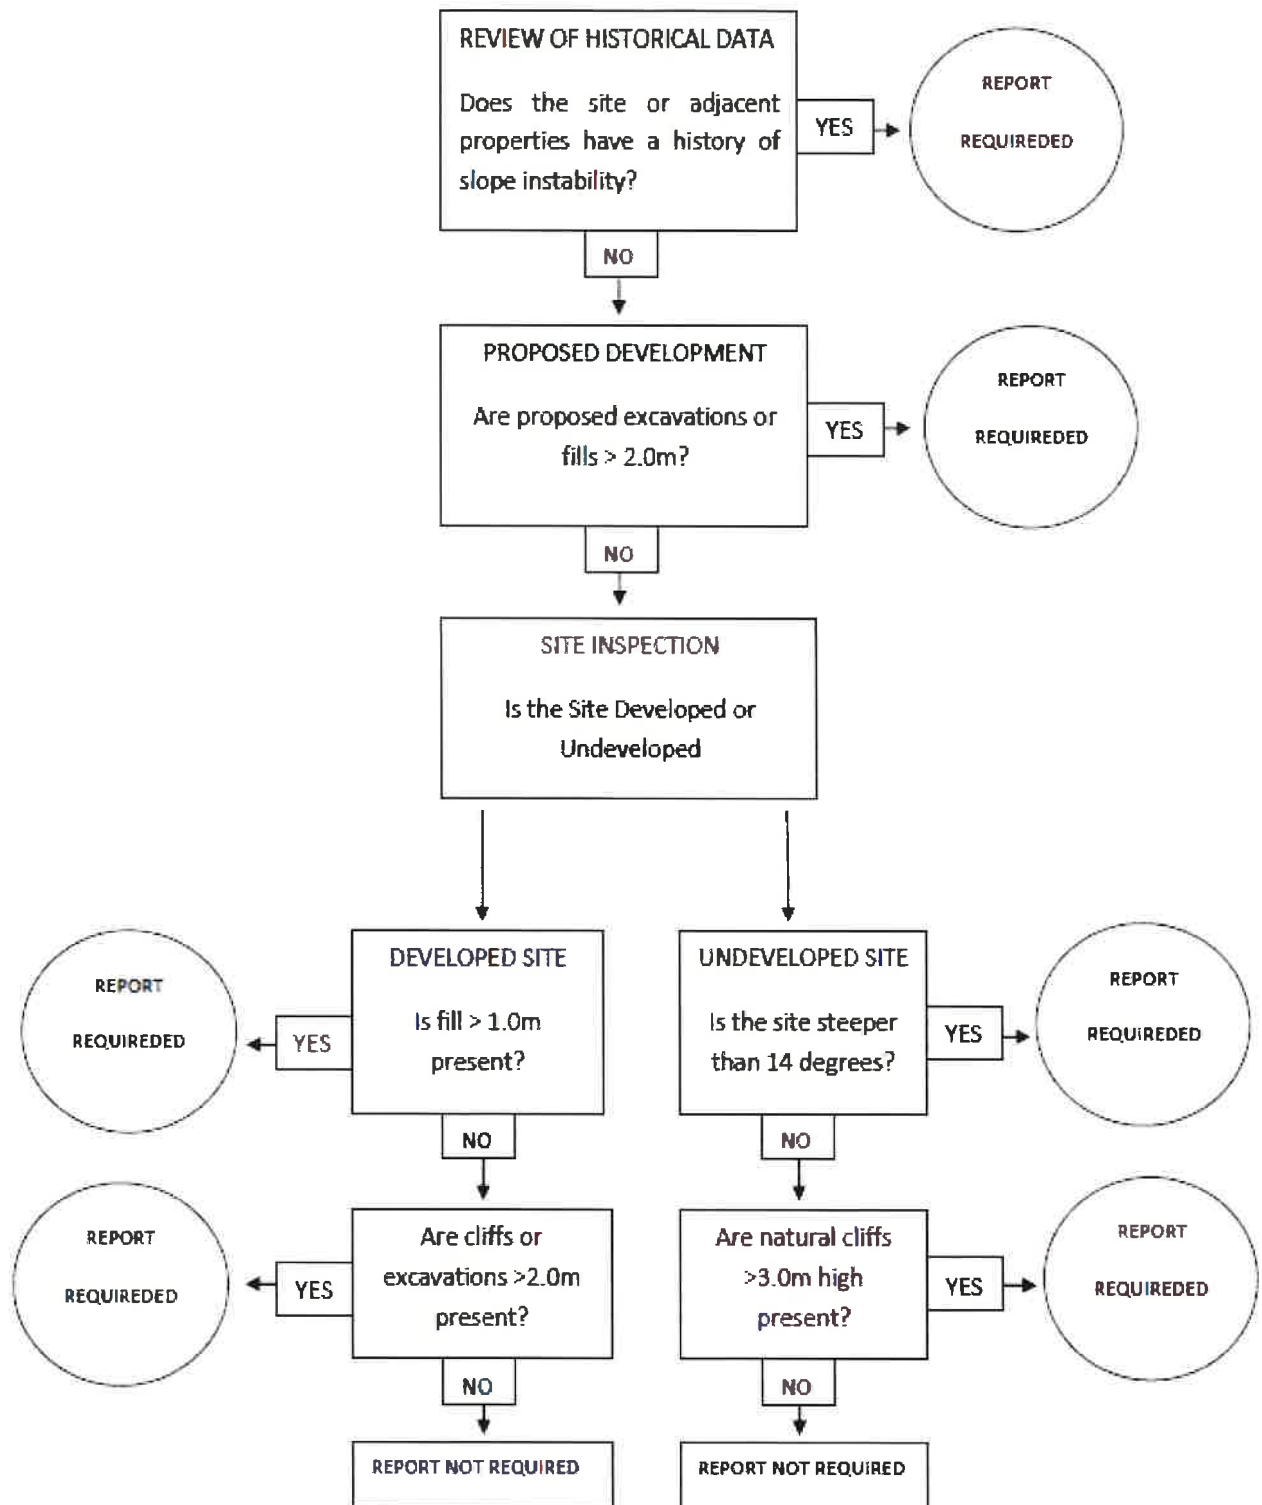
APPENDIX 1

CHECKLIST FLOW CHART FOR COUNCIL'S ASSESSMENT OF SITE CONDITIONS AND NEED FOR GEOTECHNICAL REPORT IN LANDSLIP RISK CLASSES B AND D

Appendix 1 – Checklist Flow Chart for Council's Assessment of Site Conditions and Need for Geotechnical Report in Landslip Risk Classes B and D
