PRELIMINARY GEOTECHNICAL ASSESSMENT:

29 Palomar Parade, Freshwater

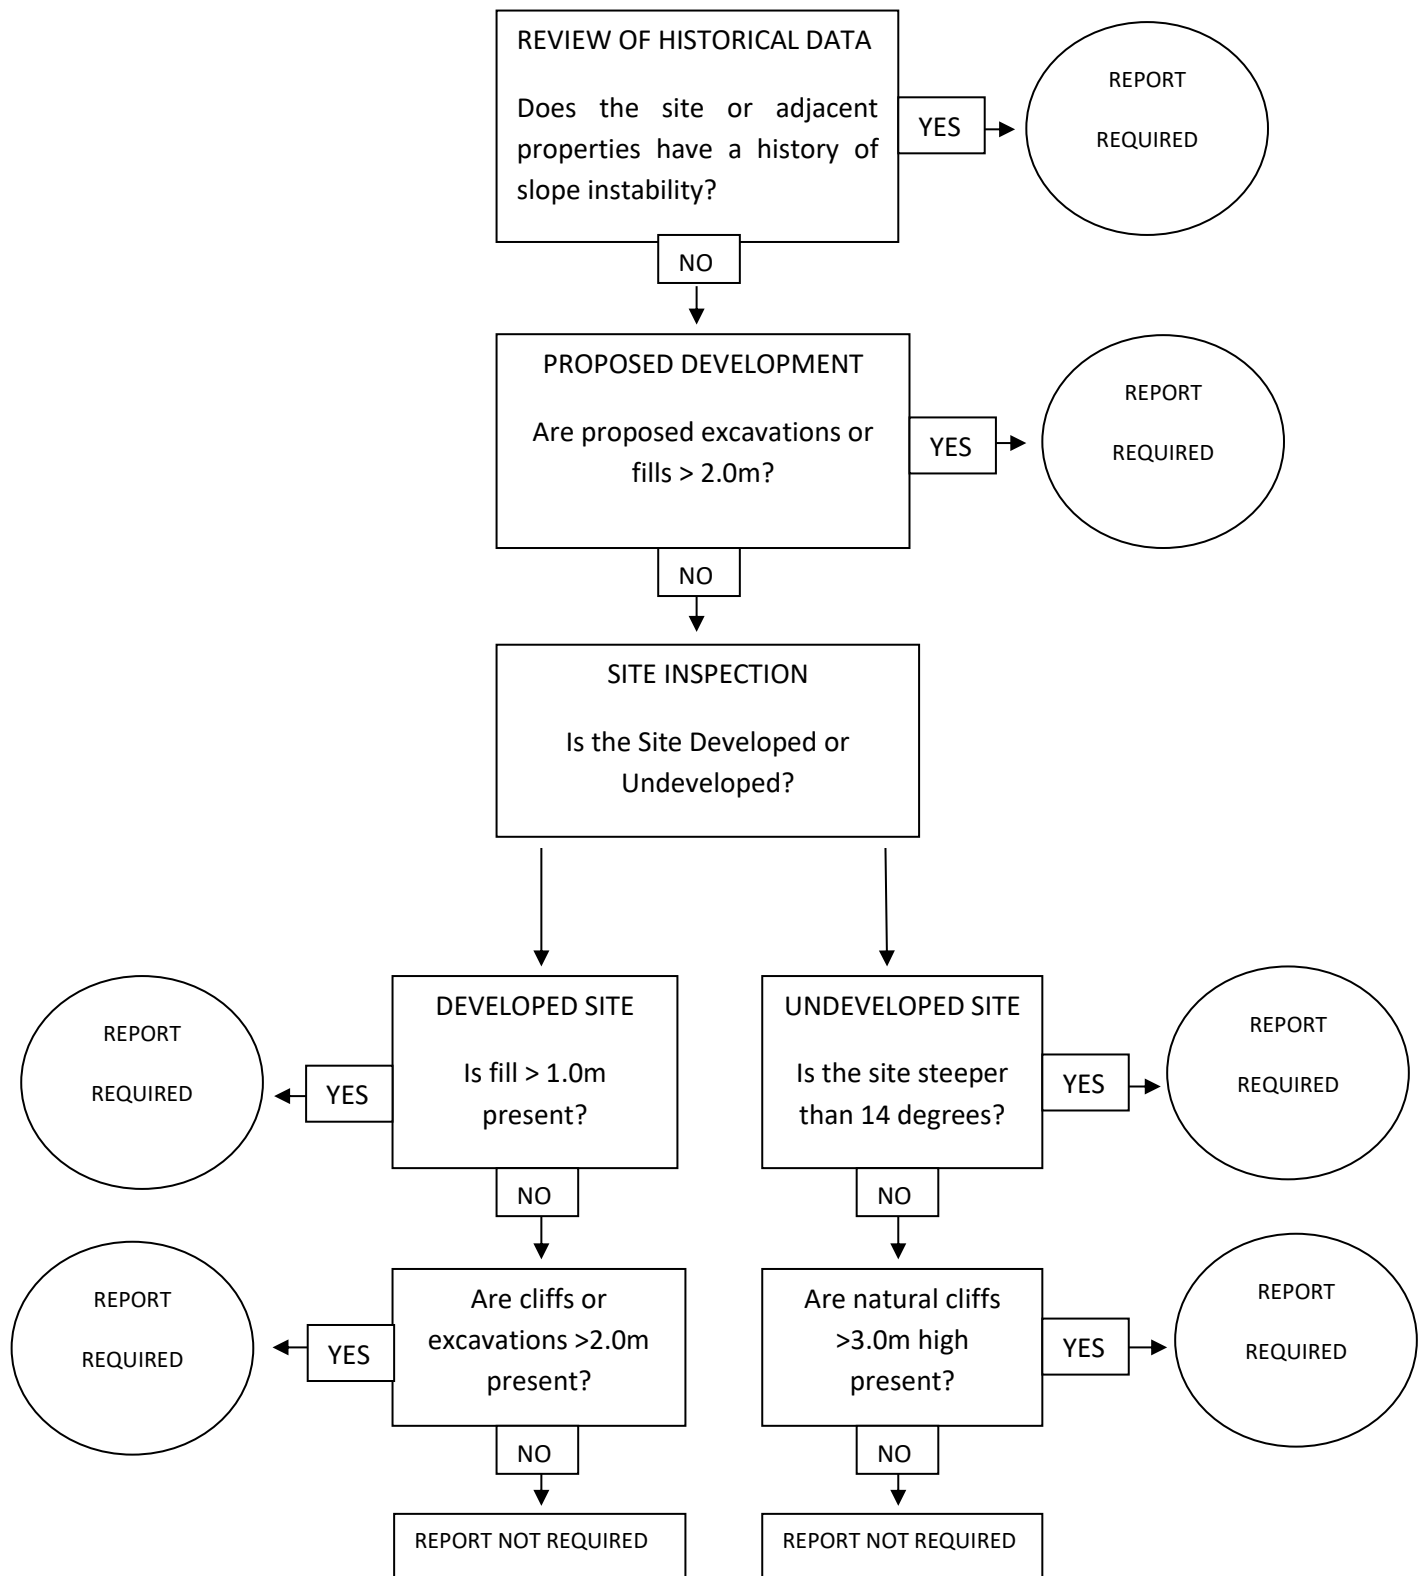
Preliminary Assessment Flow Chart – Northern Beaches Council (Warringah)

The proposed development and site conditions were considered and applied to the Council Flow Chart.
