Geotechnical Assessment

Project: Alterations and Additions
10 Wurringulla Avenue, Elvina Bay NSW.

REF: AG 20246
30 September, 2020

For Alterations and Additions at
10 Warringulla Avenue, Elvina Bay NSW

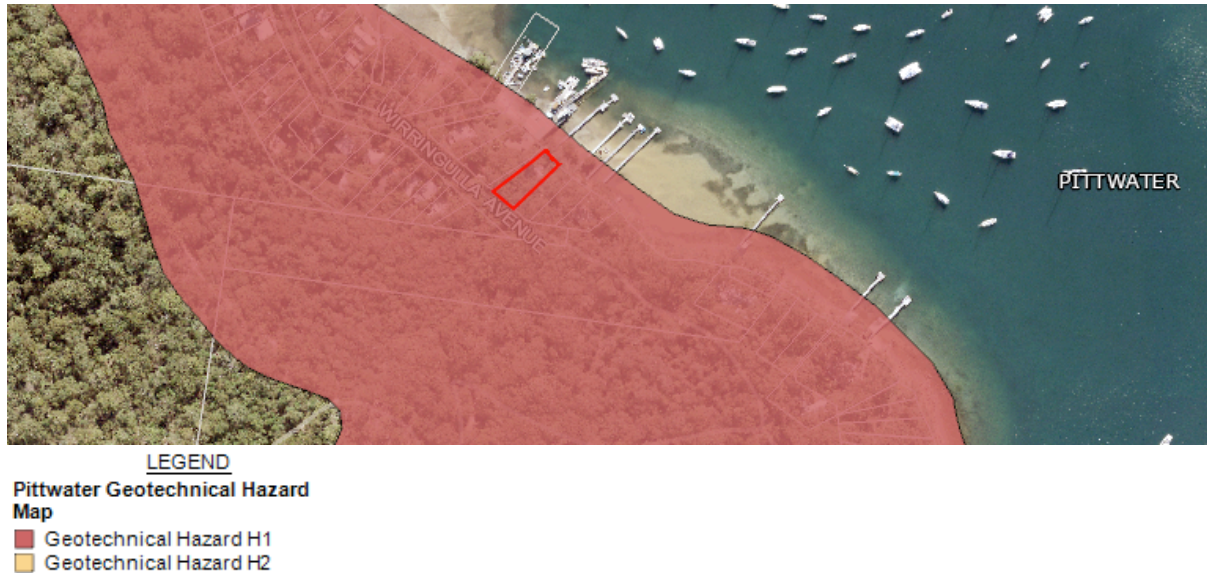
Image 2. PLEP Geotechnical Hazard Map – 10 Wirringulla Avenue, Elvina Bay NSW

- No evidence of significant soil creep, tension cracks or landslip instability were identified across the site or on adjacent properties, as viewed from the subject site, at the time of our inspection.
- The property is classified as **Geotechnical Hazard H1** with reference to Northern Beaches Council PLEP Landslip Risk Map Sheet (PLEP Geotechnical Hazard Map **Image 2** below).

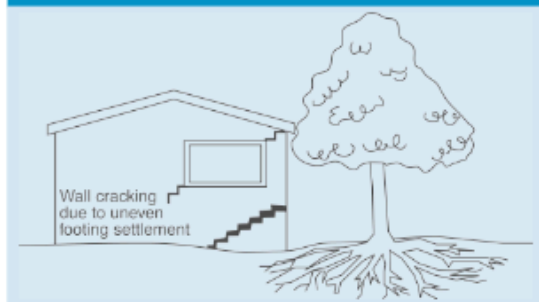
Trees can cause shrinkage and damage

As the weather pattern changes and the soil begins to dry out, the external footings will be first affected, beginning with the locations where the sun's effect is strongest. This has the effect of lowering the external footings. The doming is accentuated and cracking reduces or disappears where it occurred because of dishing, but other cracks open up. The roof lines may become convex.

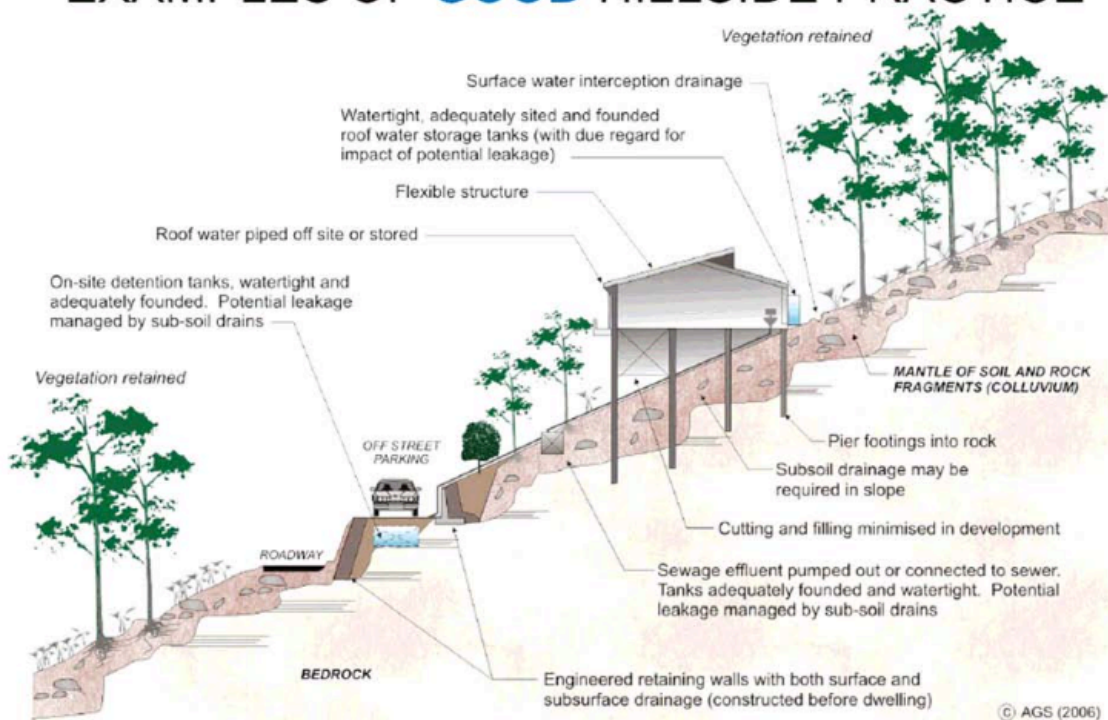
EXAMPLES OF **GOOD** HILLSIDE PRACTICE

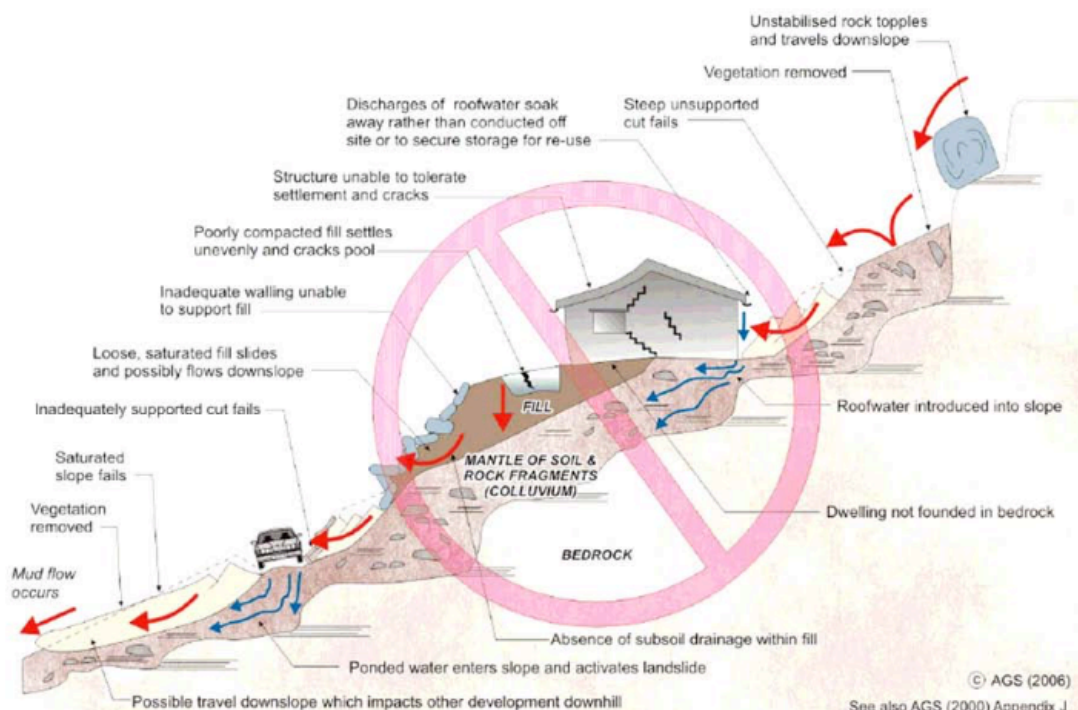
EXAMPLES OF **POOR** HILLSIDE PRACTICE
