Preliminary Geotechnical Assessment

Project: New Pool & Landscaping 32 Clarke Street, Narrabeen NSW

32 Clarke Street, Narrabeen NSW

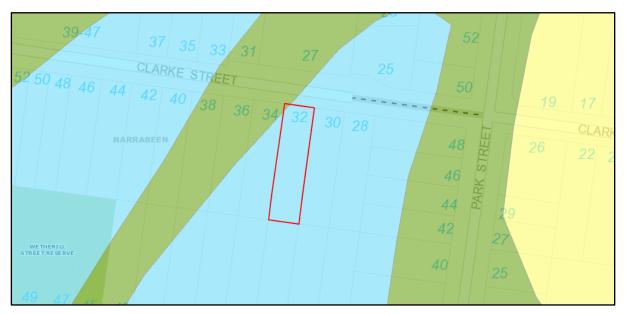
Image 1. Warringah Landslip Risk Map: 32 Clarke Street, Narrabeen NSW (© NBC Maps)

The site is mapped as Areas D & E on the Landslip Risk Map WLEP 2011 (Image 1, below).
