## Preliminary Geotechnical Assessment

For New Pool and Associated Works at  
39 The Outlook, Bilgola Plateau NSW

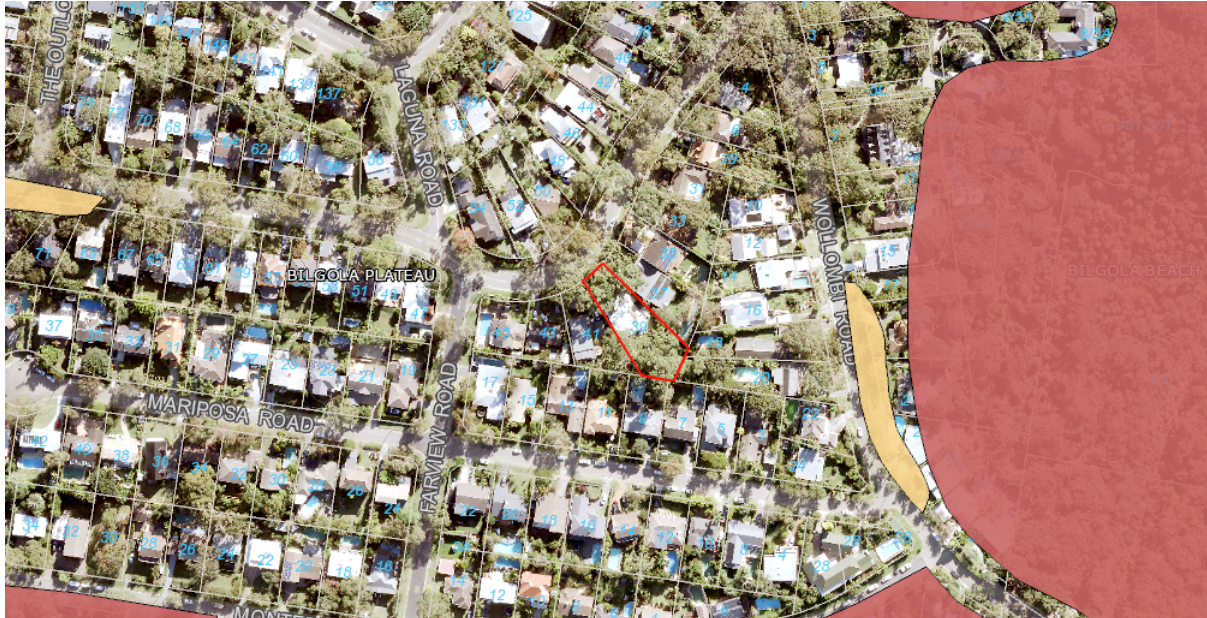
The site is not mapped as a **Geotechnical Hazard Zone** with reference to Geotechnical Hazard Map PLEP 2014 (**Image 1**, below).

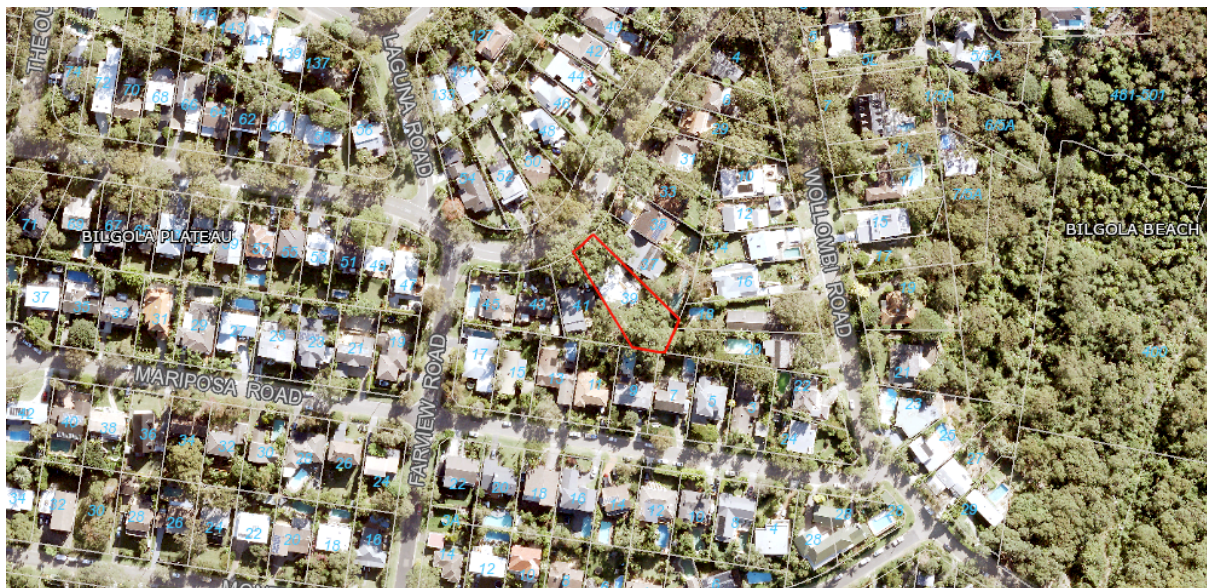
**Image 2:** Site location – 39 The Outlook, Bilgola Plateau NSW – Red Polygon (© NBC Maps)
