Preliminary Geotechnical Assessment

Project: Alterations & Additions
7A Nulgarra Street, Frenchs Forest NSW

Prepared for:
JJ Drafting Australia

Ref: AG 25067
24 February 2025

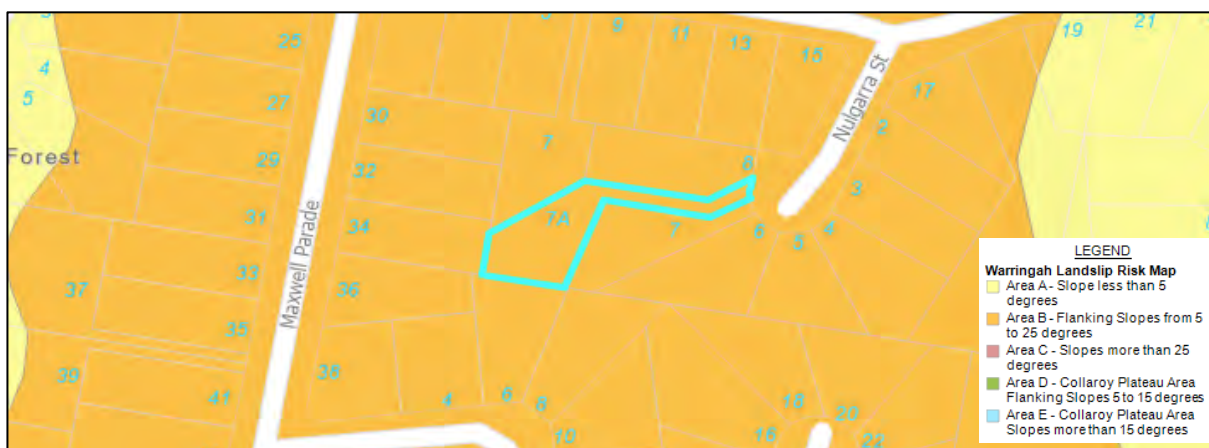
Figure 1. Warringah Landslip Risk Map: 7A Nulgarra Street, Frenchs Forest NSW (© NBC Maps)

The site is mapped as **Area B** subject to specific landslip risk/geotechnical hazard mapping with reference to the Warringah (WLEP) Landslip Risk Map, Northern Beaches Council (**Image 1**).

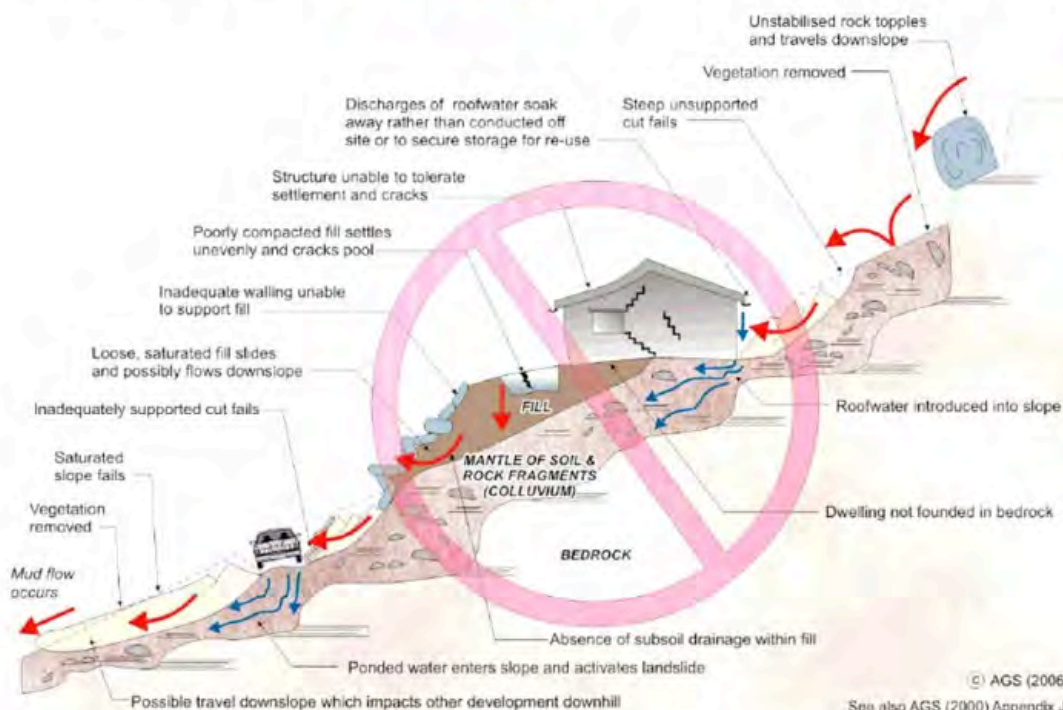
EXAMPLES OF **POOR** HILLSIDE PRACTICE
