Preliminary Geotechnical Assessment

Project: Alterations & Additions
13 Prince Edward Road, Seaforth NSW

Ref: AG 25007
16 January 2025

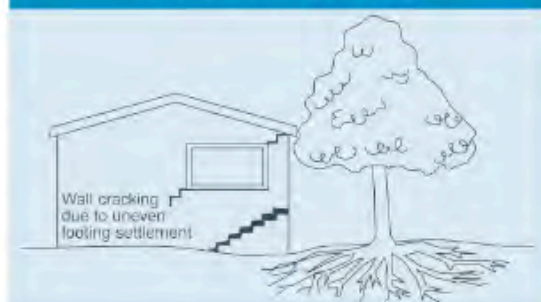
Trees can cause shrinkage and damage

As the weather pattern changes and the soil begins to dry out, the external footings will be first affected, beginning with the locations where the sun's effect is strongest. This has the effect of lowering the external footings. The doming is accentuated and cracking reduces or disappears where it occurred because of dishing, but other cracks open up. The roof lines may become convex.

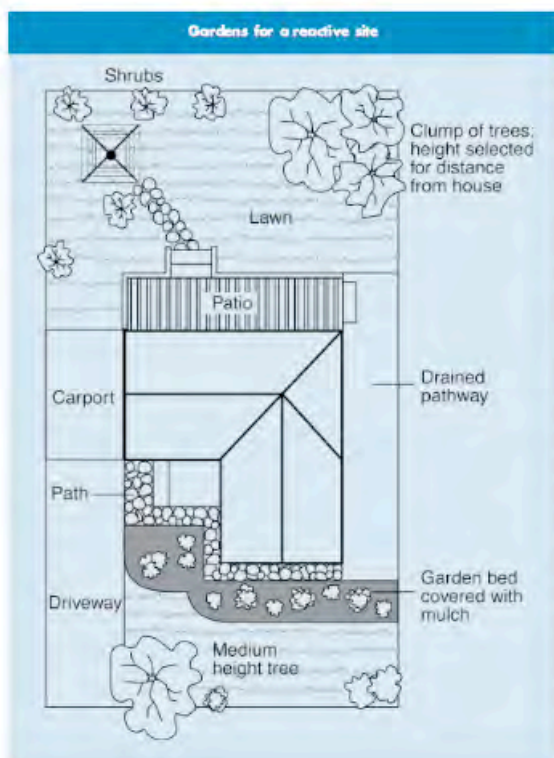
should extend outwards a minimum of 900 mm (more in highly reactive soil) and should have a minimum fall away from the building of 1:60. The finished paving should be no less than 100 mm below brick vent bases.
