Geotechnical Assessment

Project: New Dwelling

24 Sir Thomas Mitchell Drive, Davidson, NSW

REF: AG 18004

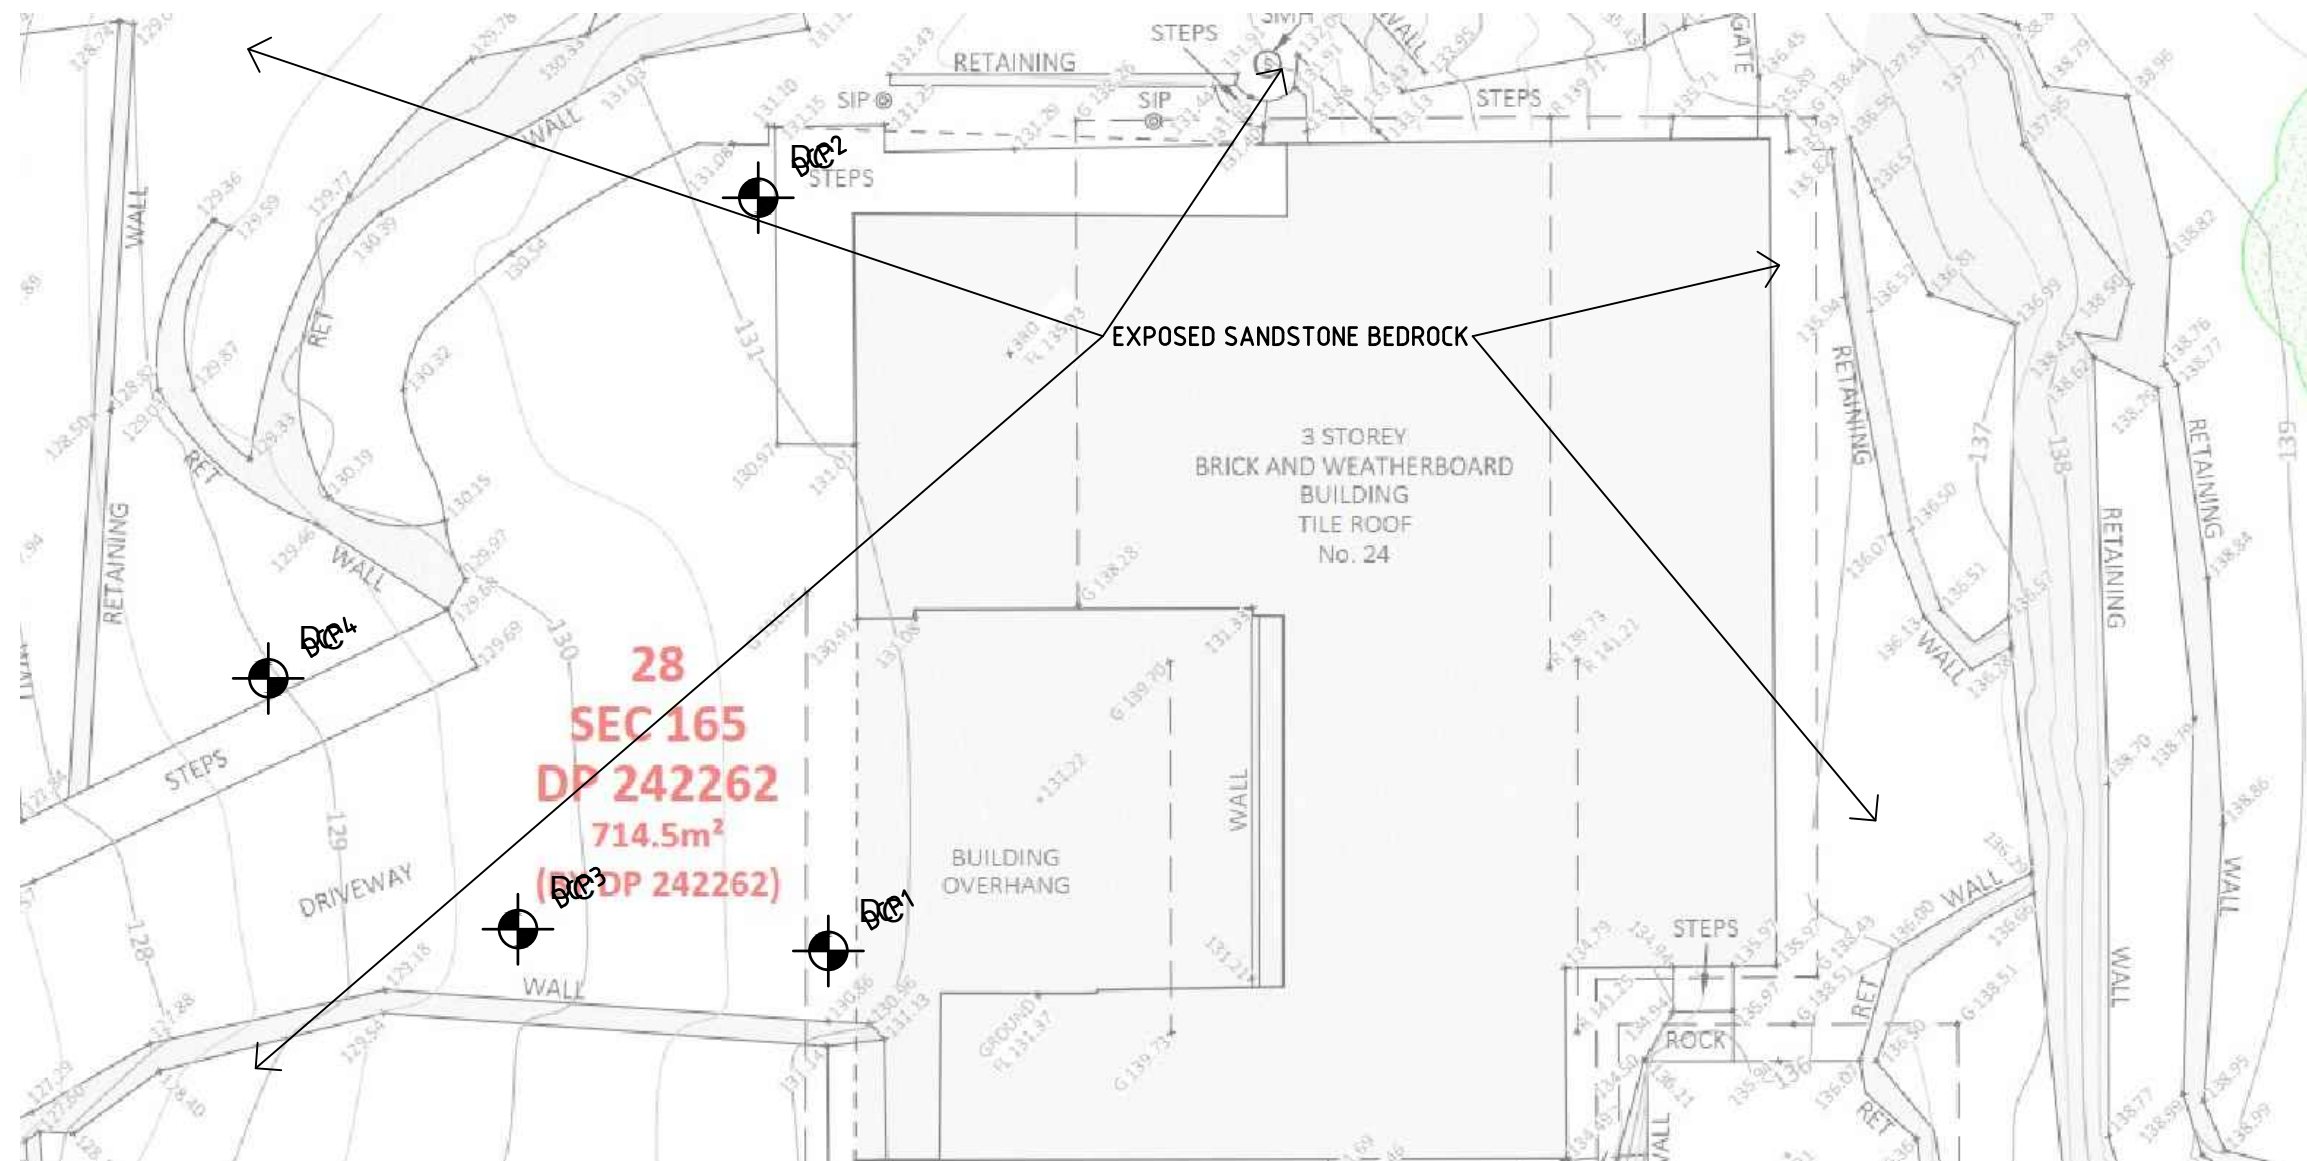
SITE PLAN / GROUND TEST LOCATIONS

SCALE: 1:100

Appendix A:	Site Plan/Ground Test Locations & Geological Cross Section
Appendix B:	Engineering logs
Appendix C:	General Notes
	CSIRO Sheet BTF-18 “Foundation Maintenance and Footing Performance: A Homeowners Guide”
	Australian Geoguide LR8 – Examples of Good/Bad Hillside Construction Practice
	Australian Geomechanics Guidelines 2007 Appendix C

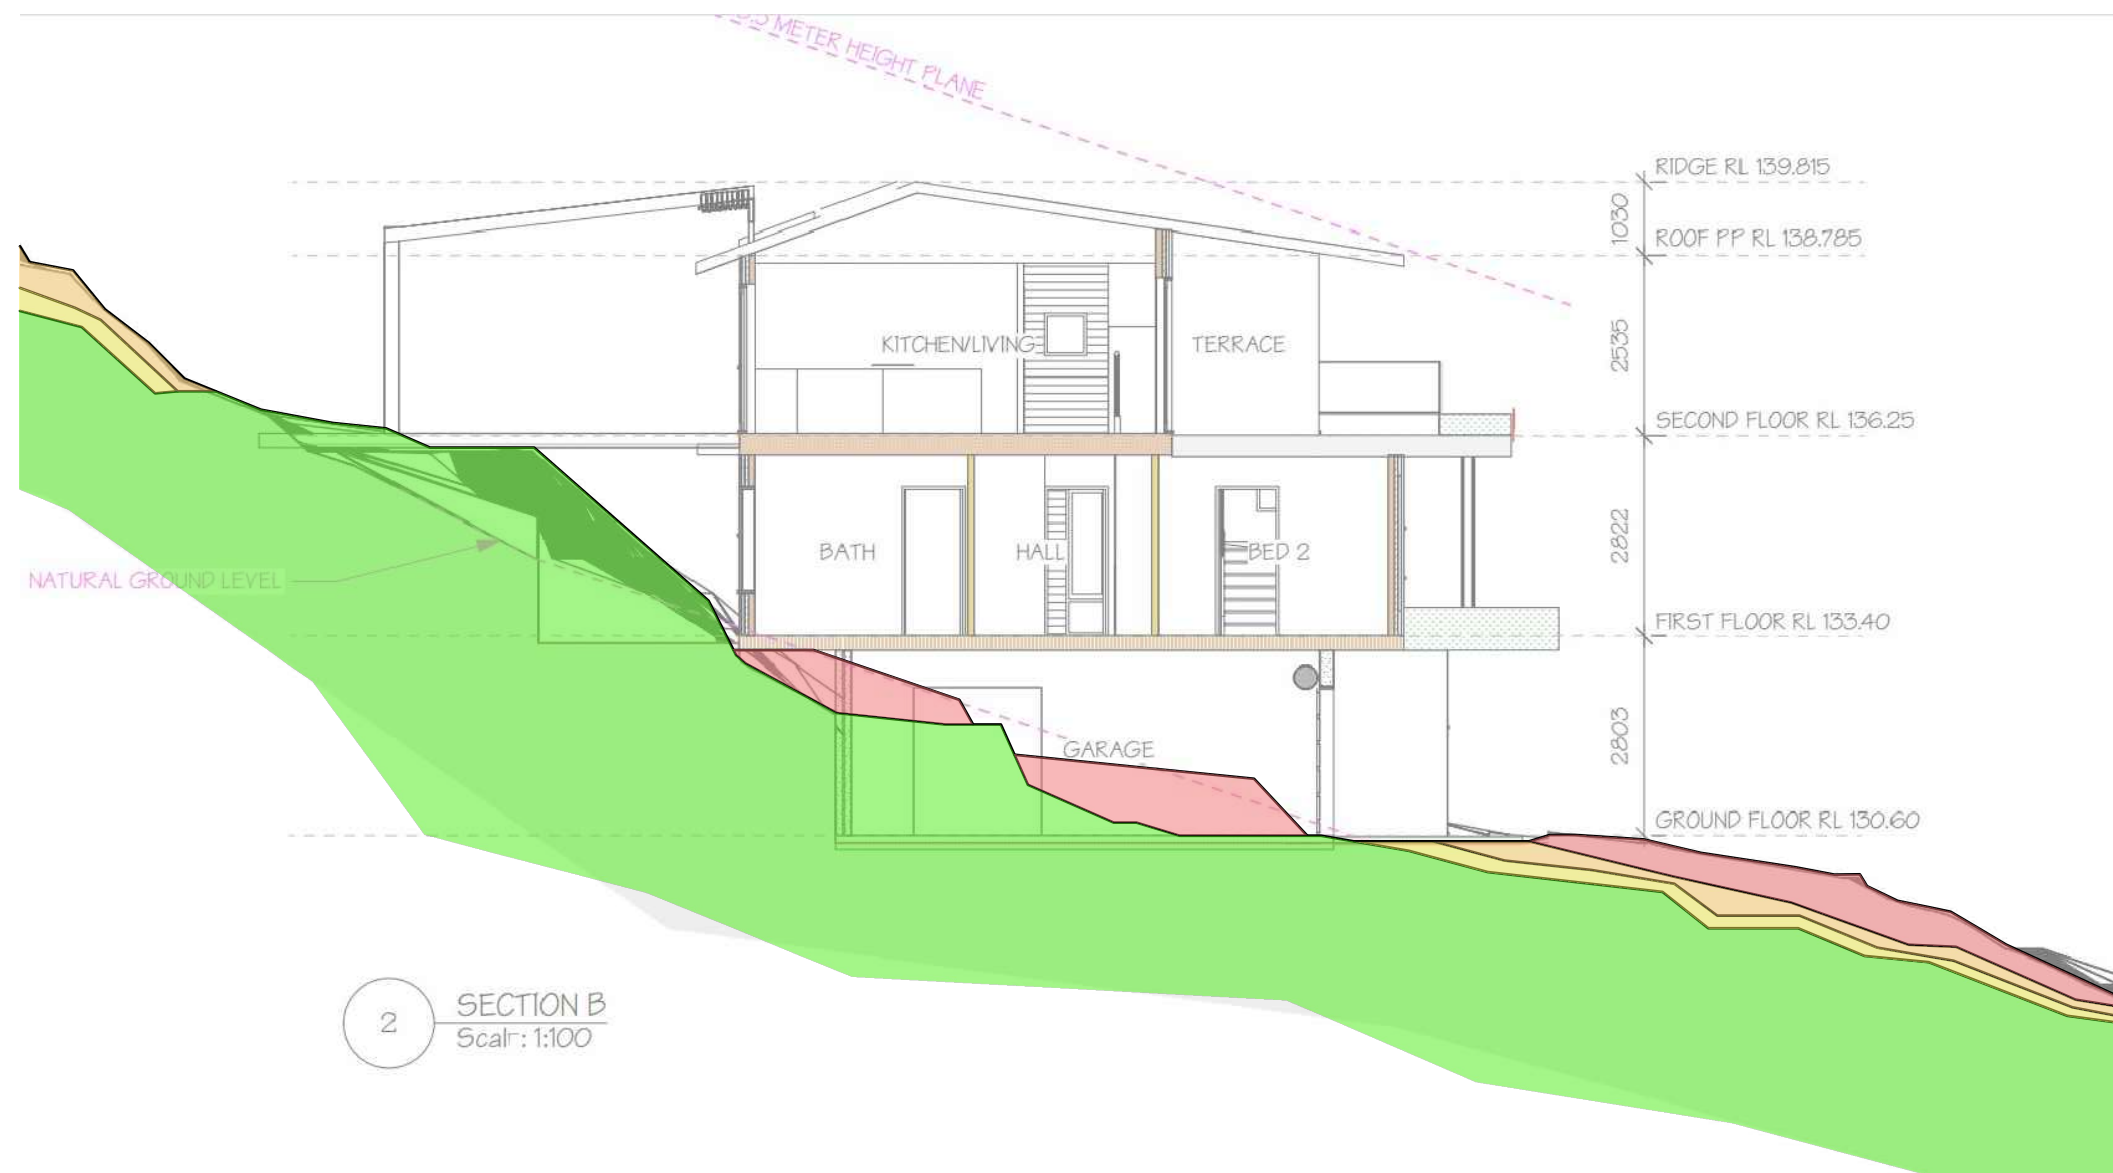
INFERRED GEOLOGICAL TYPE SECTION

INTERPRETED SUBSURFACE SECTION ONLY.
ACTUAL GROUND CONDITIONS MAY VARY.

INFERRED GEOLOGICAL SECTION
SCALE NTS
