Geotechnical Assessment

Project: New Swimming Pool
64 Dolphin Crescent, Avalon Beach NSW

Ref: AG 22141
11 May 2022

For **Swimming Pool and Associated Works** at
64 Dolphin Crescent, Avalon Beach NSW

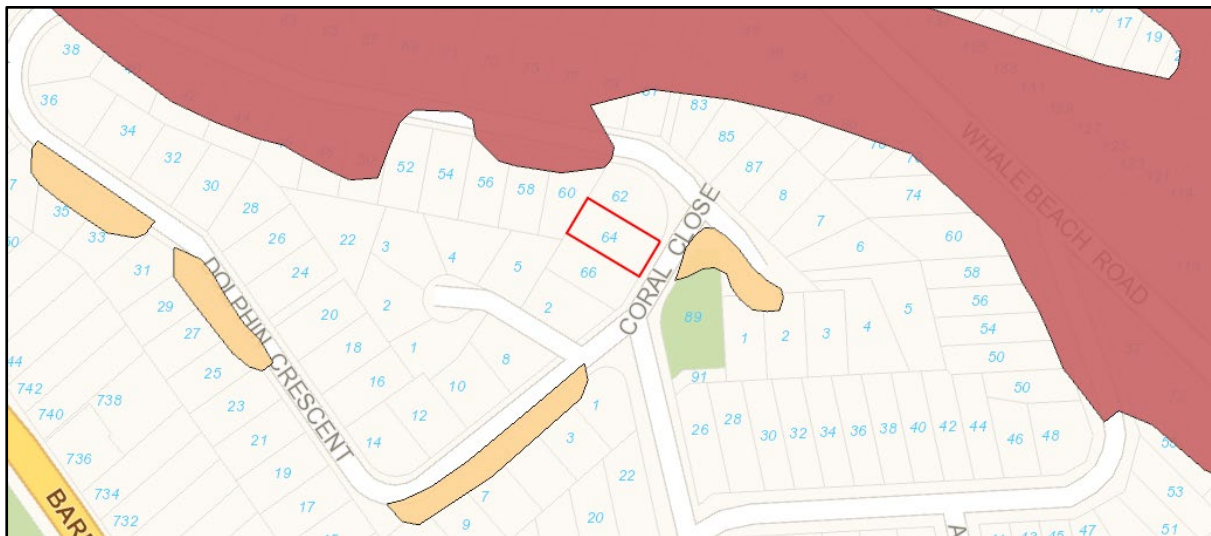
Image 2. PLEP Geotechnical Hazard Map
– 64 Dolphin Crescent, Avalon Beach NSW (© NBC Maps)

- No evidence of significant soil creep, tension cracks or landslip instability were identified across the site or on adjacent properties as viewed from the subject site at the time of our inspection.
- Based on reference to the plan entitled “Geotechnical Hazard Mapping” (Ref. P21DCP-BC-MDCP2002, dated 2007) prepared by GHD LONGMAC on behalf of Pittwater Council, the site is not mapped within a specified **Geotechnical Hazard** zone.

LEGEND
Pittwater Geotechnical Hazard Map
■ Geotechnical Hazard H1
■ Geotechnical Hazard H2

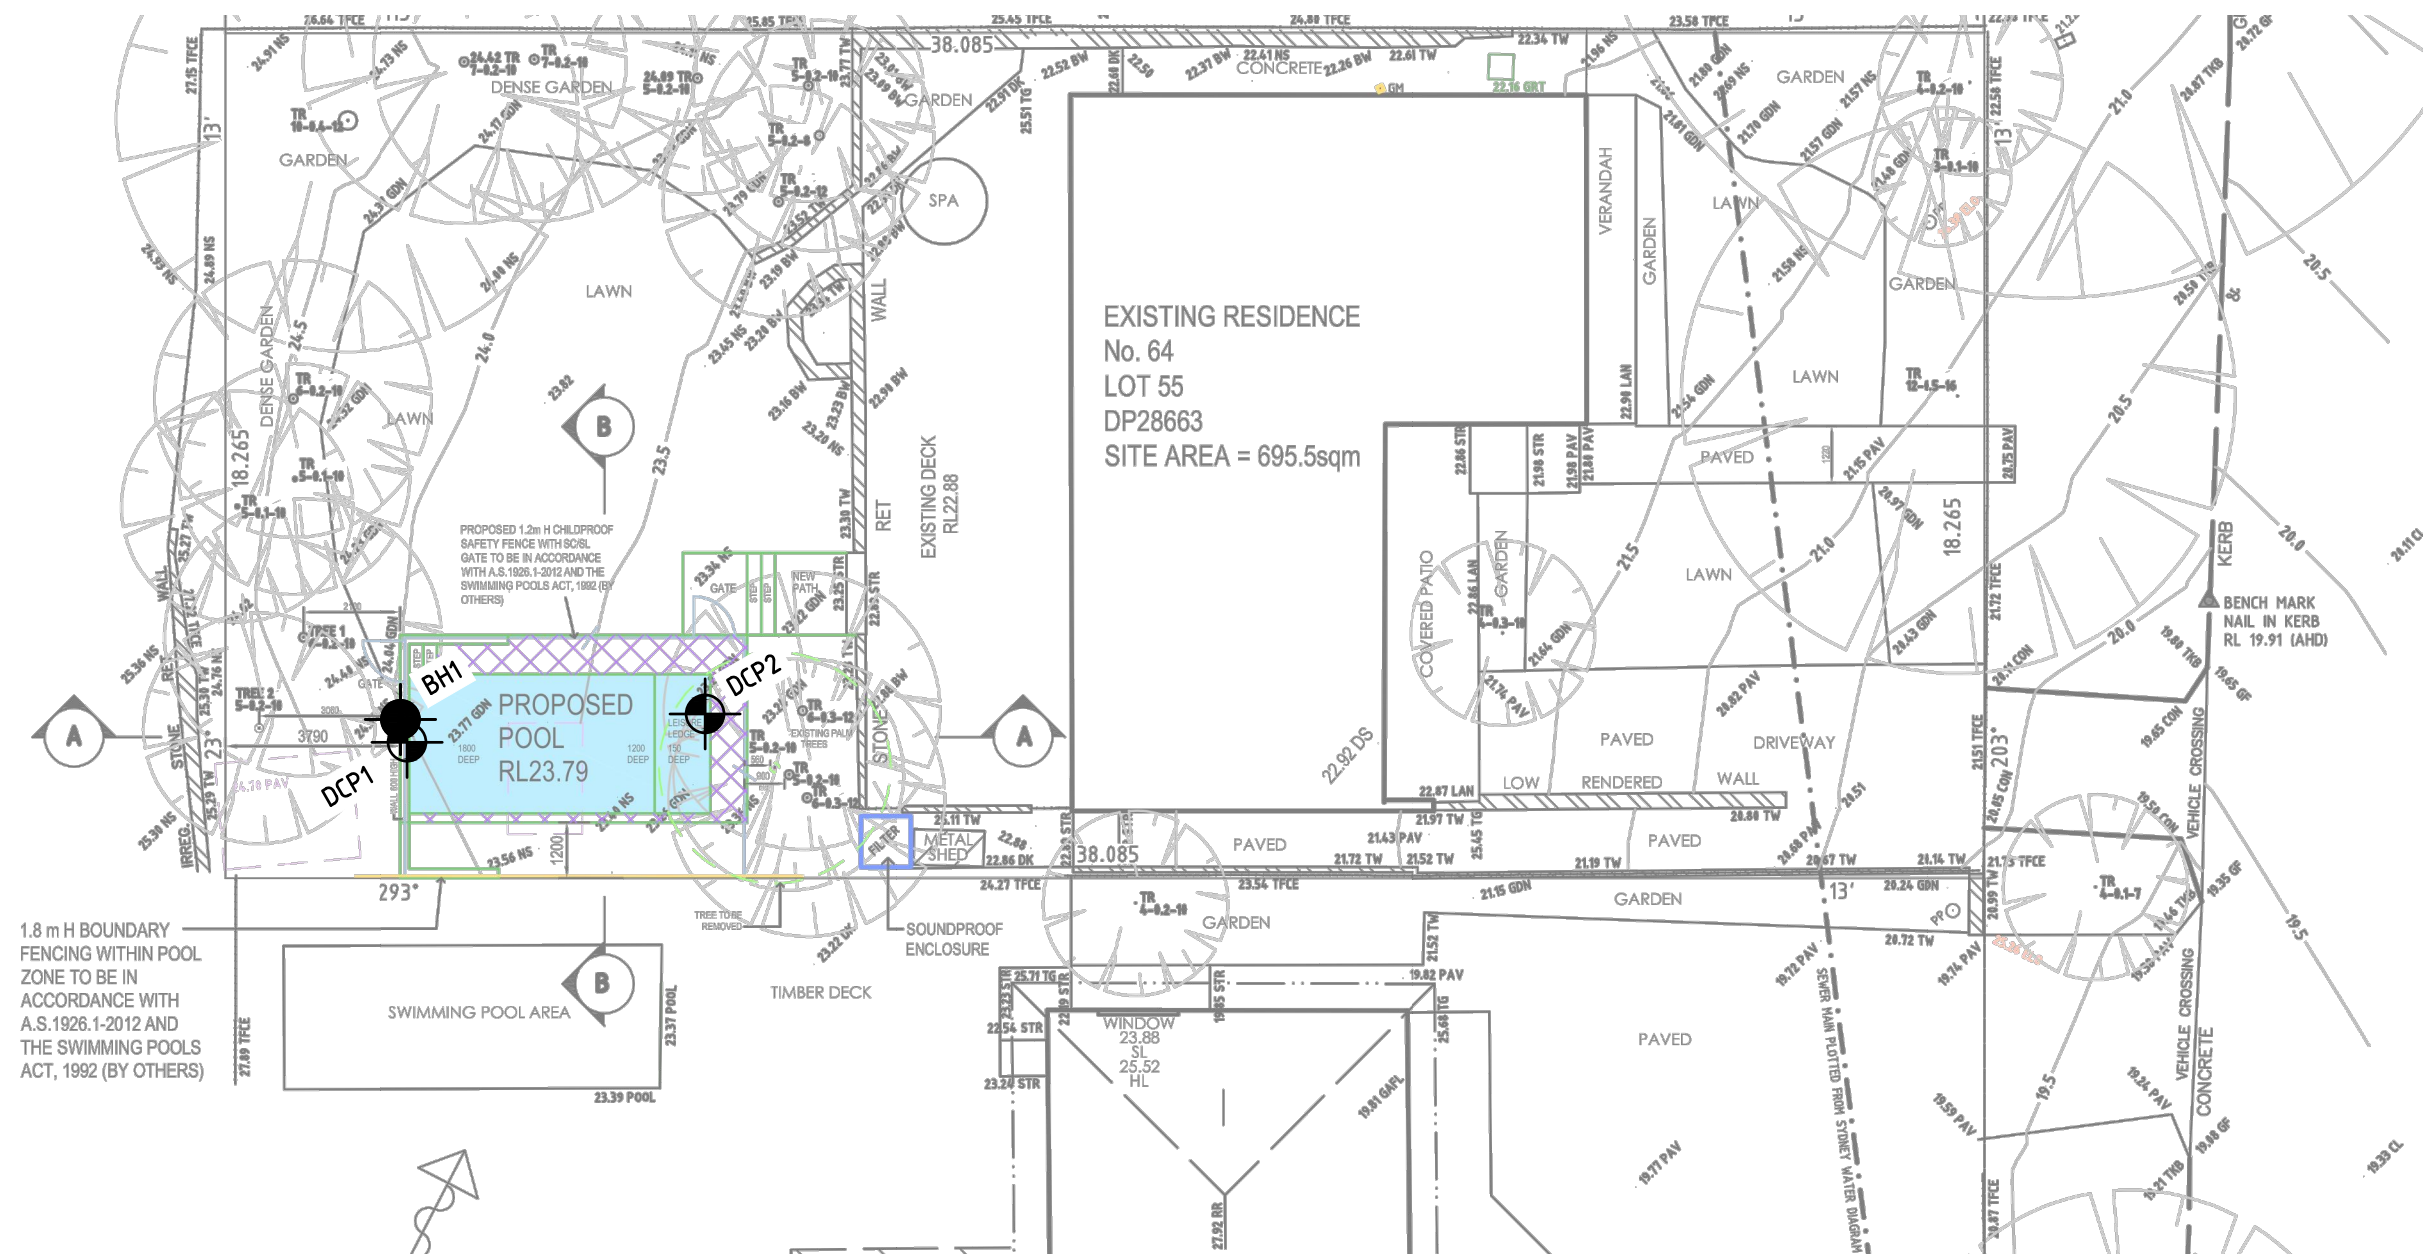
SITE PLAN/GROUND TEST LOCATIONS
SCALE NTS

DCP LOCATIONS

BOREHOLE LOCATION

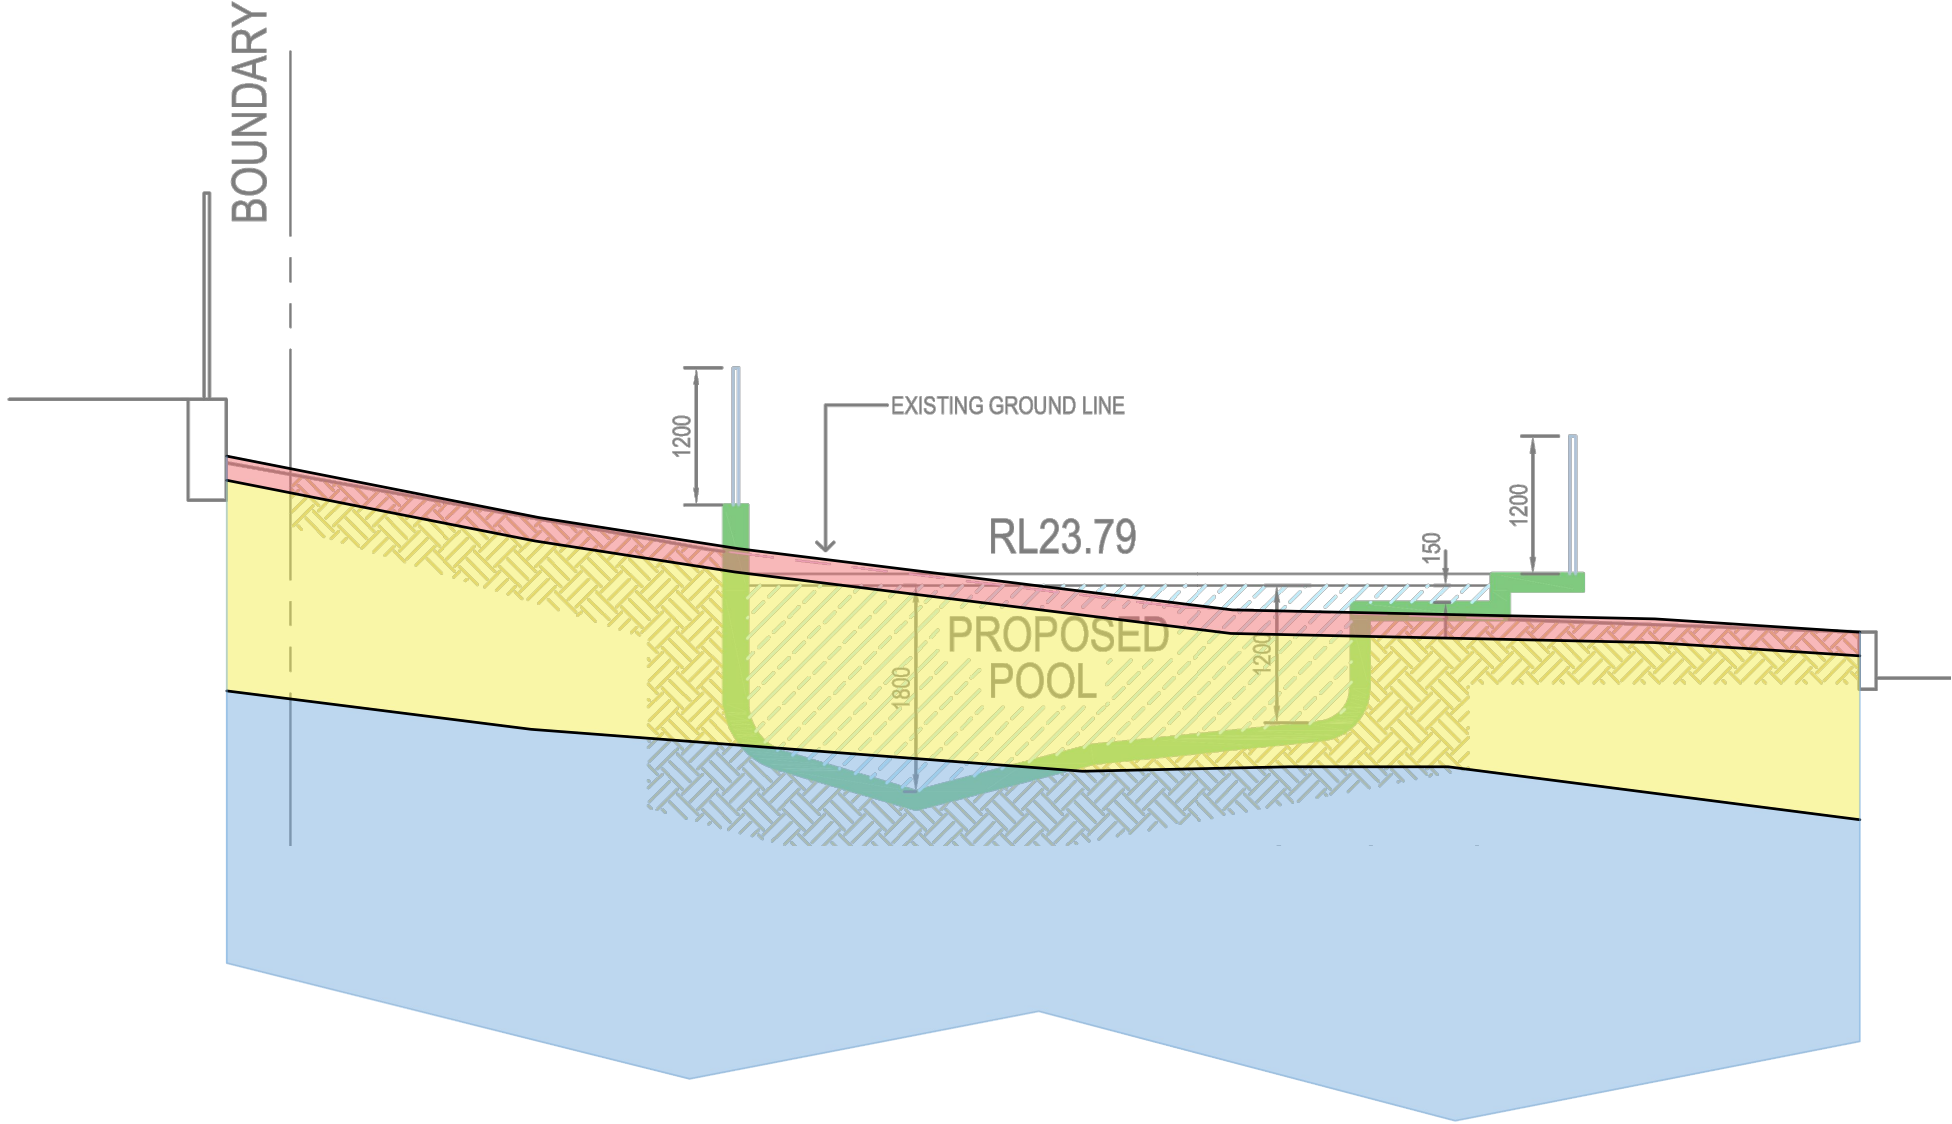
INTERPRETED SUBSURFACE SECTION ONLY.
ACTUAL GROUND CONDITIONS MAY VARY.

The soil profile consists of shallow uncontrolled fill and silty topsoil (O & A Horizons), silty clay (B Horizon) and weathered bedrock (C Horizon). Based on our observations and the results of testing on site, we would expect weathered shale bedrock to be found within 1.50 to 2.20 metres below current surface levels across the area of the proposed works. Bedrock conditions should be expected to be extremely low to low strength shale. Medium to high strength Sandstone bedrock is not anticipated within the proposed range of excavation.
