# **Geotechnical Assessment**

**Project:** Alterations & Additions 8 Wakely Place, Forestville NSW

**Ref:** AG 24369 12 September 2024

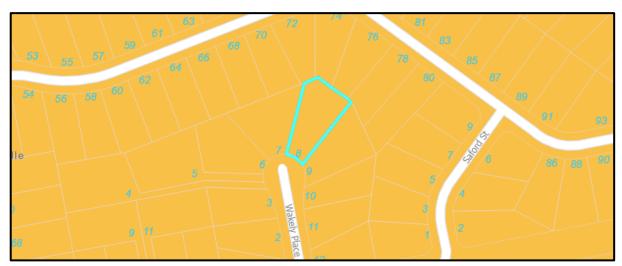
**Figure 1.** Warringah Landslip Risk Map: 8 Wakely Place, Forestville NSW (© **NBC Maps**)

The site is mapped as **Area B** subject to specific landslip risk/geotechnical hazard mapping with reference to the Warringah (WLEP) Landslip Risk Map, Northern Beaches Council (**Image 1**).
