From: Bob Chambers
Sent: 13/05/2022 1:56:54 PM
To: Council Northernbeaches Mailbox
Subject: DA2022/0469 - 1102 Barrenjoey Road, Palm Beach (Our Ref:21-131A)
Attachments: Submission Final.pdf;

**Re: DA2022/0469 (“the DA”);
Construction of shop top housing (“the proposal”);
1102 Barrenjoey Road, Palm Beach (“the development site”).**

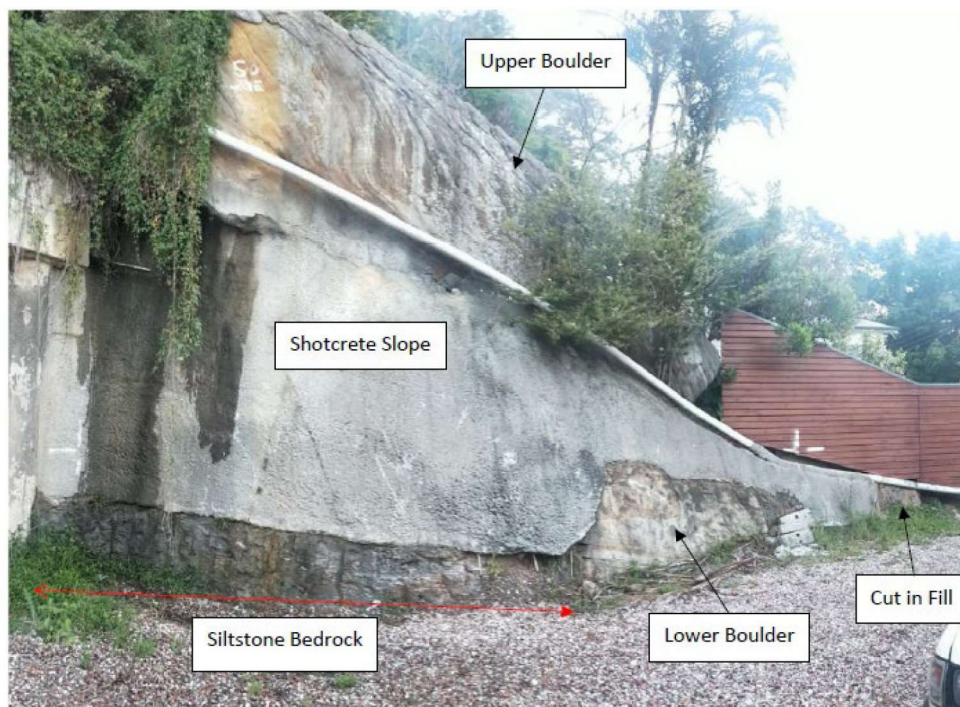
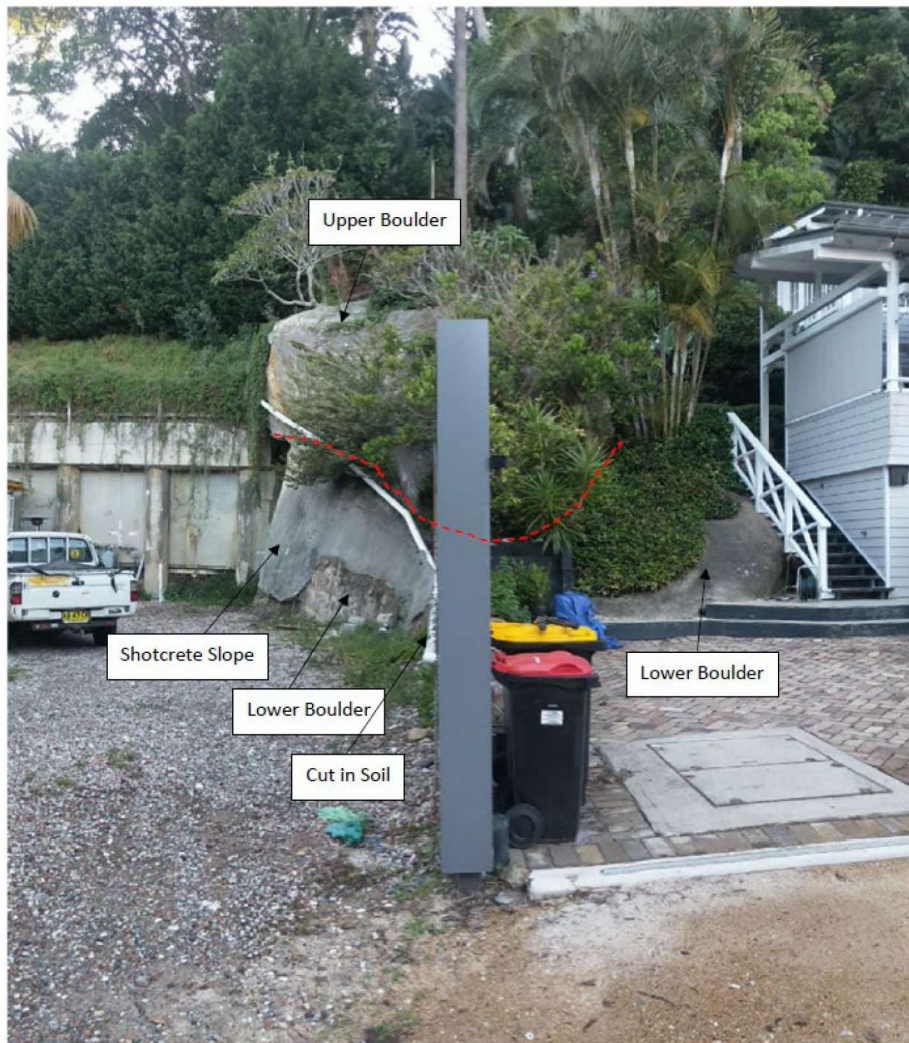
The common boundary condition between the development site and our client's home is shown on the photographs in the geotechnical report submitted with the DA: see below: -

Photos extracted from report prepared by JK Geotechnics

The JK Geotechnics report from November 2020 refers to upper and lower boulders on the southern boundary. Both of these boulders extend onto our client's property.

The geotechnical report says that “portions of the existing boulders and shotcrete (and possibly mesh and bolts) at the southern end of the site will be removed during excavation of the proposed excavation footprint) (Section 7.1.3, page 19, JK Geotechnics report).

We understand this to mean that the part of the boulder above the excavation will be removed/ cut. Our understanding is reinforced by reference to Section 7.3.3 on page 26 of the JK Geotechnics report which states:

“Following removal of the required section of the sandstone boulder along the southern boundary, excavation and support of the underlying siltstone bedrock must be completed with care.”
