Geotechnical Assessment

Project: Alterations and Additions
38 Mildred Avenue, Manly Vale NSW.

Preliminary Geotechnical Assessment

For Alterations and Additions at
38 Mildred Avenue, Manly Vale NSW

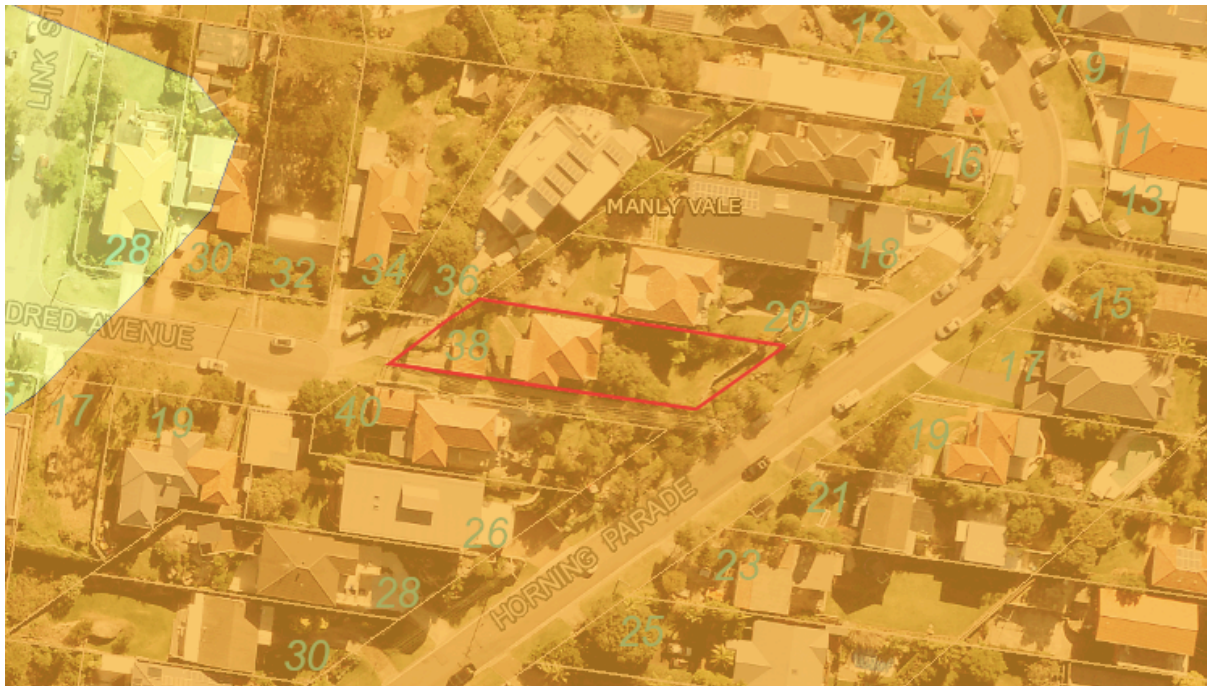
WARRINGAH LANDSLIP RISK MAP

The property is classified as **Area B** with reference to Northern Beaches Council WLEP Landslip Risk (WLEP Landslip Risk Map **Image 2** below).

- Area A - Slope less than 5 degrees
- Area B - Flanking Slopes from 5 to 25 degrees
- Area C - Slopes more than 25 degrees
- Area D - Collaroy Plateau Area Flanking Slopes 5 to 15 degrees
- Area E - Collaroy Plateau Area Slopes more than 15 degrees

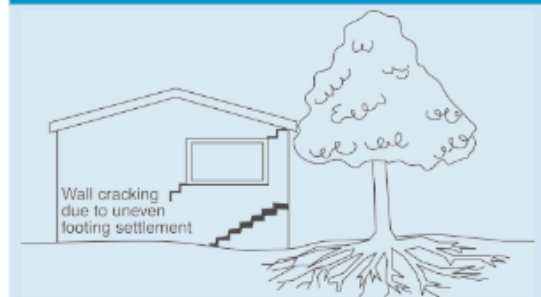
Trees can cause shrinkage and damage

As the weather pattern changes and the soil begins to dry out, the external footings will be first affected, beginning with the locations where the sun's effect is strongest. This has the effect of lowering the external footings. The doming is accentuated and cracking reduces or disappears where it occurred because of dishing, but other cracks open up. The roof lines may become convex.
