# Preliminary Geotechnical Assessment

**Project:** Alterations & Additions  
28 Allambie Road, Allambie Heights NSW

**Prepared for:**  
Add-Style Home Additions Pty Ltd

**Ref:** AG 25084  
4 March 2025

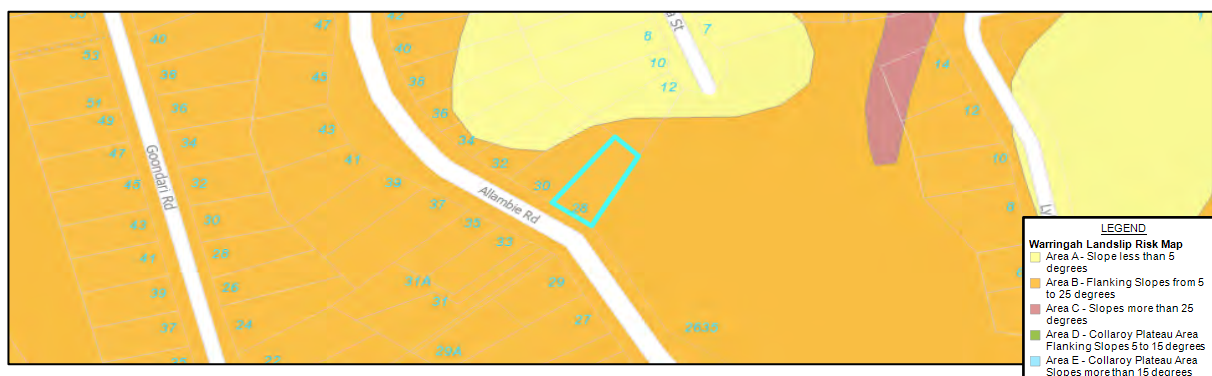
**Figure 1.** Warringah Landslip Risk Map: 28 Allambie Road, Allambie Heights NSW (© NBC Maps)

The site is mapped as **Area B** subject to specific landslip risk/geotechnical hazard mapping with reference to the Warringah (WLEP) Landslip Risk Map, Northern Beaches Council (**Image 1**).

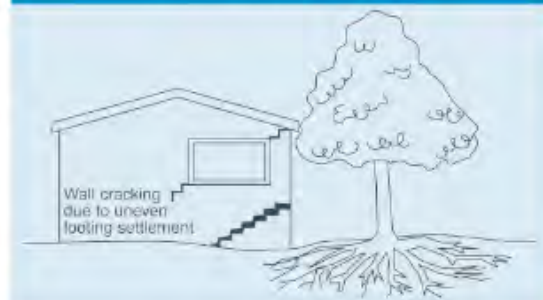
#### Trees can cause shrinkage and damage

As the weather pattern changes and the soil begins to dry out, the external footings will be first affected, beginning with the locations where the sun's effect is strongest. This has the effect of lowering the external footings. The doming is accentuated and cracking reduces or disappears where it occurred because of dishing, but other cracks open up. The roof lines may become convex.
