# Geotechnical Assessment

**Project:** Alterations & Additions  
98 Waratah Street, Mona Vale NSW

## Preliminary Geotechnical Assessment

For Alterations & Additions at

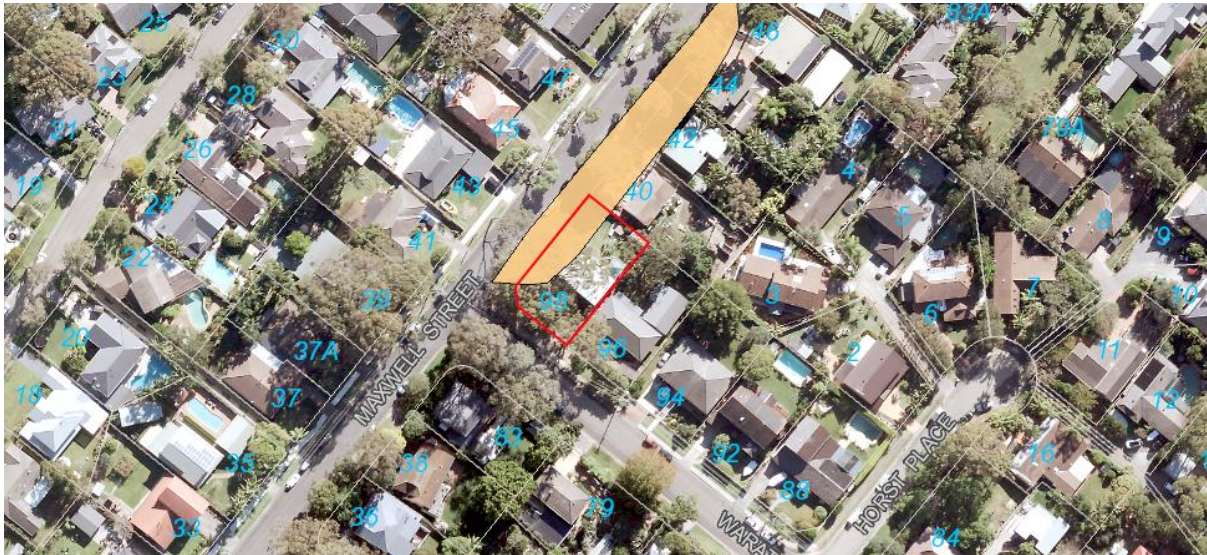
Based on reference to the plan entitled 'Geotechnical Hazard Mapping' (Ref. P21DCP-BC-MDCP2002, dated 2007) prepared by GHD LONGMAC on behalf of Pittwater Council, the site is located within **Geotechnical Hazard Zone H2**.

**Image 1.** Pittwater Geotechnical Hazard Risk Map:  
98 Waratah Street, Mona Vale NSW (© NBC Maps)
