## Geotechnical Assessment

**Project:** Alterations & Additions  
24 The Serpentine, Bilgola Beach NSW

**Ref:** AG 22247  
10 May 2023

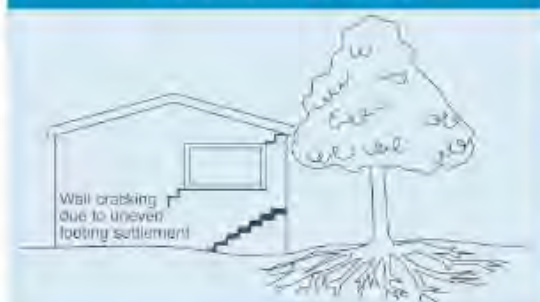
#### Trees can cause shrinkage and damage

As the weather pattern changes and the soil begins to dry out, the external footings will be first affected, beginning with the locations where the sun's effect is strongest. This has the effect of lowering the external footings. The doming is accentuated and cracking reduces or disappears where it occurred because of dishing, but other cracks open up. The roof lines may become convex.
