Geotechnical Assessment

Project: Alterations & Additions

13 Barrabooka Street, Clontarf, NSW

REF: AG 20182 26 April 2021

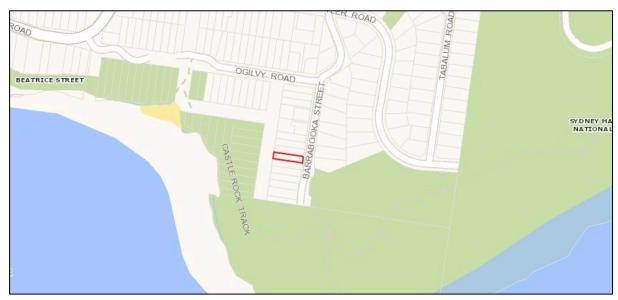
Manly Landslide Risk Map

The site is not subject to specific landslip risk/geotechnical hazard mapping with reference to the Manly Landslip Risk Map (Image 1).
