## **Geotechnical Assessment**

**Project:** Alterations & Additions  
4 Cabarita Road, Avalon Beach NSW

**Ref:** AG 19067  
14 April 2022

**4 Cabarita Road, Avalon Beach, NSW**

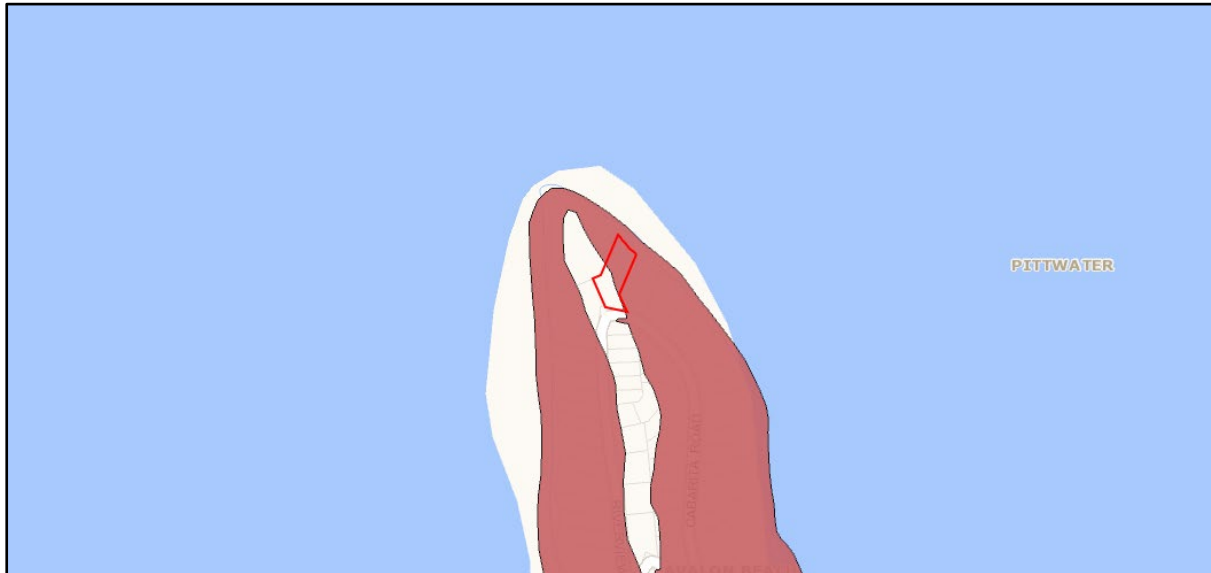
**Image 2.** PLEP Geotechnical Hazard Map  
– 4 Cabarita Road, Avalon Beach ((c) NBC Maps)

- The Narrabeen Group rock strata exposed along the steep northern embankment is weathered at the surface and is prone to minor localised failures as it delaminates with salt erosion, spreading tree roots and the natural chemical decomposition of the rock.
- Minor localised rock fall and topple has been identified on the site over a number of years and is considered to represent natural erosion of the bank.
- The property Based on reference to the plan entitled ‘Geotechnical Hazard Mapping’ (Ref. P21DCP-BC-MDCP2002, dated 2007) prepared by GHD LONGMAC on behalf of Pittwater Council, the site is located within **Geotechnical Hazard Zone H1**.

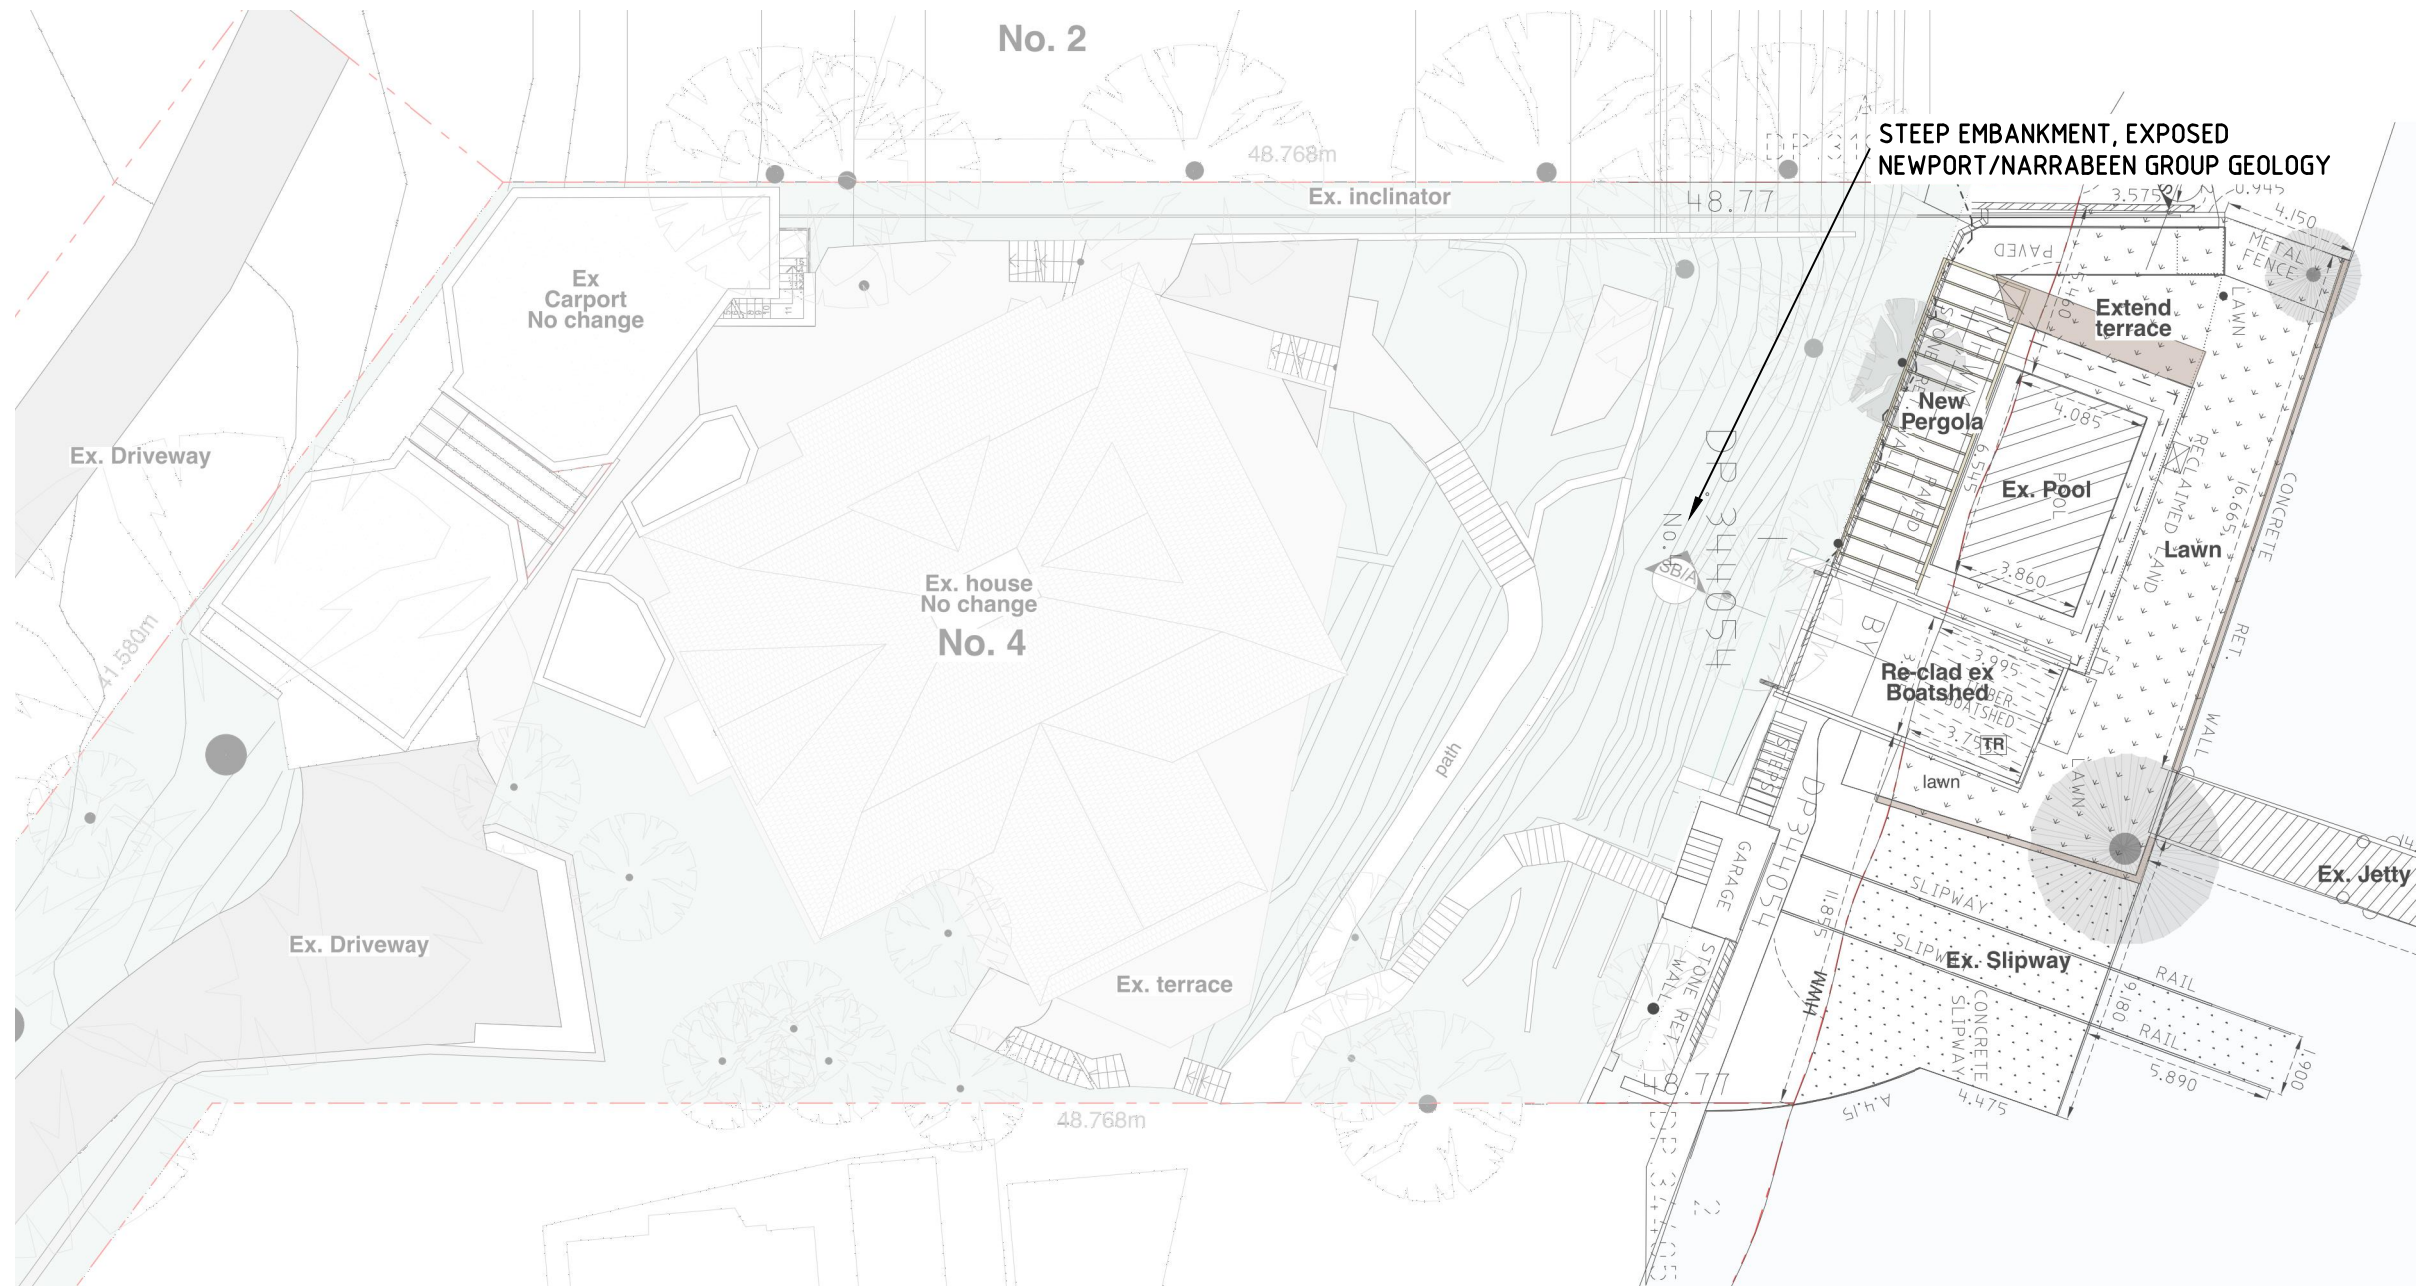
DATE: 14/04/2022  
SCALE: AS SHOWN @ A3  
DRAWING TITLE:  
**SITE PLAN**  
DRAWING NO:  
**AG 19067- S1**

**SITE PLAN/GROUND TEST LOCATIONS**  
SCALE NTS

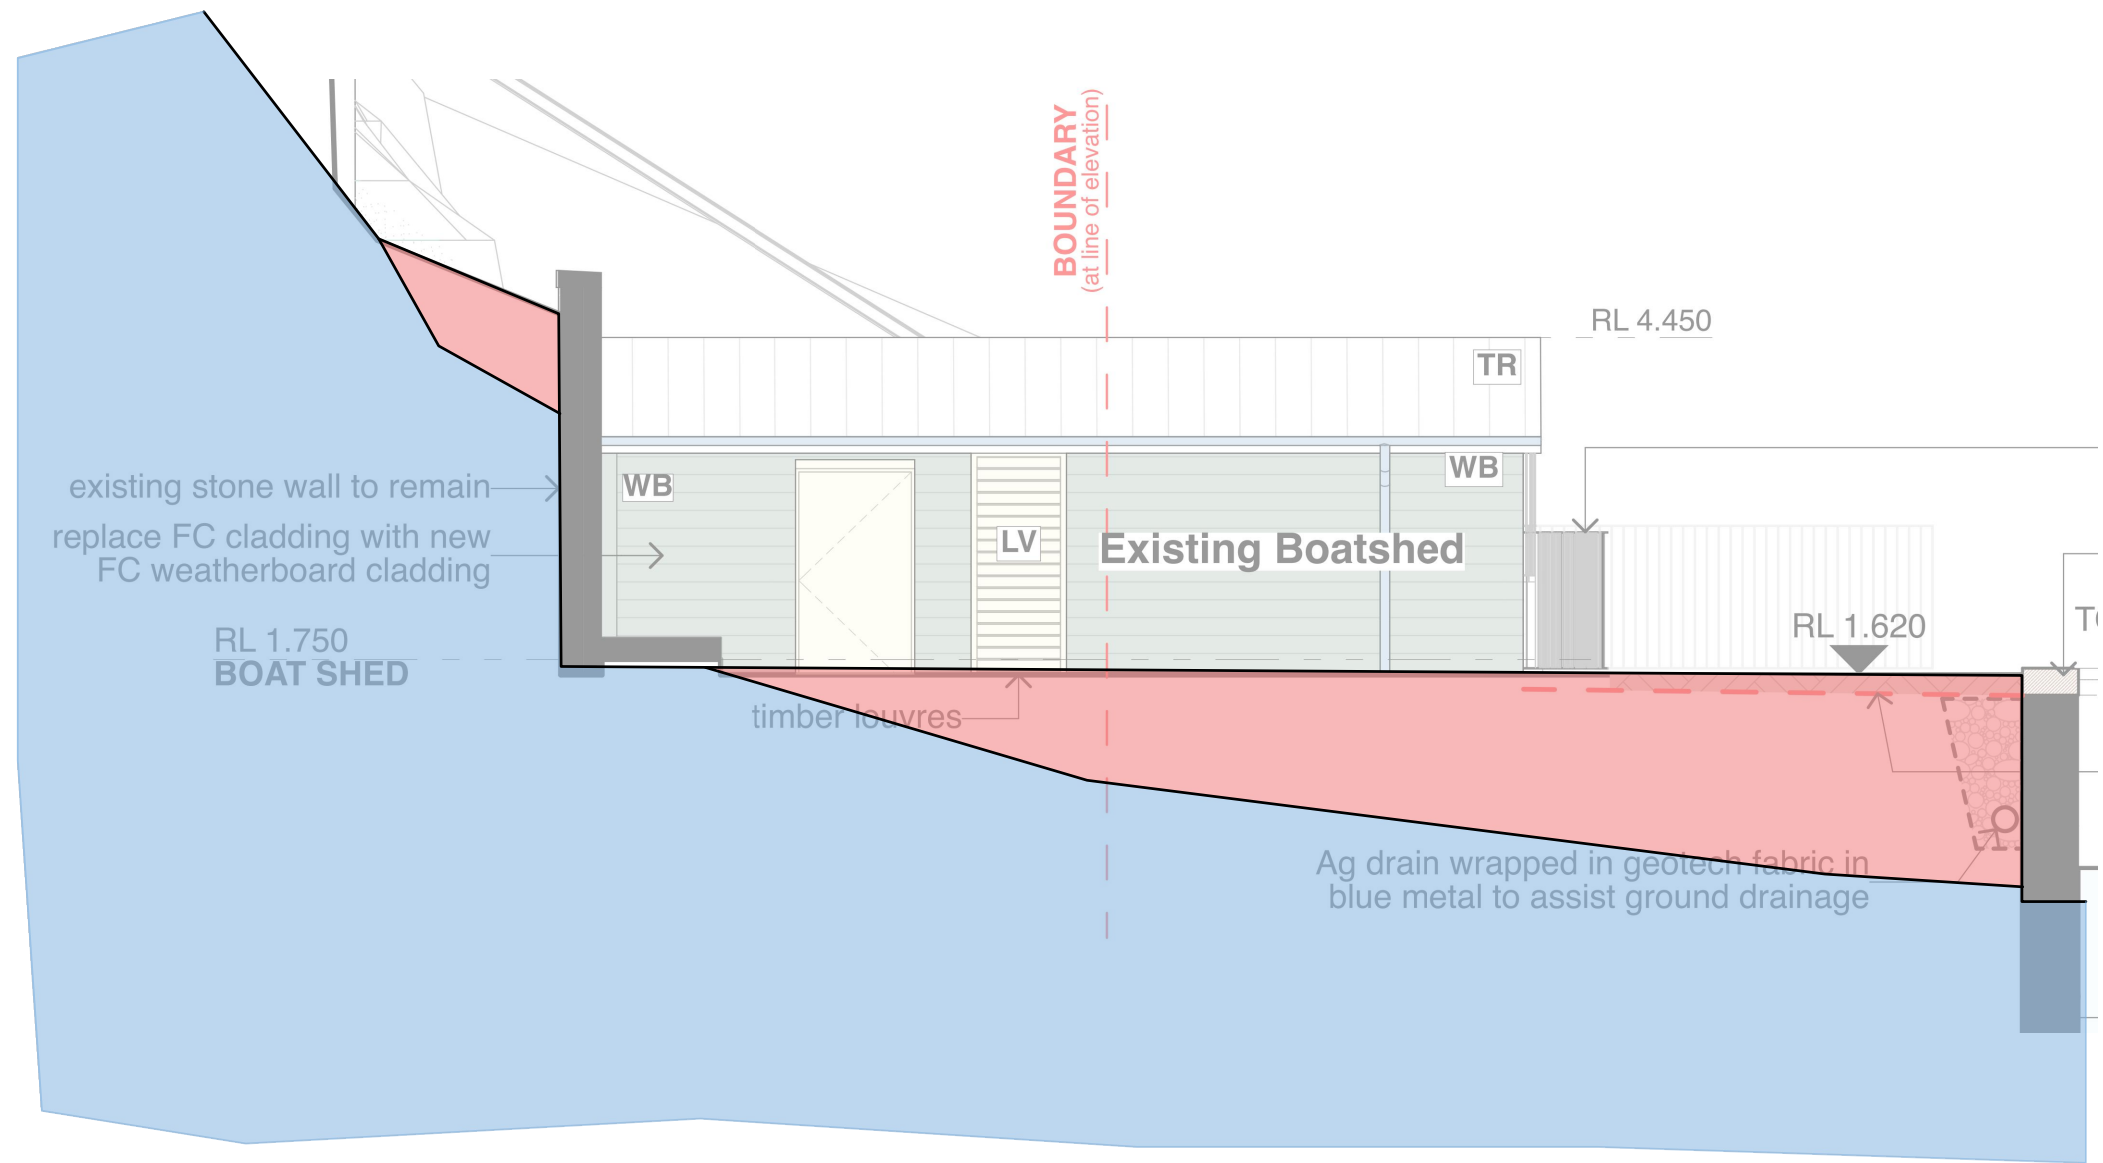
INTERPRETED SUBSURFACE SECTION ONLY.  
ACTUAL GROUND CONDITIONS MAY VARY.

- FILL
- NARRABEEN GROUP GEOLOGY
