# Preliminary Geotechnical Assessment

**Project:** Alterations & Additions  
13 Highview Avenue, Manly Vale NSW

**Ref:** AG 24134  
18 April 2024

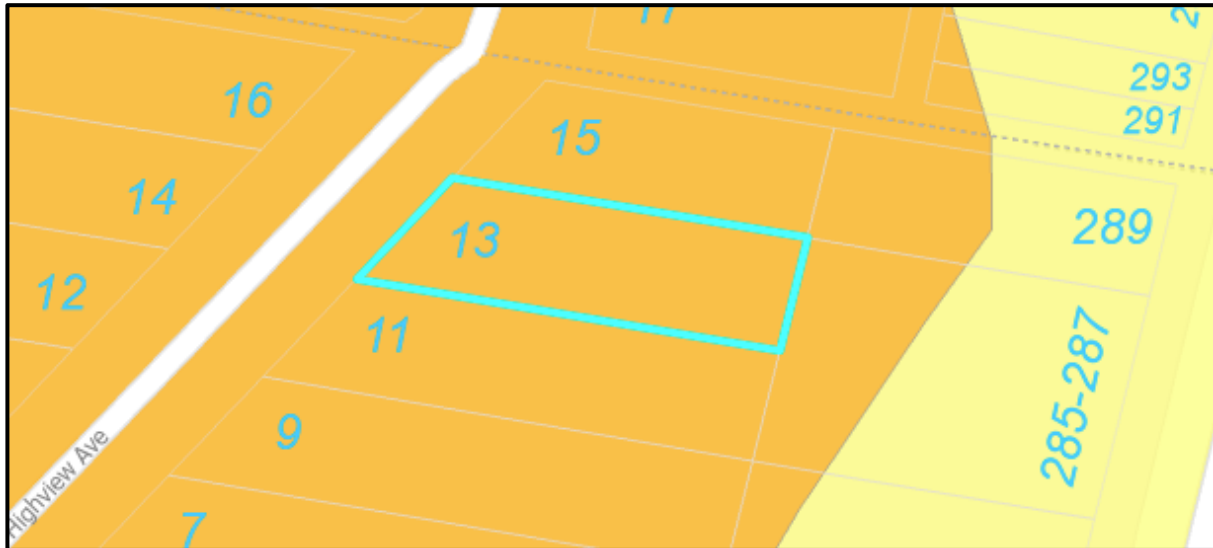
The site is mapped as **Area B** subject to specific landslip risk/geotechnical hazard mapping with reference to the Warringah (WLEP) Landslip Risk Map, Northern Beaches Council (**Image 1**).

**Figure 1.** Warringah Landslip Risk Map:  
13 Highview Avenue, Manly Vale NSW (© NBC Maps)
