**From:** Peter Galvin  
**Sent:** 6/12/2021 1:33:27 AM  
**To:** Council Northernbeaches Mailbox  
**Subject:** Submission DA2021/2097  
**Attachments:** 918 Submission DA2021\_2097\_ 051221.pdf;

**Re: DA2021/2097 Submission - 918 Barrenjoey Rd Palm Beach**

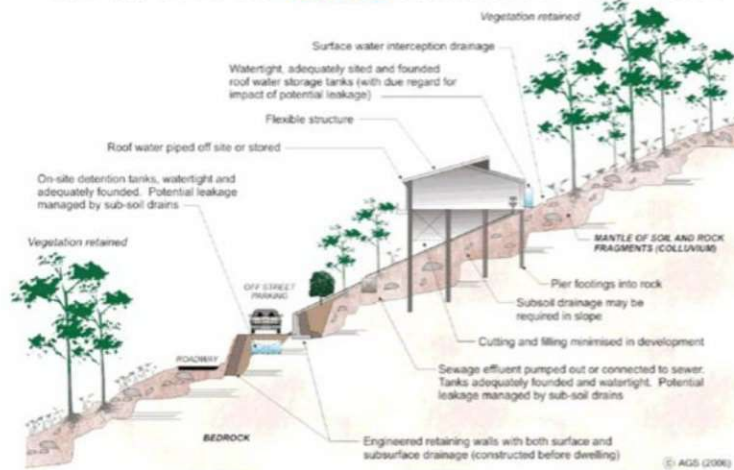
## EXAMPLES OF GOOD HILLSIDE PRACTICE

The pictorial below illustrates the proper hillside practices required by the geotechnical engineer
