J1725A. 30th March, 2020. Page 1.

PRELIMINARY GEOTECHNICAL ASSESSMENT:

Lot 1, 41 May Road, Dee Why

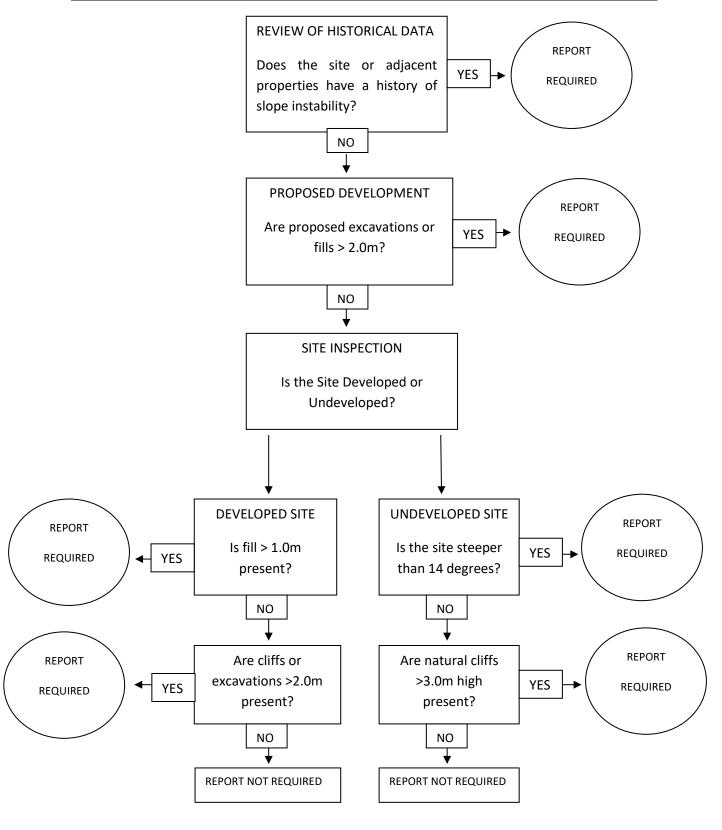
<u>Preliminary Assessment Flow Chart – Northern Beaches Council (Warringah)</u>

The proposed development and site conditions were considered and applied to the Council

Geotechnical assessment is recommended for the proposed development.
