## **Geotechnical Assessment**

**Project:** Alterations & Additions  
52 Burchmore Road, Manly Vale NSW

**REF: AG 21220**  
28 September 2021

For **Alterations & Additions** at  
**52 Burchmore Road, Manly Vale NSW**

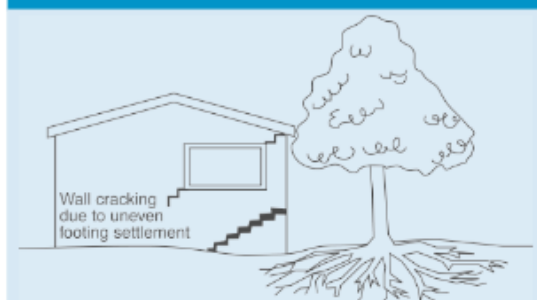
#### Trees can cause shrinkage and damage

As the weather pattern changes and the soil begins to dry out, the external footings will be first affected, beginning with the locations where the sun's effect is strongest. This has the effect of lowering the external footings. The doming is accentuated and cracking reduces or disappears where it occurred because of dishing, but other cracks open up. The roof lines may become convex.

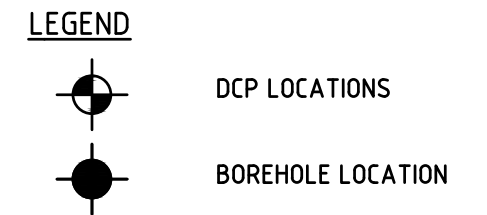
### Site Plan | Testing Locations

| | | | | | | <div><br/><b>ASCENT</b><br/><b>GEOTECHNICAL CONSULTING</b></div> | ABN: 71 621 428 402<br>www.ascentgeo.com.au<br><br>(02) 9913 3179<br>admin@ascentgeo.com.au<br><br>1457 Pittwater Road<br>North Narrabeen NSW 2101 | CLIENT:<br><b>MORTEN SCHEIBYE</b> | SITE PLAN/GROUND TEST LOCATIONS<br>AT 52 BURCHMORE ROAD<br>MANLY VALE NSW | DATE: 08/07/2021 |

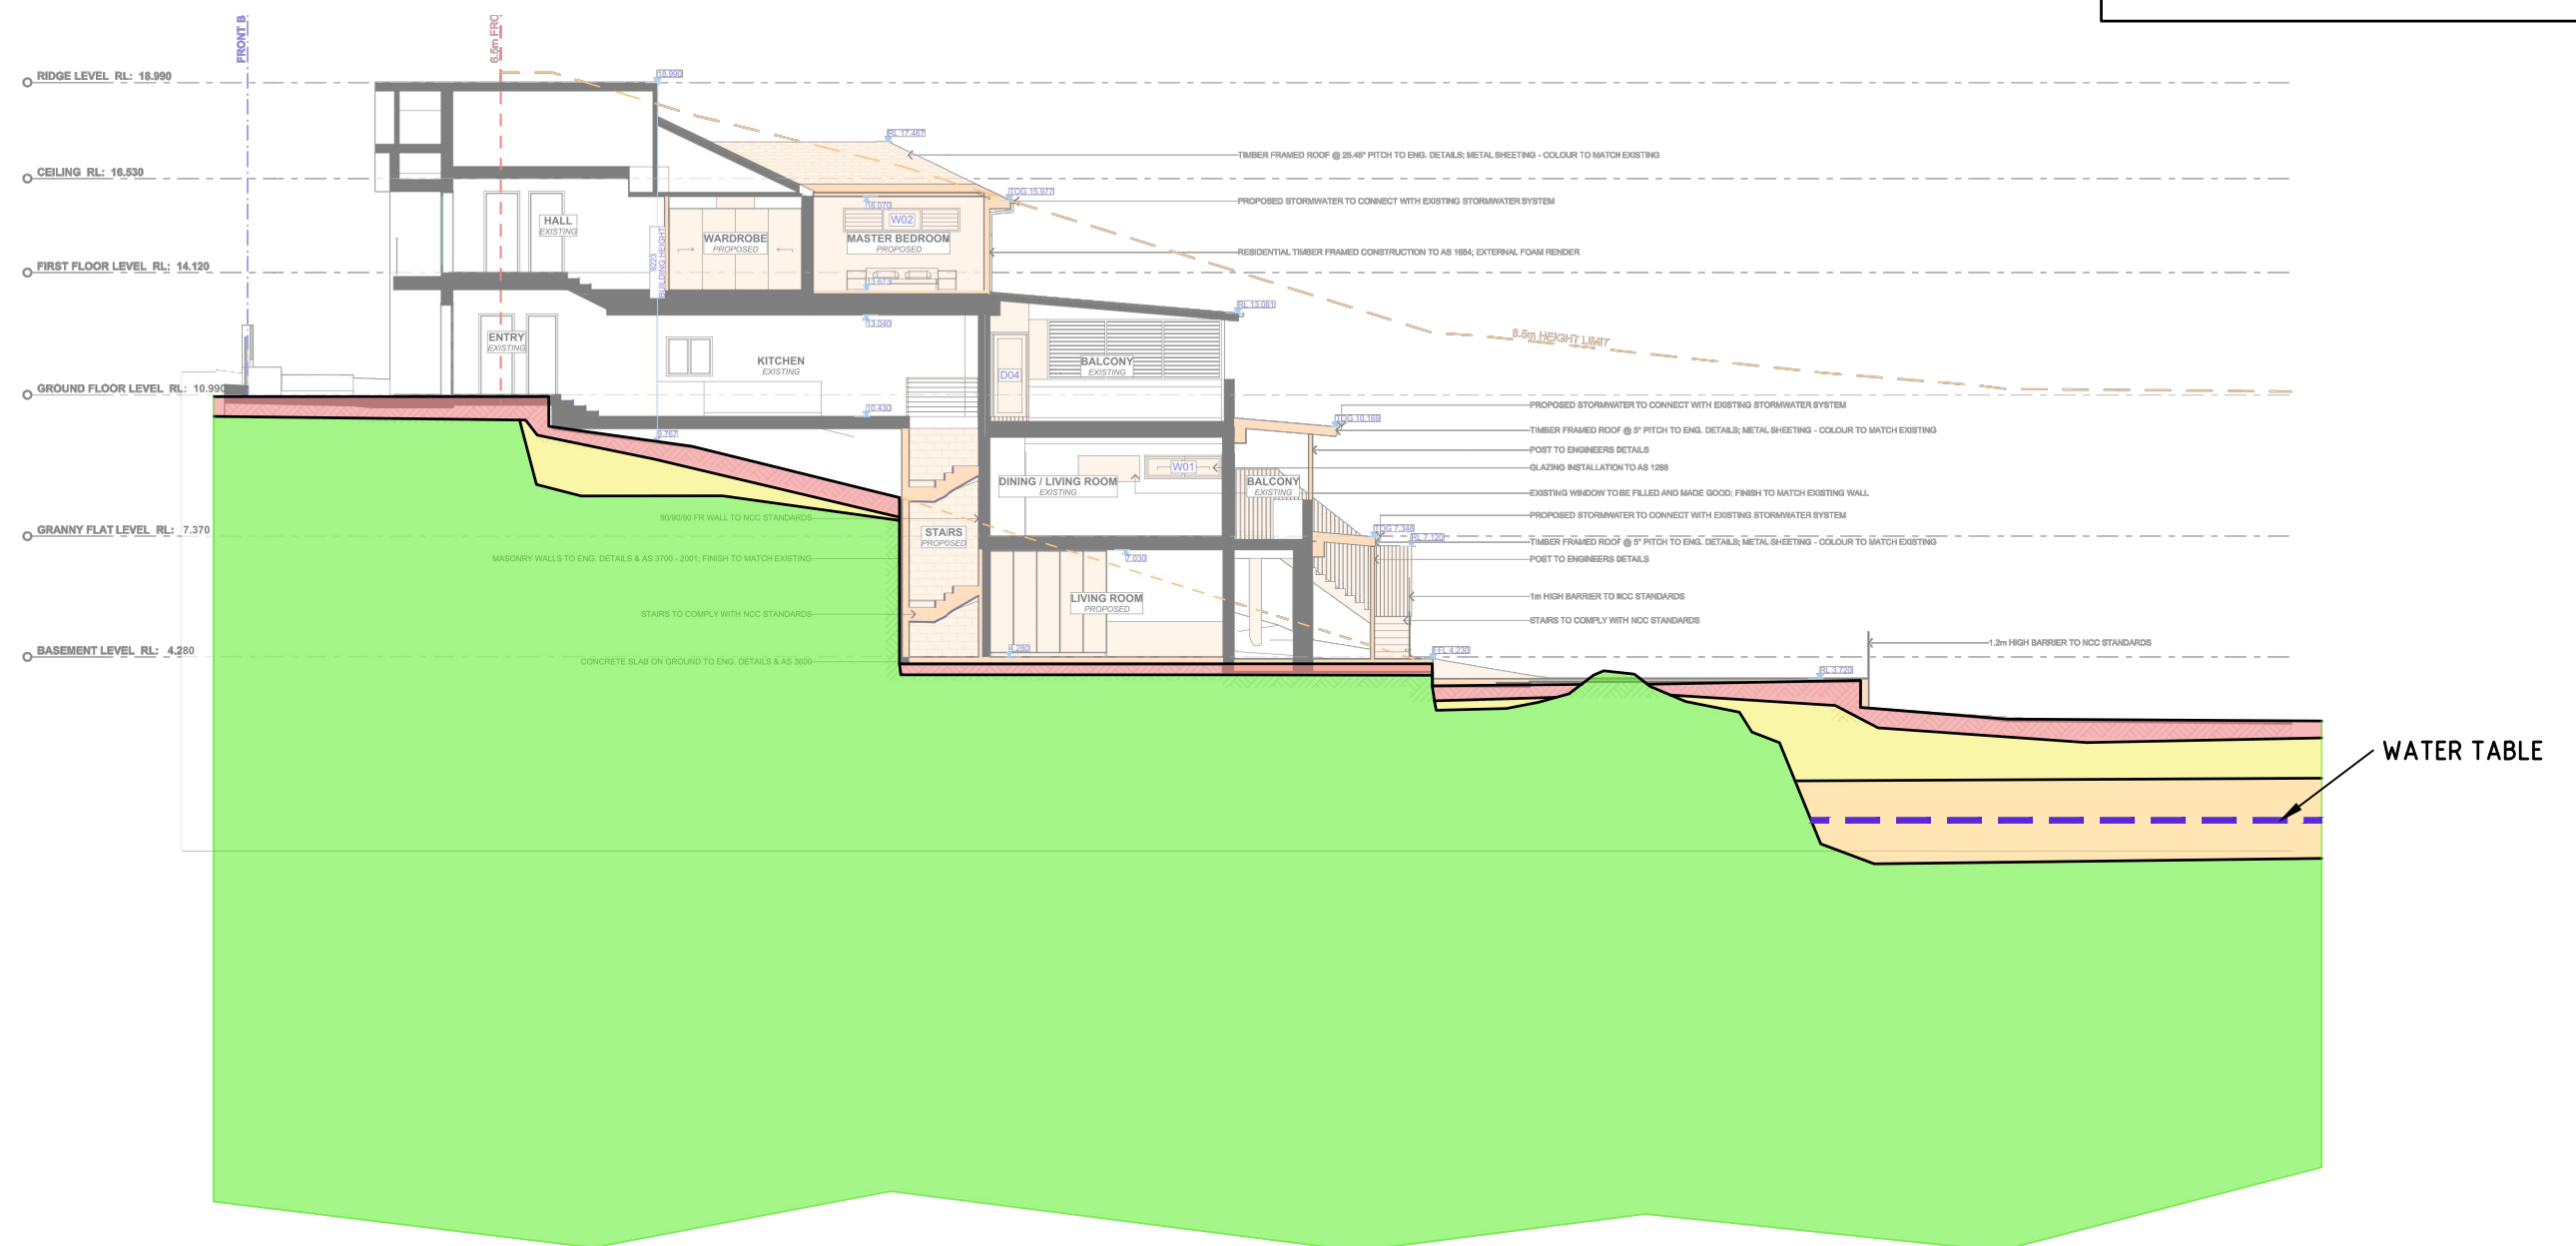
**INFERRED GEOLOGICAL SECTION**  
SCALE NTS

INTERPRETED SUBSURFACE SECTION ONLY.  
ACTUAL GROUND CONDITIONS MAY VARY.
