## **Geotechnical Assessment**

**Project:** Alterations & Additions  
169 Plateau Road, Bilgola Plateau NSW

**Ref:** AG 22273  
3 August 2022

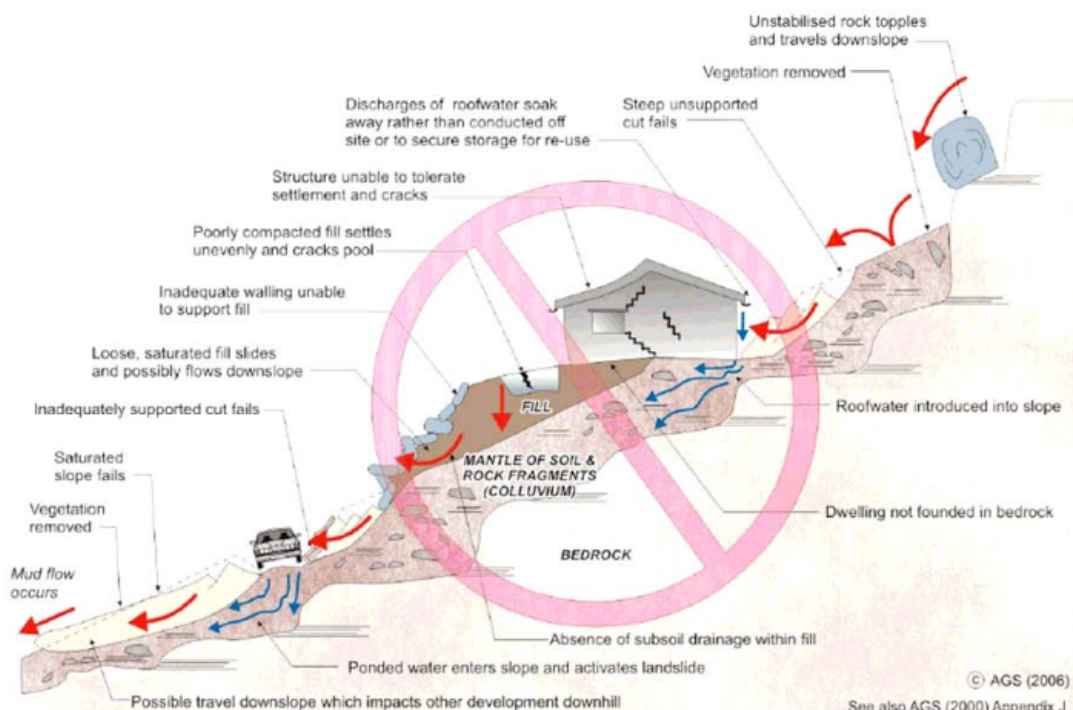
## EXAMPLES OF **POOR** HILLSIDE PRACTICE

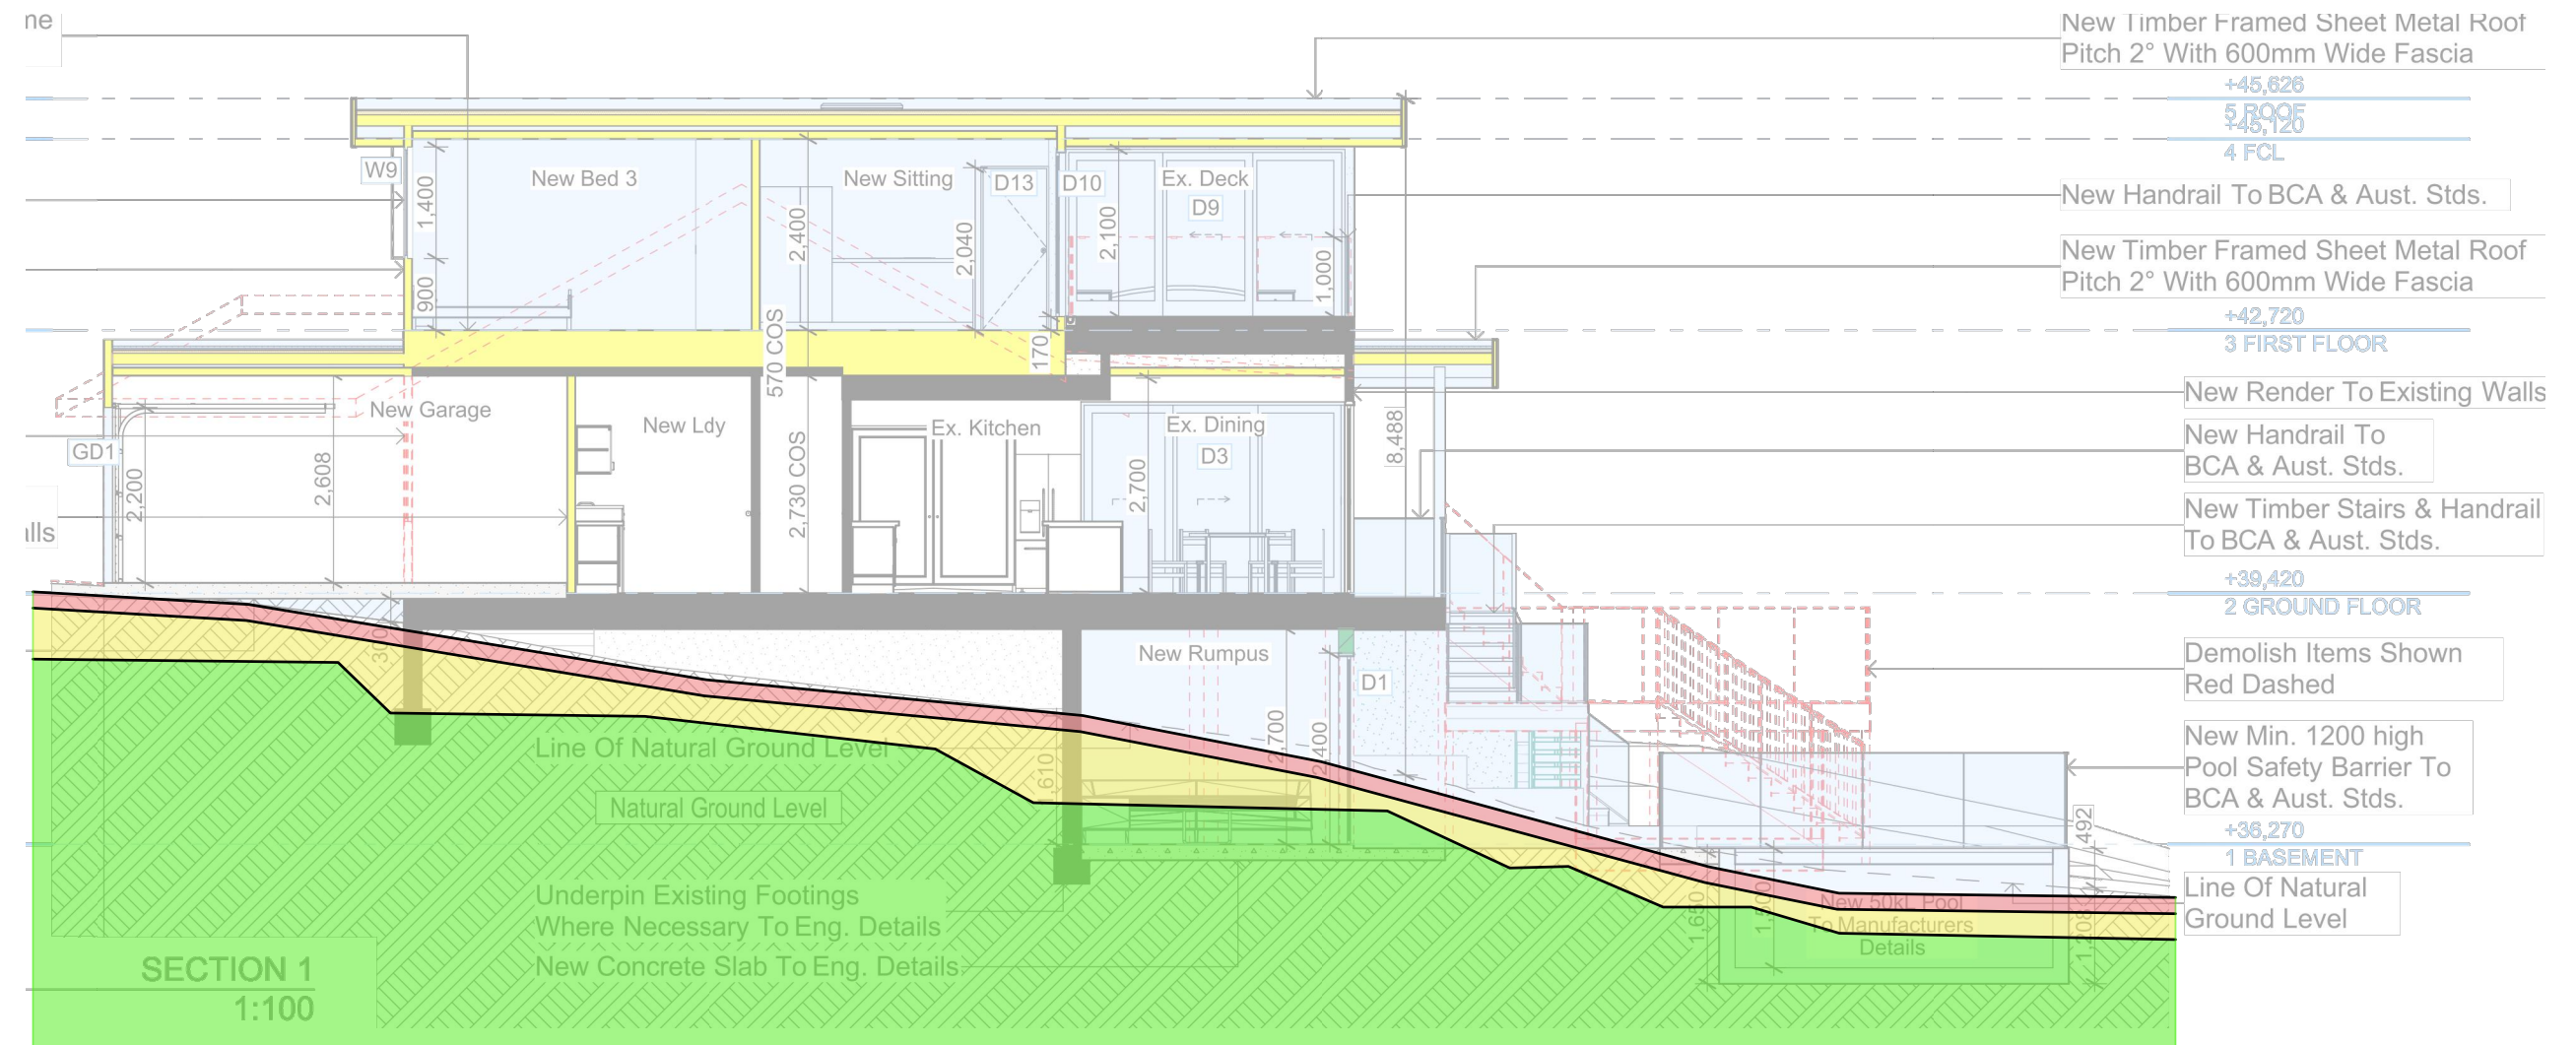
**INFERRED GEOLOGICAL SECTION**  
SCALE NTS

INTERPRETED SUBSURFACE SECTION ONLY.  
ACTUAL GROUND CONDITIONS MAY VARY.

The soil profile consists of sandy topsoil (O & A Horizons), clayey sand (B Horizon) and weathered low-strength bedrock (C Horizon). Based on our observations and the results of testing on site, we would expect weathered bedrock to be found within 1.90 to 3.10 metres below current surface levels across the area of the proposed works.
