# Preliminary Geotechnical Assessment

**Project:** Alterations & Additions  
53 Timaru Road, Terrey Hills NSW

**Ref:** AG 25147  
7 April 2025

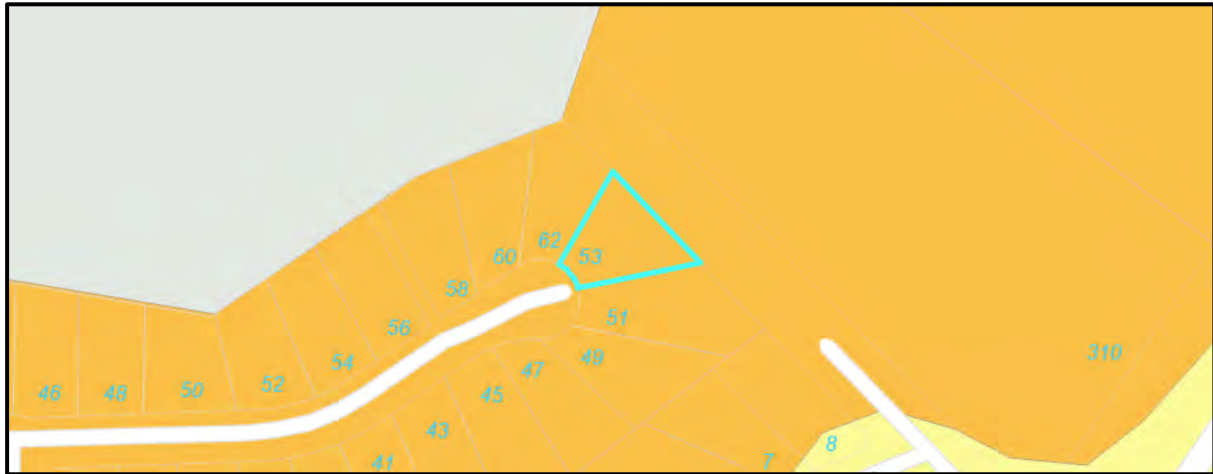
The site is mapped as **Area B** subject to specific landslip risk/geotechnical hazard mapping with reference to the Warringah (WLEP) Landslip Risk Map, Northern Beaches Council (**Image 1**).

**Figure 1.** Warringah Landslip Risk Map: 53 Timaru Road, Terrey Hills NSW  
(© NBC Maps)
