## **Geotechnical Assessment**

**Project:** Alterations and Additions  
30 Davidson Avenue, Forestville NSW.

**Prepared for:**  
Nicole & John Cubbin  
30 Davidson Avenue  
Forestville, NSW, 2087

**REF: AG 20109**  
26<sup>th</sup> May, 2020

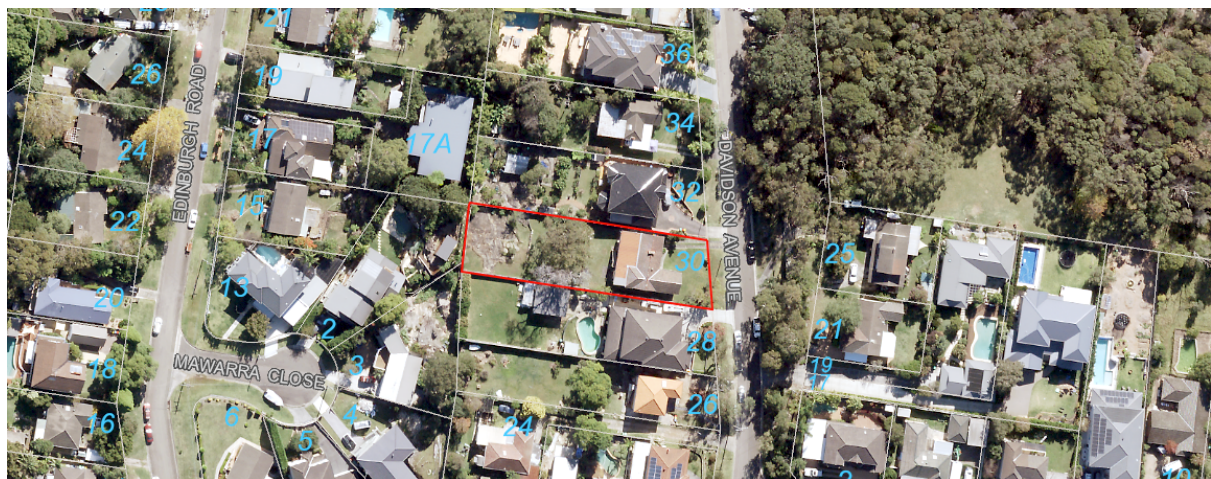
**Image 1:** Site location – 30 Davidson Avenue, Forestville NSW – Red Polygon (© NBC Maps).

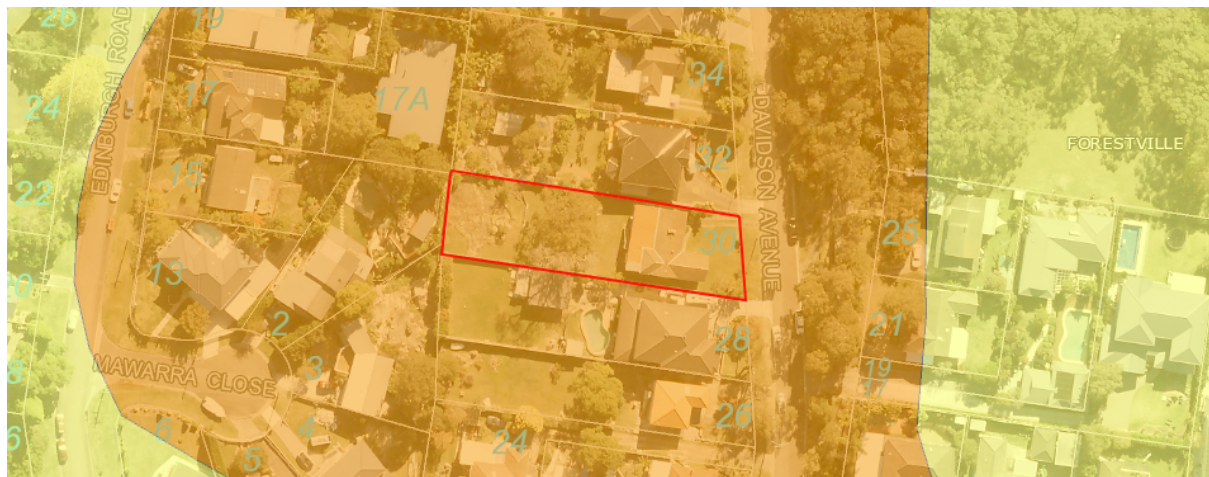
**WARRINGAH LANDSLIP RISK MAP**

- Area A - Slope less than 5 degrees
- Area B - Flanking Slopes from 5 to 25 degrees
- Area C - Slopes more than 25 degrees
- Area D - Collaroy Plateau Area Flanking Slopes 5 to 15 degrees
- Area E - Collaroy Plateau Area Slopes more than 15 degrees

- No evidence of significant soil creep, tension cracks or other indicators of slope instability were identified at the time of our inspection.
- The existing structures displayed no evidence of significant cracking or settlement that could be attributed to slope instability.
- The property is classified as **Areas A & B** with reference to Northern Beaches Council WLEP Landslip Risk Map (WLEP Landslip Risk Map **Image 2** below).

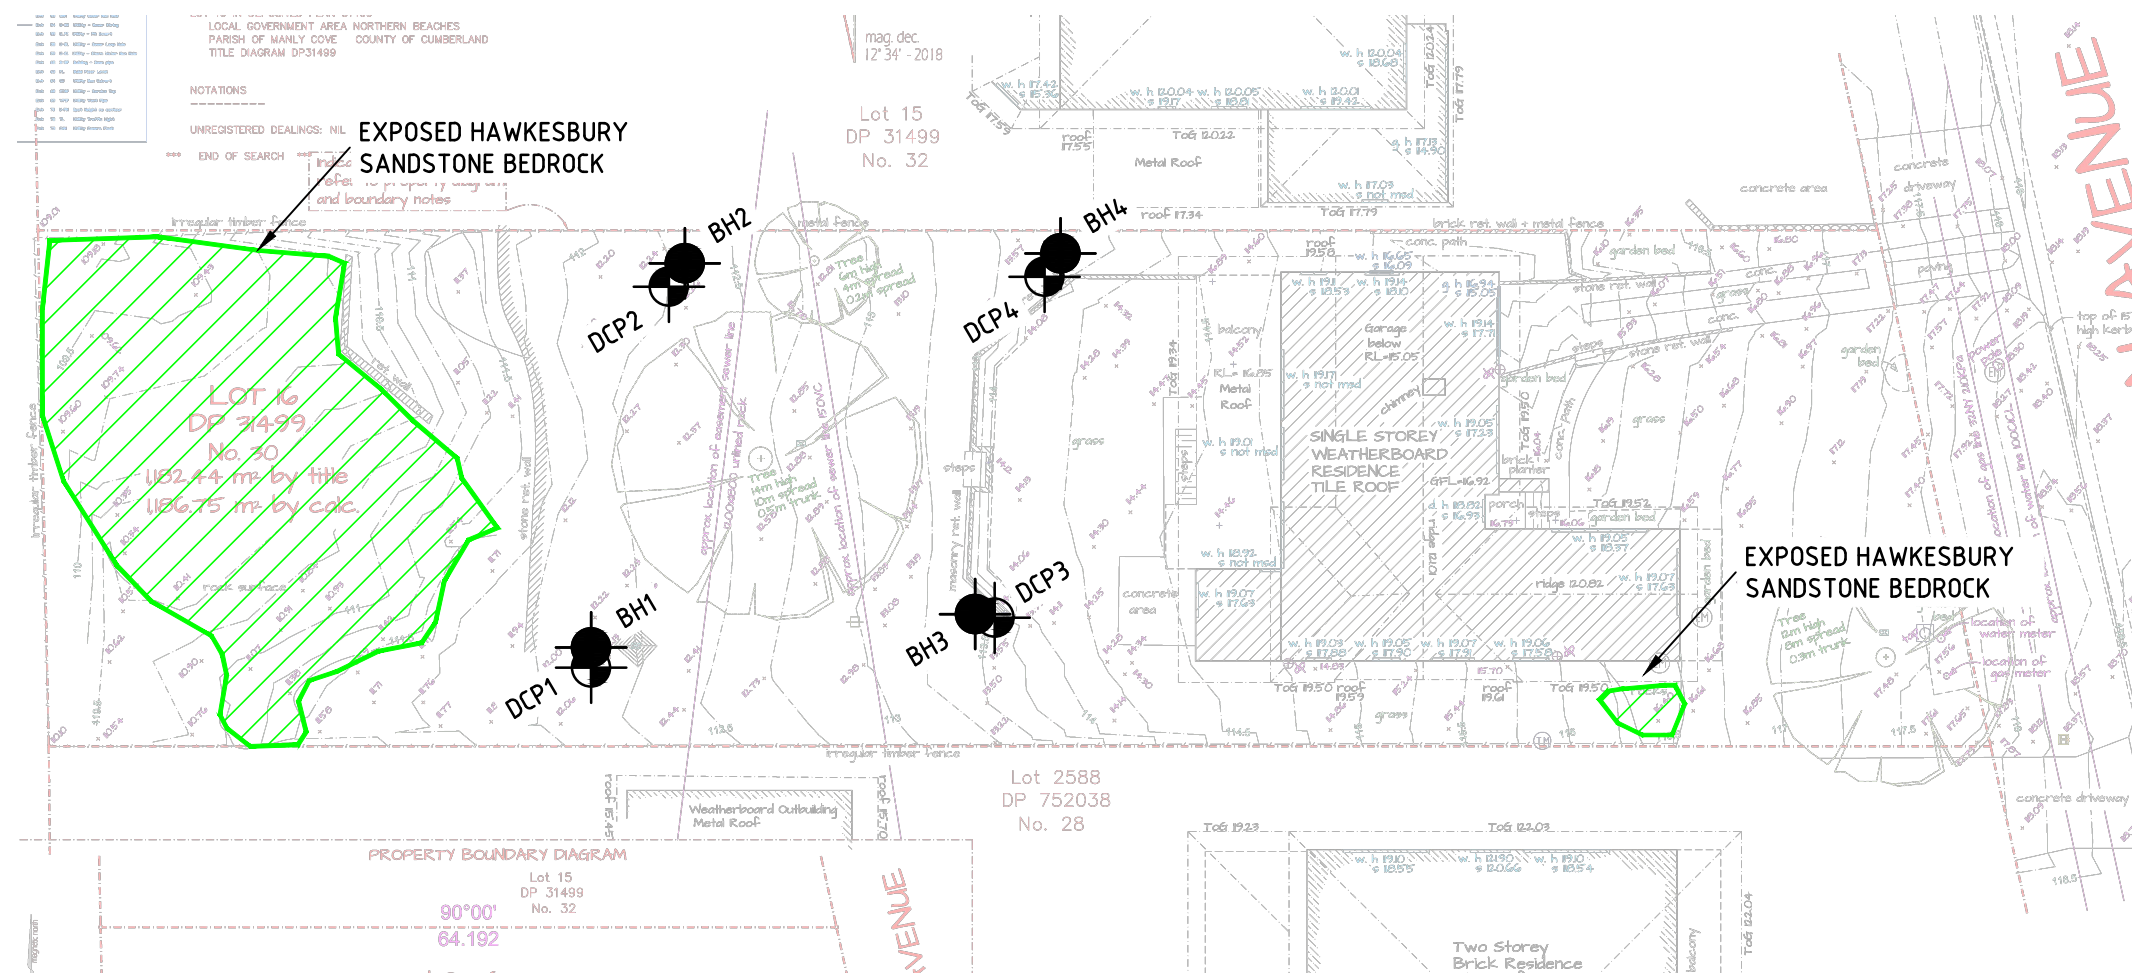
## SITE PLAN/GROUND TEST LOCATIONS

BOREHOLE LOCATIONS

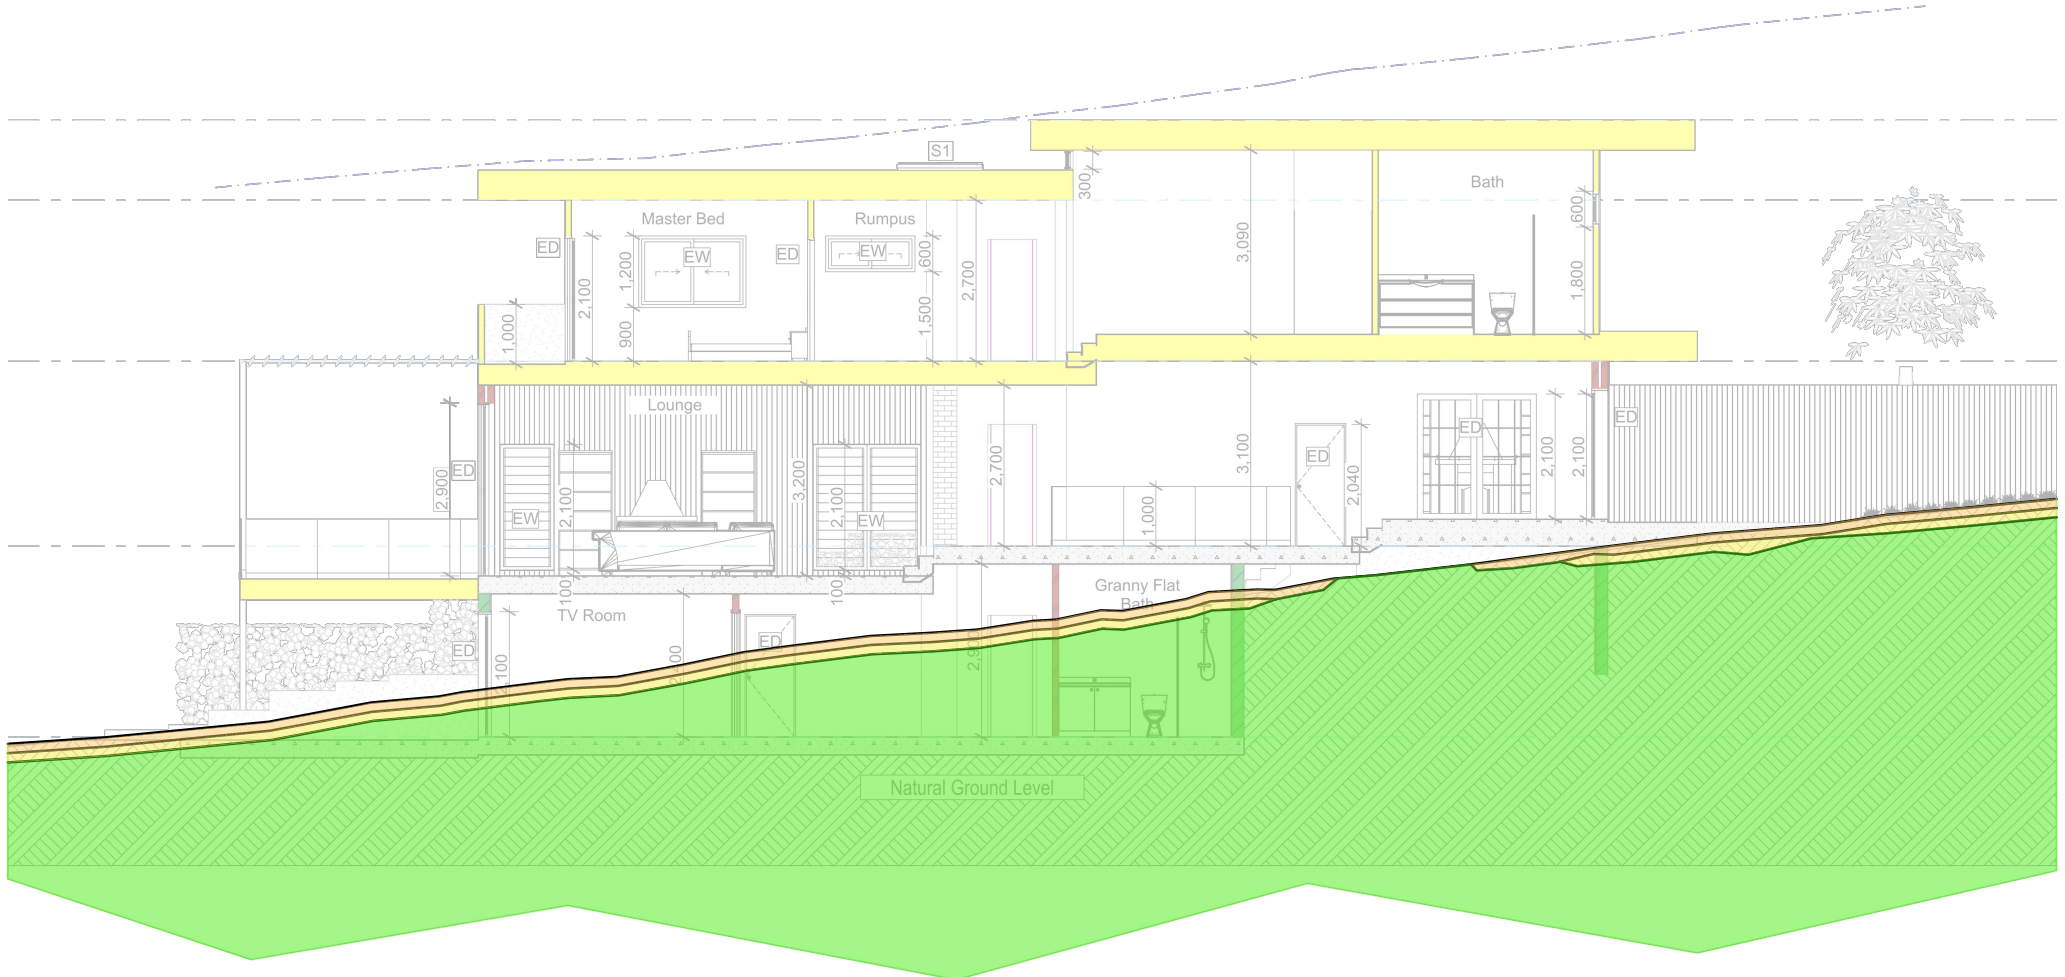
**INFERRED GEOLOGICAL SECTION**  
SCALE NTS

INTERPRETED SUBSURFACE SECTION ONLY.  
ACTUAL GROUND CONDITIONS MAY VARY.

The soil profile is interpreted to consists of sandy topsoil and shallow uncontrolled fill (O & A Horizons), with sand, silt and clay (B Horizon) overlying weathered sandstone bedrock (C Horizon). Based on our observations and the results of testing onsite, we would expect competent weathered bedrock to be found between 100-1000mm from current surface levels across the site, where not already exposed.
