## AS2870-2011 SITE CLASSIFICATION

CLIENT:  
Icon Homes

SITE ADDRESS:  
Lot 32, No 5 Ross Street, North Curl Curl NSW

AS2870 Site Classification

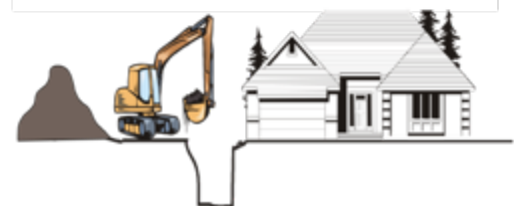
Fig. 11 De-stabilizing house foundations

- Ensuring that excavations are well supported or are dug to avoid collapses. (Fig. 11)
- Constructing well-compacted and retained 'soil aprons' around the building to stop erosion.

- Special considerations if any excavations are to be dug near adjoining structures. (Fig. 11)
- Sloping the soil and paths away from the building by the minimum amount required by the building regulations to prevent water flowing towards the building foundations. (Fig. 10 & 18)

- Running machinery over shallow drain pipes may break them causing leaks and subsequent foundation movements.
- Any excavations close to building footings can cause them to sink by disturbing the foundation material or by drying the foundation clay. (Fig 11)

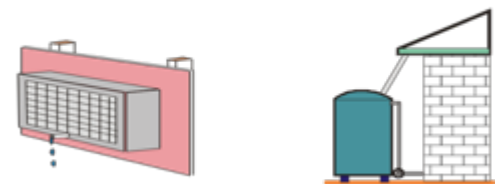
Fig. 16 Air con, up to 35 L/day loss

Fig.17 Leaky pipe:
