## **Geotechnical Assessment**

**Project:** Alterations & Additions  
169 Plateau Road, Bilgola Plateau NSW

**Ref:** AG 22273  
3 August 2022

For Alterations & Additions at  
169 Plateau Road, Bilgola Plateau NSW

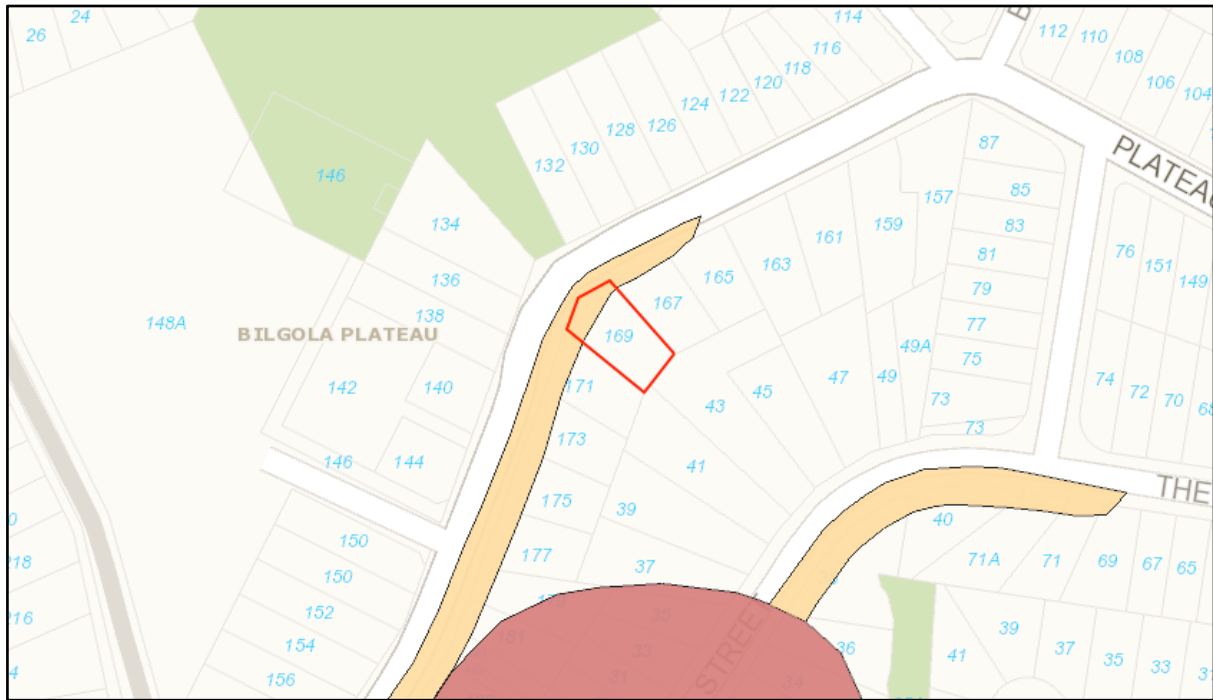
**Image 2.** PLEP Geotechnical Hazard Map  
– 169 Plateau Road, Bilgola Plateau NSW (NBC Maps)

- No evidence of significant soil creep, tension cracks or landslip instability were identified across the site or on adjacent properties as viewed from the subject site at the time of our inspection.
- Based on reference to the plan entitled "Geotechnical Hazard Mapping" (Ref. P21DCP-BC-MDCP2002, dated 2007) prepared by GHD LONGMAC on behalf of Pittwater Council, the site is mapped as a **Geotechnical Hazard H2** zone.

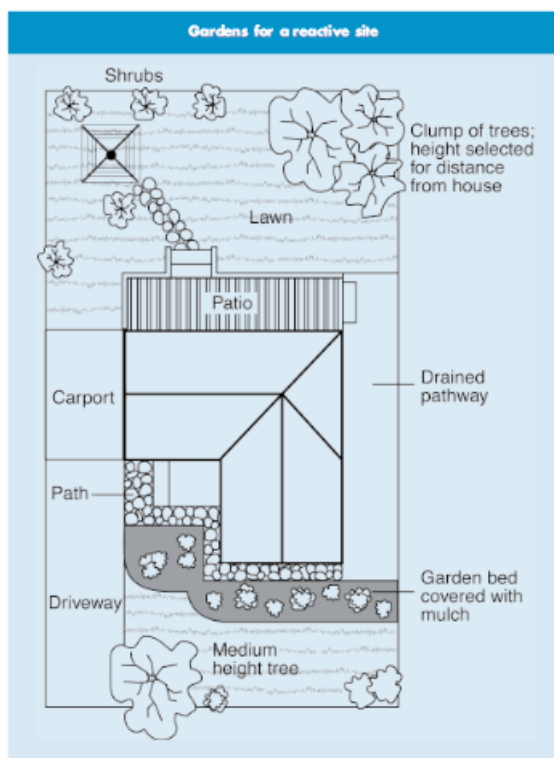
should extend outwards a minimum of 900 mm (more in highly reactive soil) and should have a minimum fall away from the building of 1:60. The finished paving should be no less than 100 mm below brick vent bases.

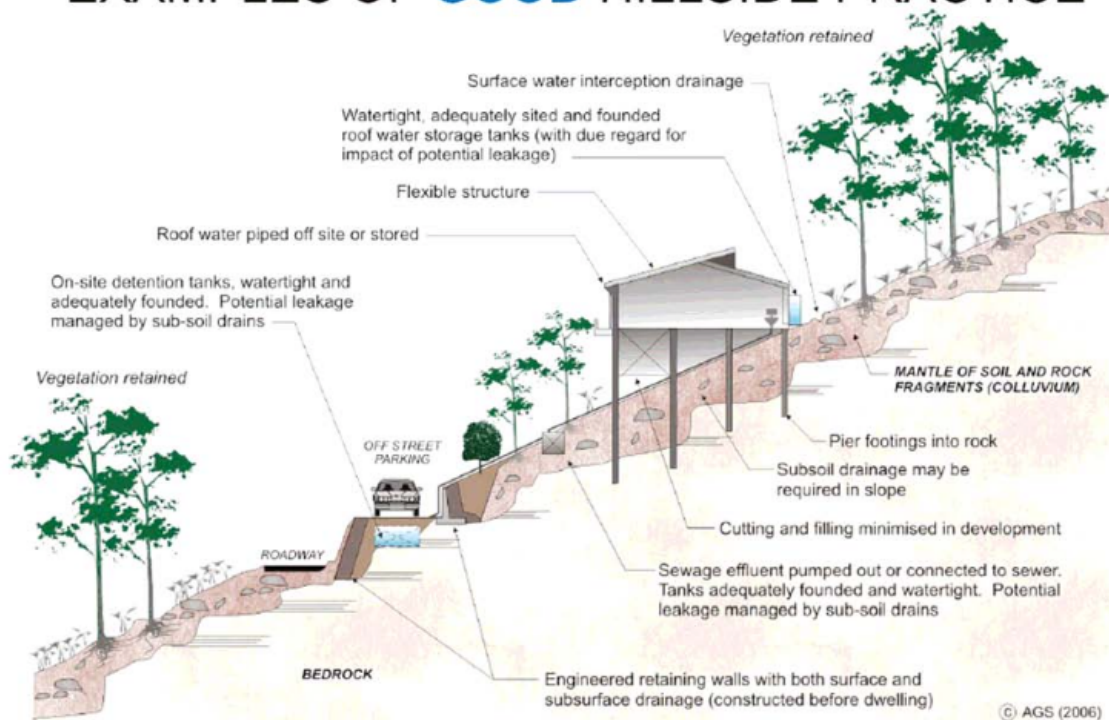
## EXAMPLES OF **GOOD** HILLSIDE PRACTICE

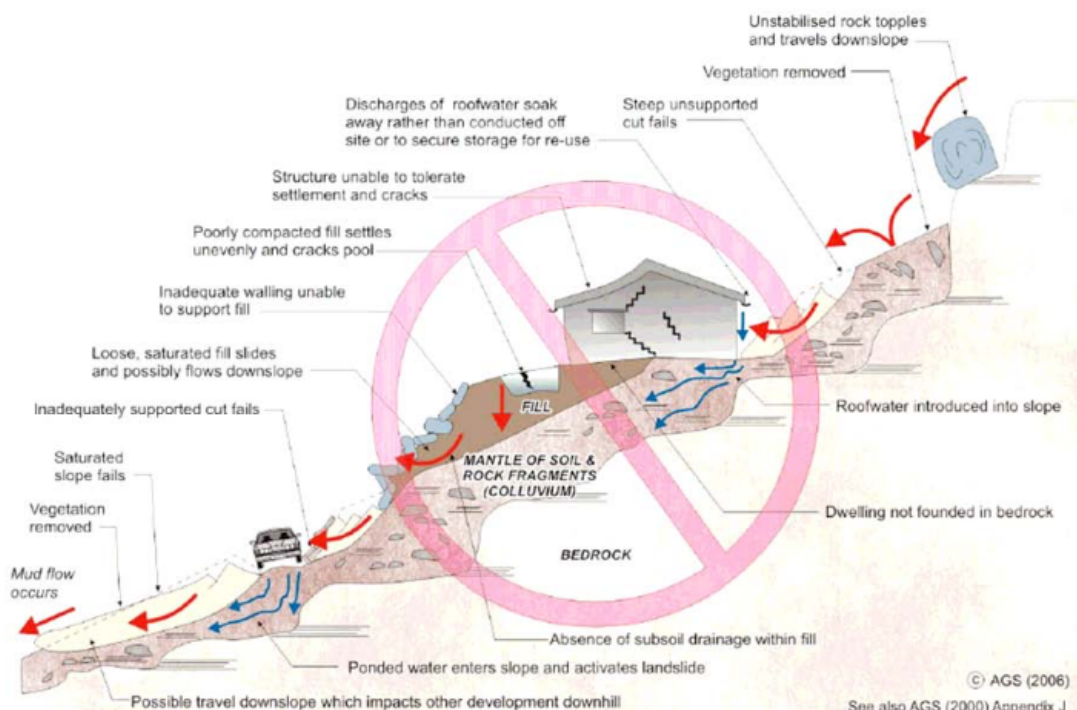
## EXAMPLES OF **POOR** HILLSIDE PRACTICE

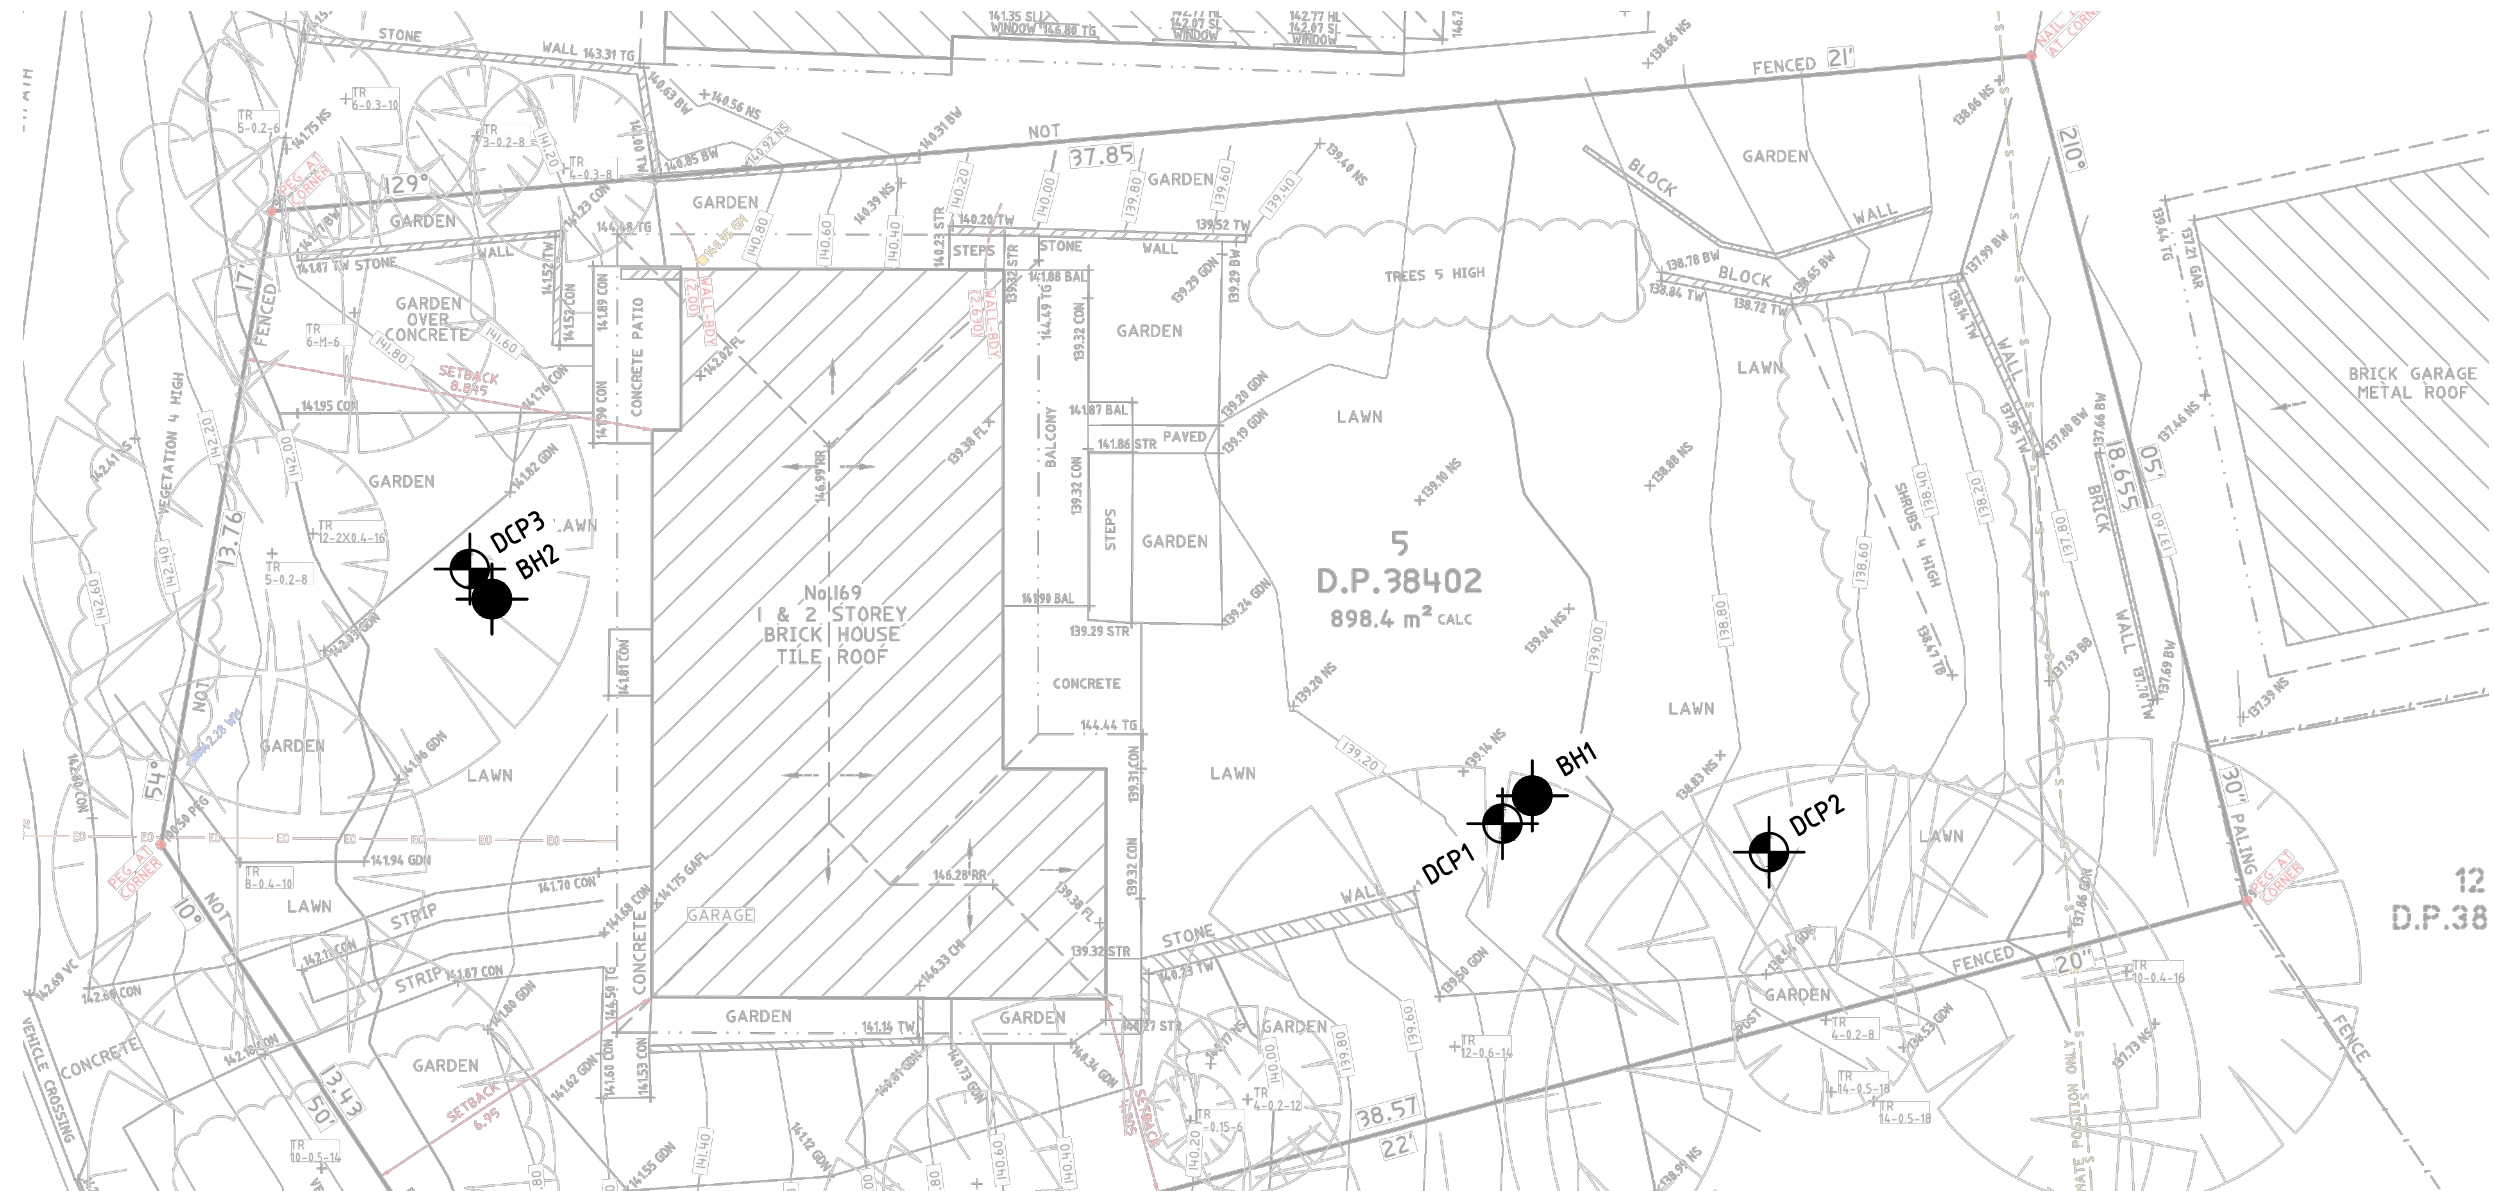
DCP LOCATIONS

BOREHOLE LOCATIONS

SITE PLAN/GROUND TEST LOCATIONS  
SCALE NTS

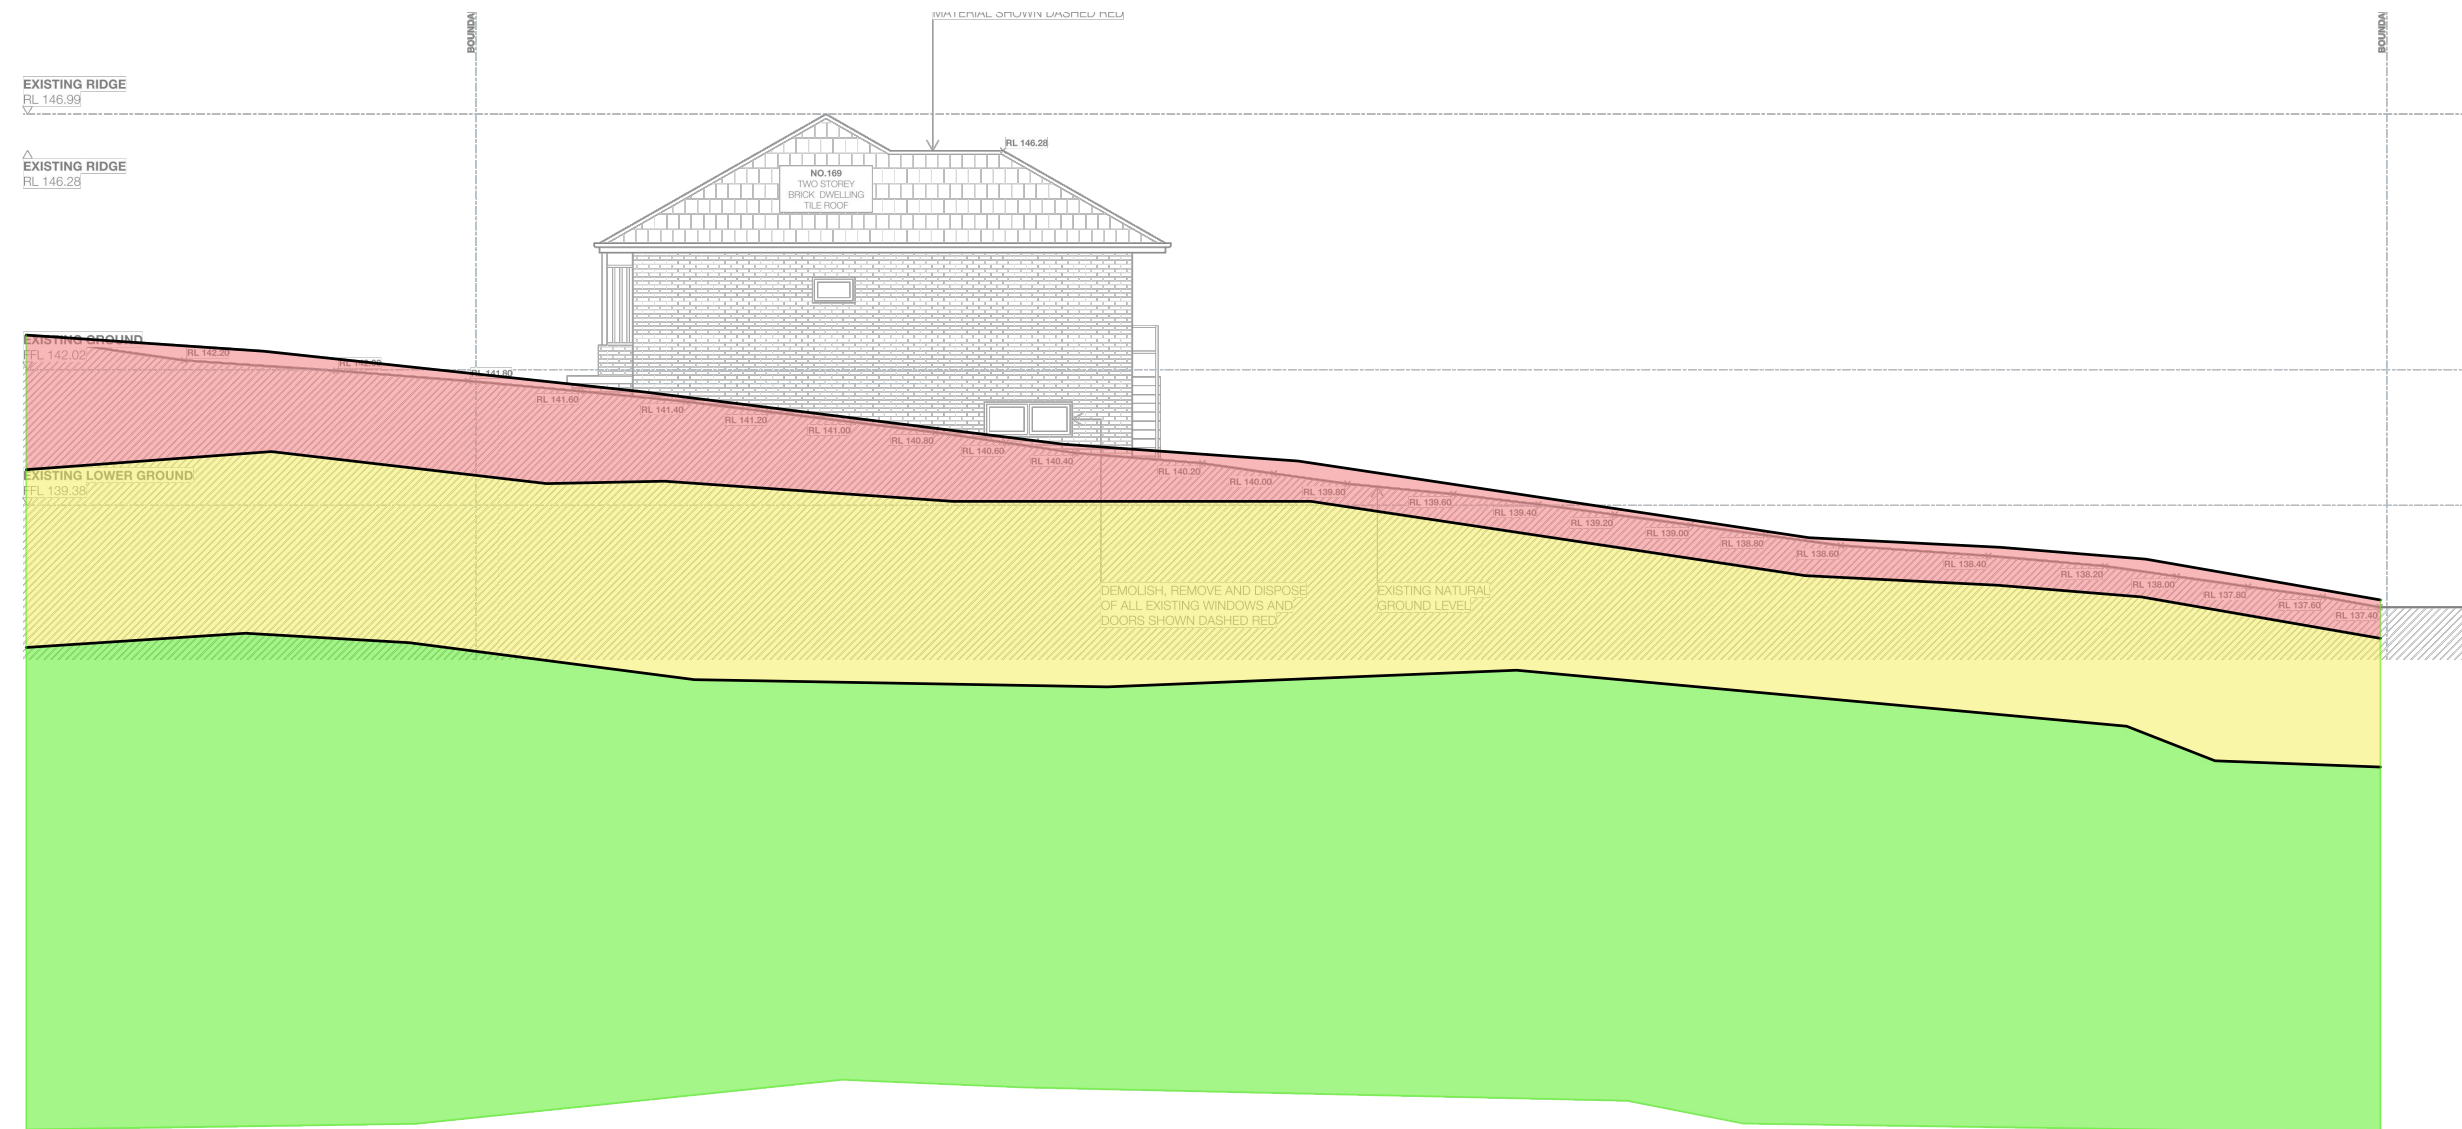
INTERPRETED SUBSURFACE SECTION ONLY.  
ACTUAL GROUND CONDITIONS MAY VARY.

**INFERRED GEOLOGICAL SECTION**  
SCALE NTS

The soil profile consists of sandy topsoil (O & A Horizons), clayey sand (B Horizon) and weathered low-strength bedrock (C Horizon). Based on our observations and the results of testing on site, we would expect weathered bedrock to be found within 1.90 to 3.10 metres below current surface levels across the area of the proposed works.
