## **Geotechnical Assessment**

**Project:** Alterations & Additions  
180 McCarrs Creek Road, Church Point NSW

**REF: AG 21101**  
7 April 2021

For **Alterations & Additions** at  
**180 McCarrs Creek Road, Church Point NSW**

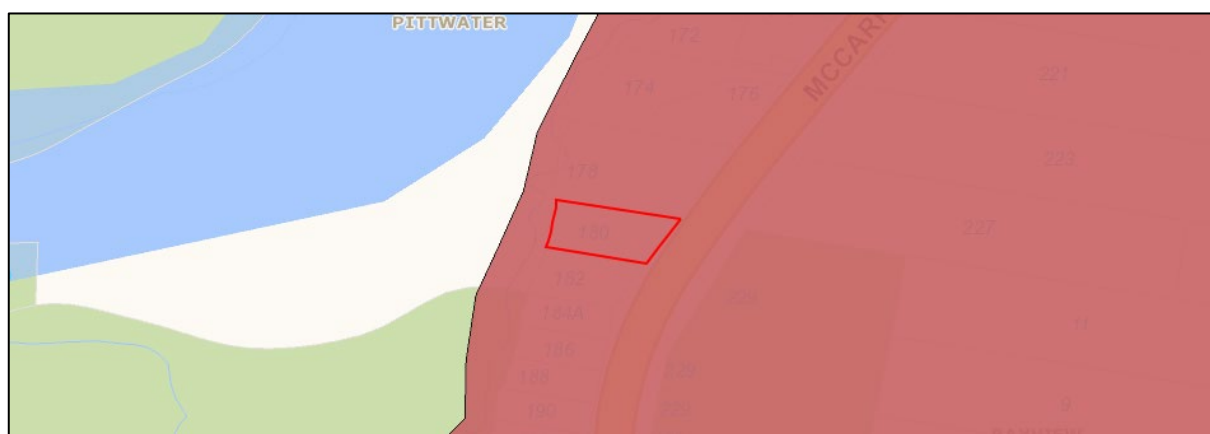
**Image 2.** PLEP Geotechnical Hazard Map  
– 180 McCarrs Creek Road, Church Point NSW

**LEGEND**  
Pittwater Geotechnical Hazard Map  
■ Geotechnical Hazard H1  
■ Geotechnical Hazard H2

- No evidence of significant soil creep, tension cracks or landslip instability were identified across the site or on adjacent properties, as viewed from the subject site at the time of our inspection.
- The property is classified as **Geotechnical Hazard H1** with reference to Northern Beaches Council PLEP Geotechnical Hazard Map (**Image 2**).

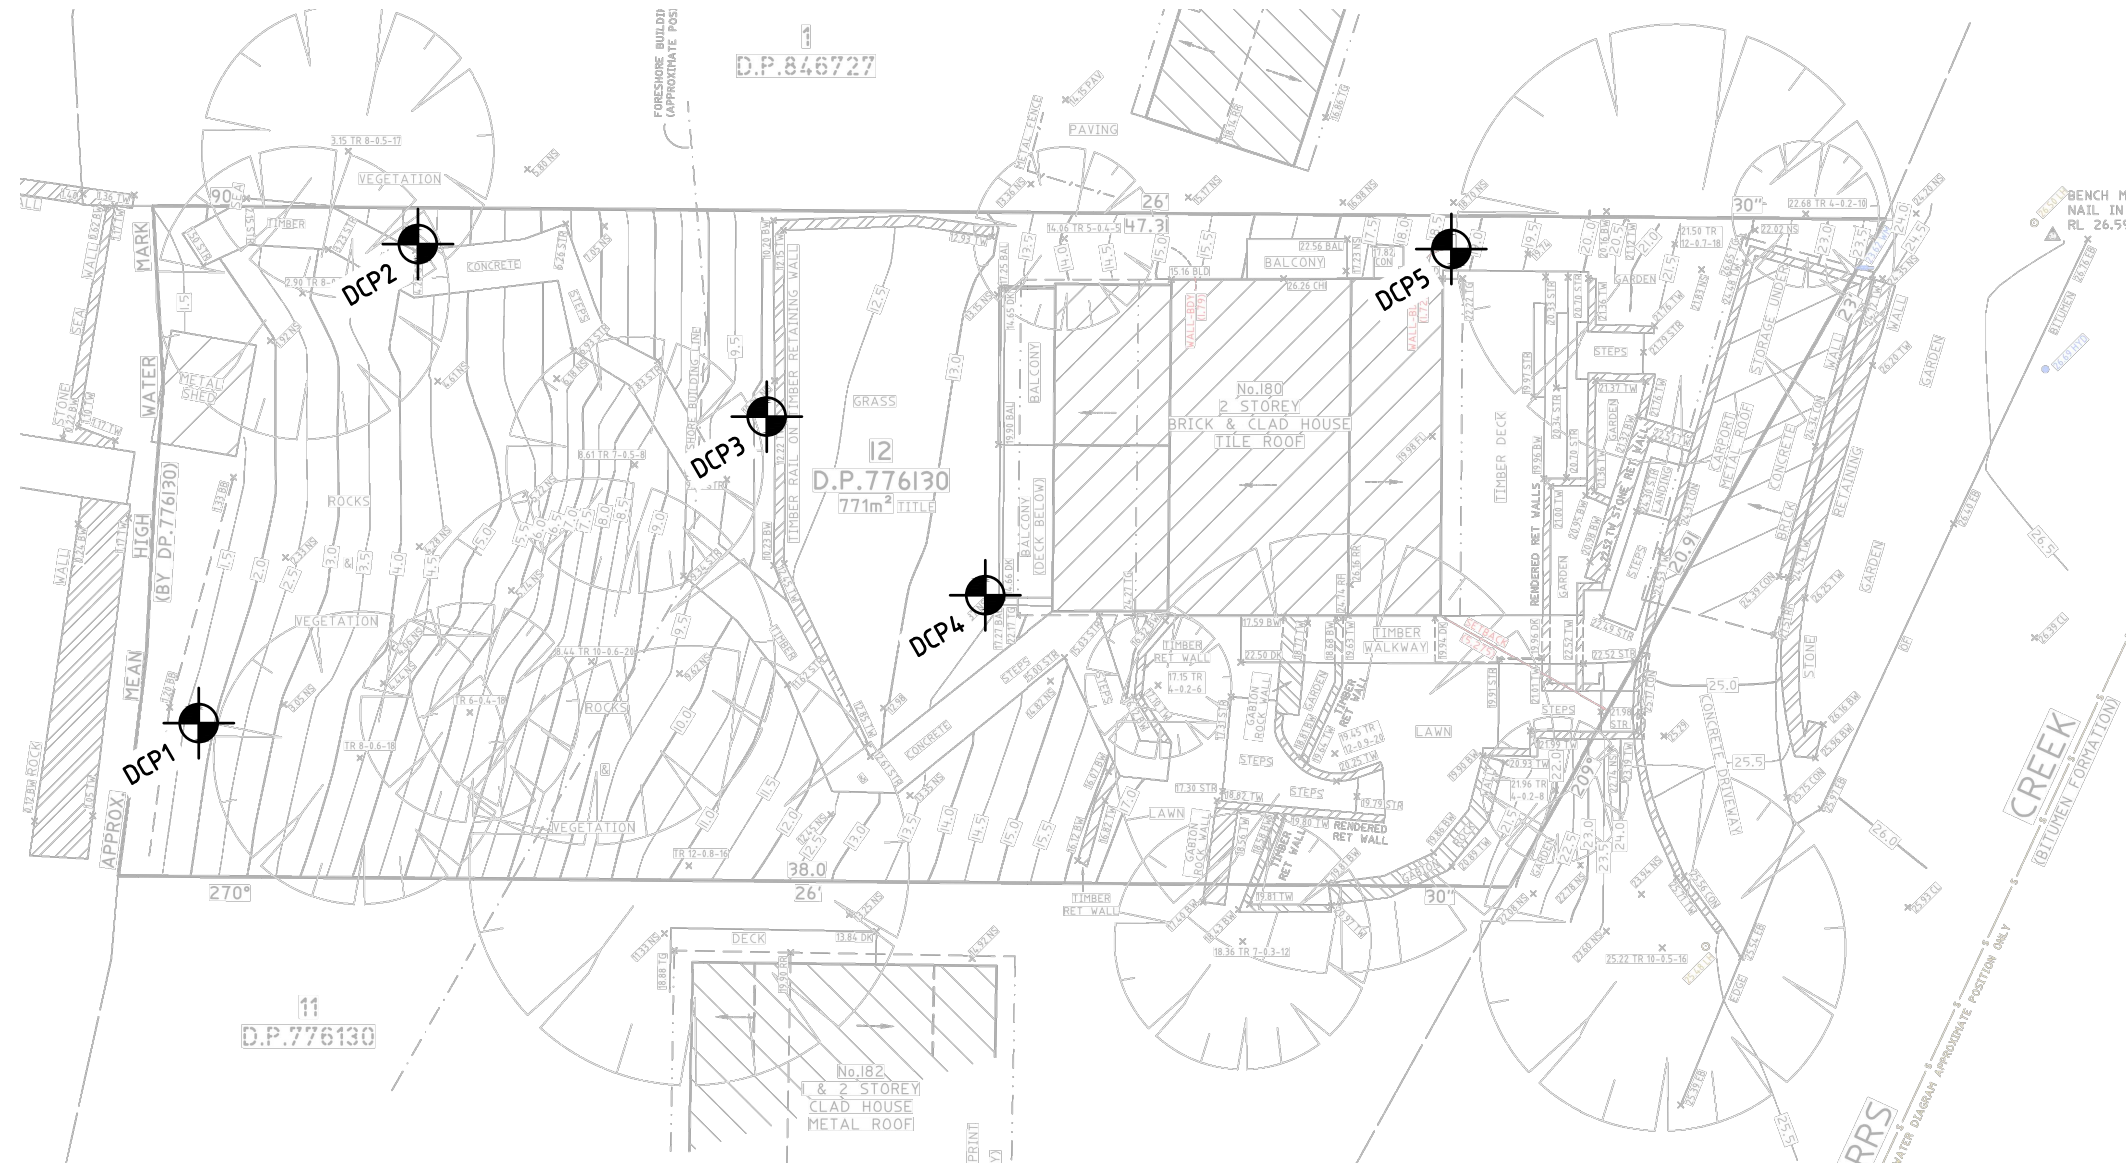
## SITE PLAN/GROUND TEST LOCATIONS

## DCP LOCATIONS

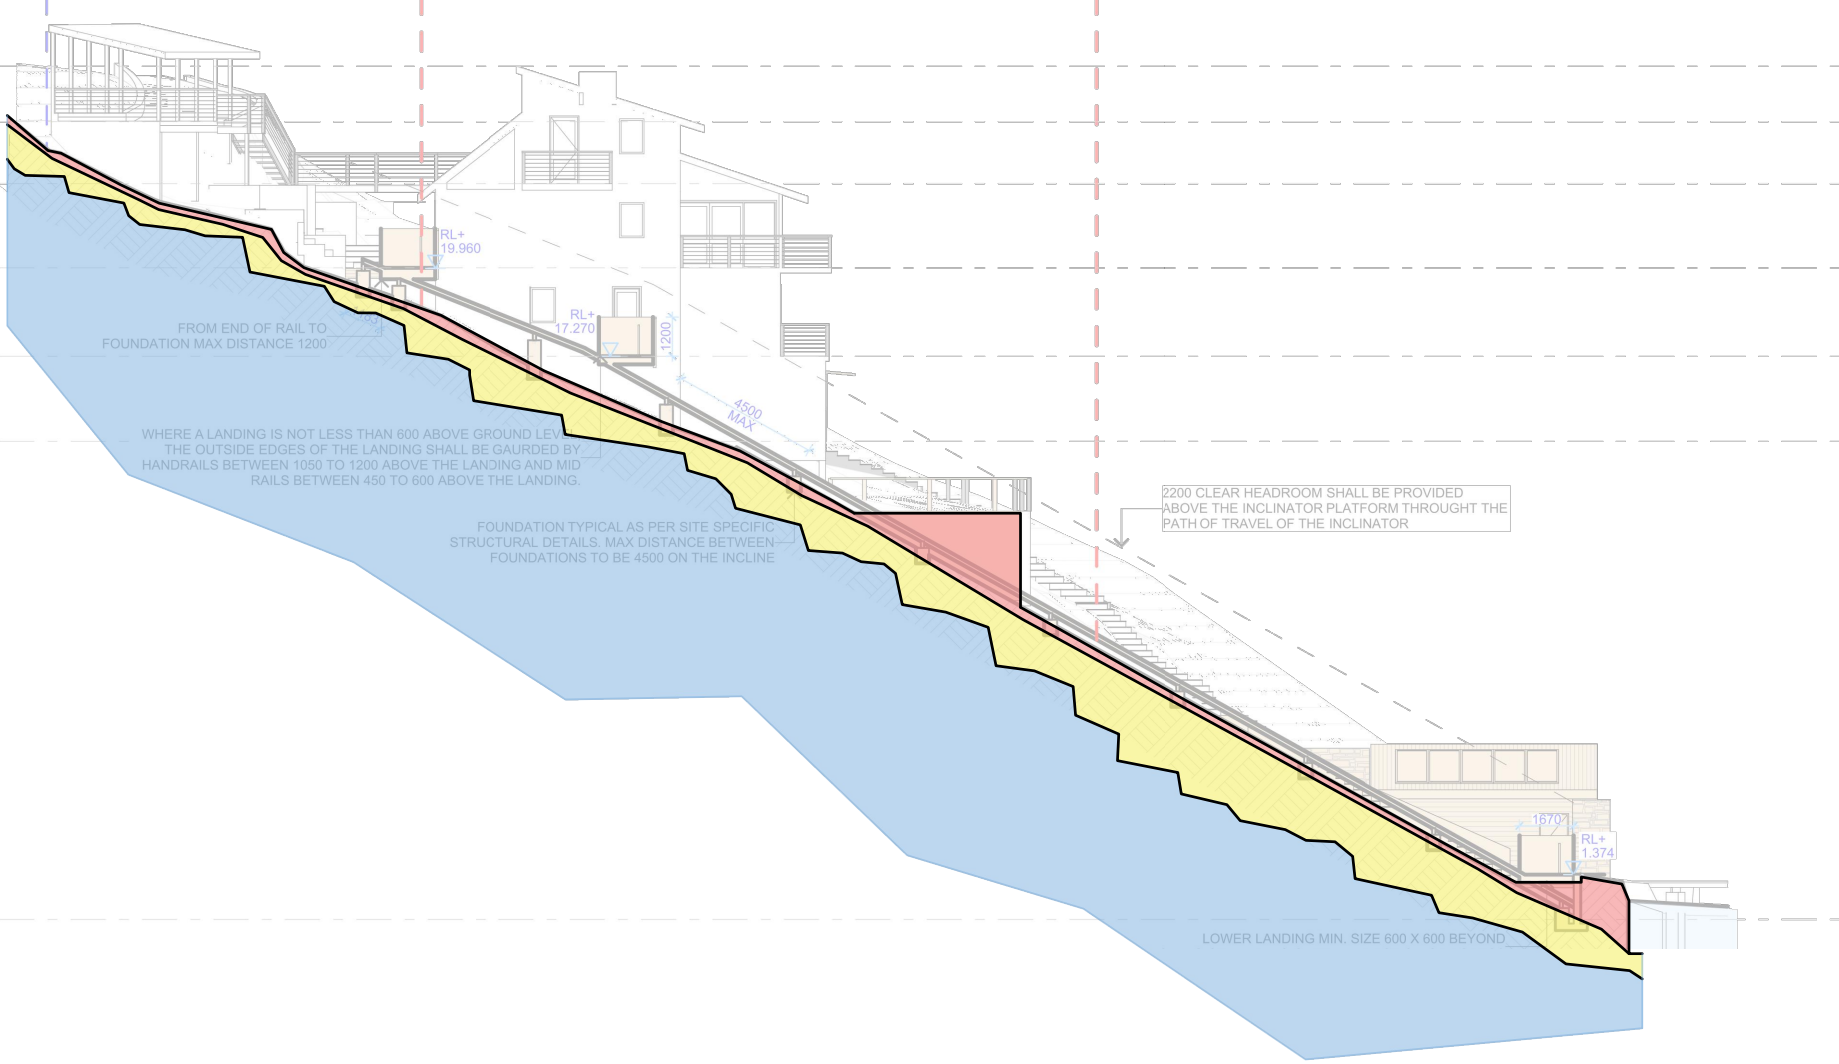
# INFERRED GEOLOGICAL SECTION

INTERPRETED SUBSURFACE SECTION ONLY.  
ACTUAL GROUND CONDITIONS MAY VARY.

The soil profile consists of uncontrolled fill and silty topsoil (O & A Horizons), silty clay (B Horizon), and weathered bedrock (C Horizon), with the potential for abundant detached joint blocks or sandstone floaters in the upper soil profile. Based on our observations and the results of testing on site and previous geotechnical investigations carried out on site, we would expect competent weathered bedrock, to be found within 1000–1800mm from current surface levels across the area of the proposed works.
