# Preliminary Geotechnical Assessment

**Project:** Alterations & Additions  
1 Highview Avenue, Queenscliff NSW

**Prepared for:**  
Nest Renovations

**Ref:** AG 24040  
6 March 2024

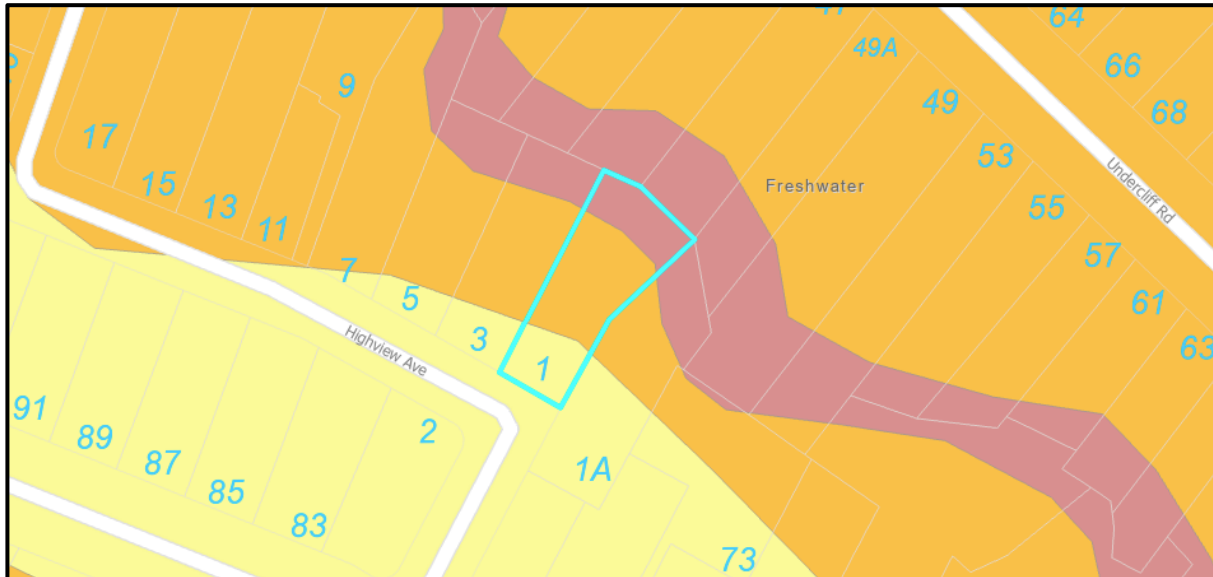
The site is mapped as **Area A, B & C** subject to specific landslip risk/geotechnical hazard mapping with reference to the Warringah (WLEP) Landslip Risk Map, Northern Beaches Council (**Image 1**).

**Figure 1.** Warringah Landslip Risk Map:  
1 Highview Avenue, Queenscliff NSW (© NBC Maps)
