### **Geotechnical Assessment**

**Project:** Site Classification 17 Narroy Road, North Narrabeen NSW

**Ref:** AG 24454 24 October 2024

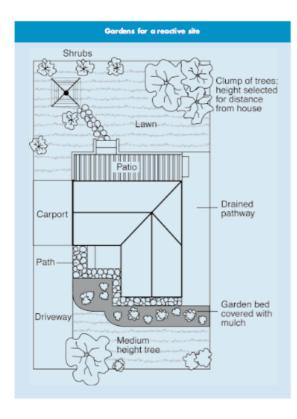
For this reason, particularly where problems exist or are likely to occur, it is recommended that an apron of paving be installed around as much of the building perimeter as necessary. This paving

should extend outwards a minimum of 900 mm (more in highly reactive soil) and should have a minimum fall away from the building of 1:60. The finished paving should be no less than 100 mm below brick vent bases.
