Geotechnical Assessment

Project: Alterations & Additions
46 Elanora Road, Elanora Heights NSW

Ref: AG 22489
18 November 2022

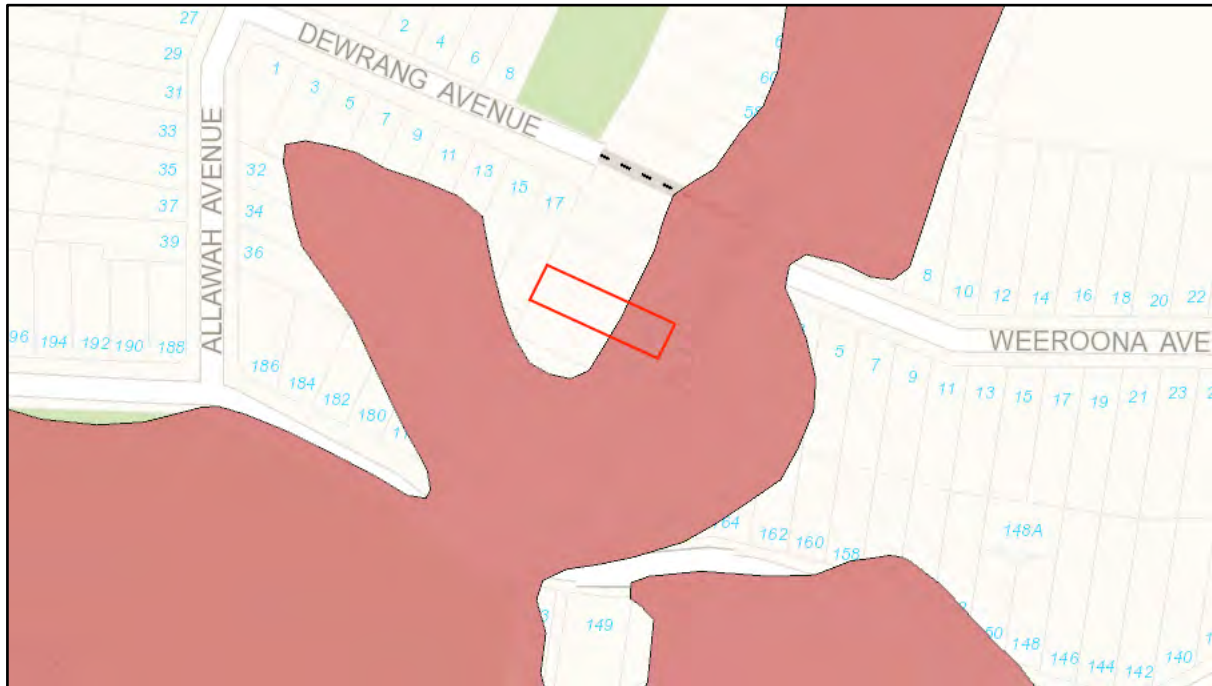
Based on reference to the plan entitled 'Geotechnical Hazard Mapping' (Ref. P21DCP-BC-MDCP2002, dated 2007) prepared by GHD LONGMAC on behalf of Pittwater Council, the site is located within **Geotechnical Hazard Zone H1**.

Image 1. Pittwater Geotechnical Hazard Risk Map:
46 Elanora Road, Elanora Heights NSW (© NBC Maps)
