## **Geotechnical Assessment**

**Project:** New Residence

61 Loombah Street, Bilgola Plateau NSW

**Ref:** AG 22313

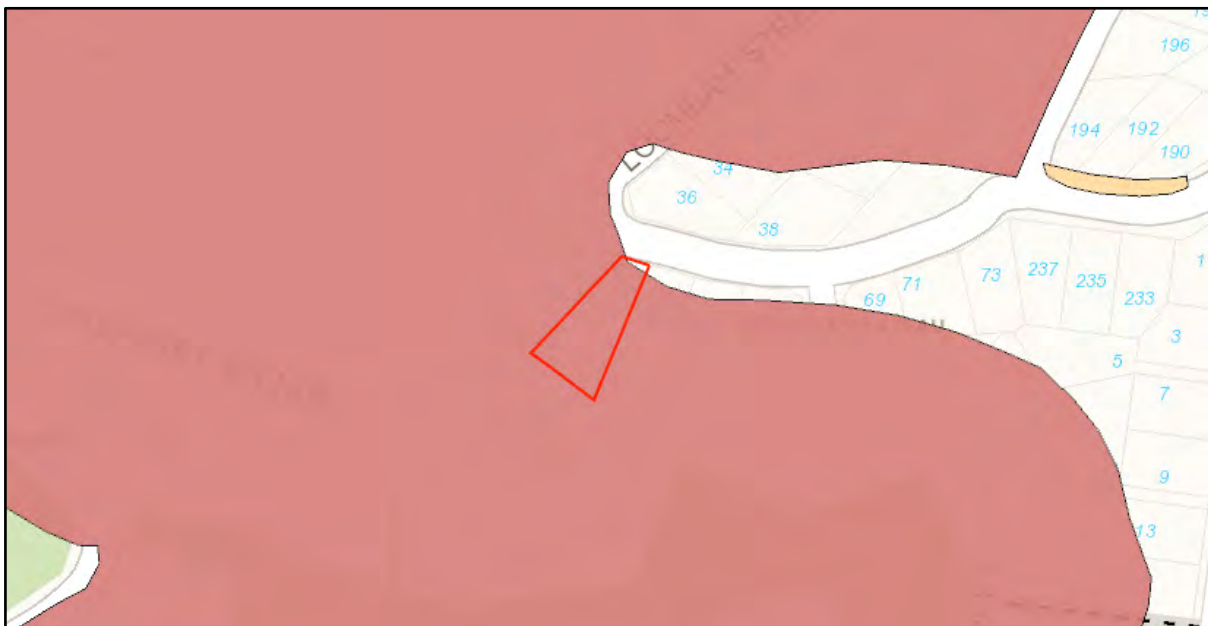
**Image 2.** PLEP Geotechnical Hazard Map  
– 61 Loombah Street, Bilgola Plateau NSW (NBC Maps)

**LEGEND**  
Pittwater Geotechnical Hazard Map  
■ Geotechnical Hazard H1  
■ Geotechnical Hazard H2

- Existing sandstone floaters were found to be well embedded with the soil profile and situated on the portion of the slope with a lesser gradient.
- Based on reference to the plan entitled “Geotechnical Hazard Mapping” (Ref. P21DCP-BC-MDCP2002, dated 2007) prepared by GHD LONGMAC on behalf of Pittwater Council, the site is mapped as a **Geotechnical Hazard H1** zone.

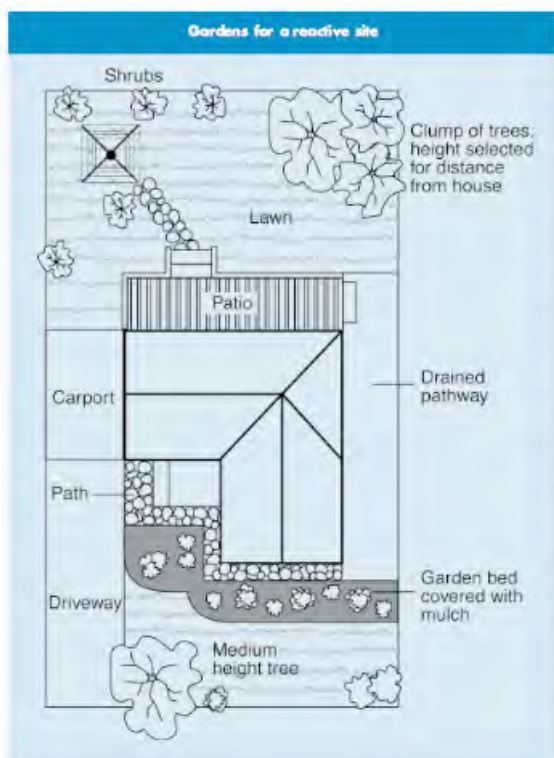
should extend outwards a minimum of 900 mm (more in highly reactive soil) and should have a minimum fall away from the building of 1:60. The finished paving should be no less than 100 mm below brick vent bases.

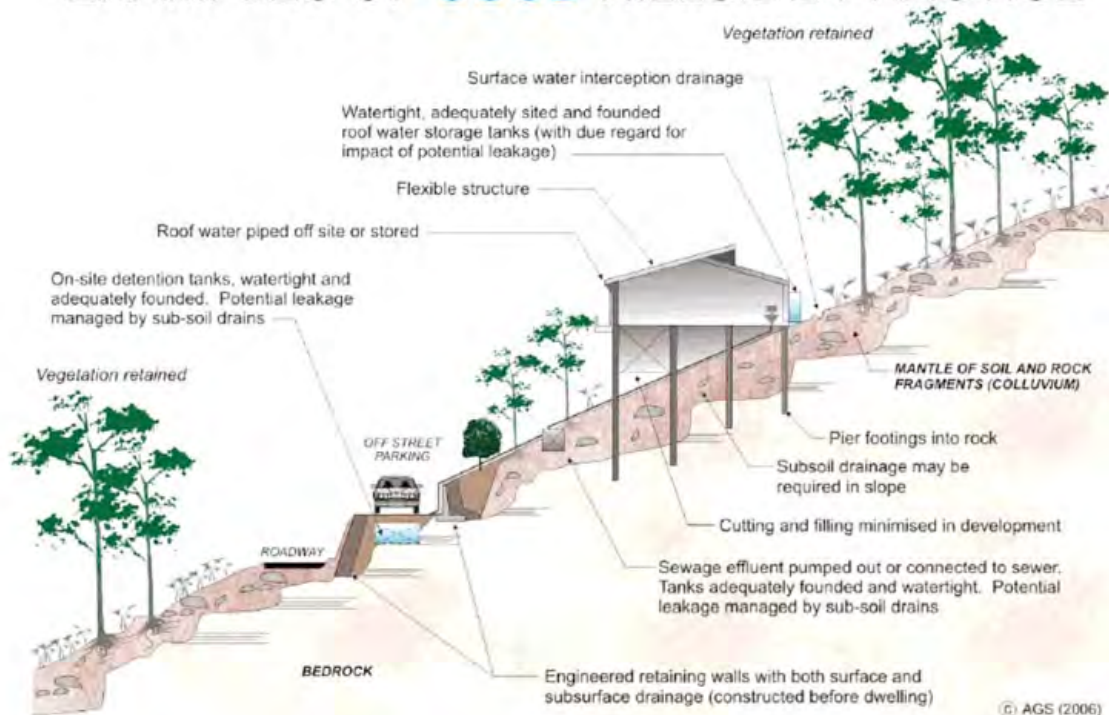
## EXAMPLES OF **GOOD** HILLSIDE PRACTICE

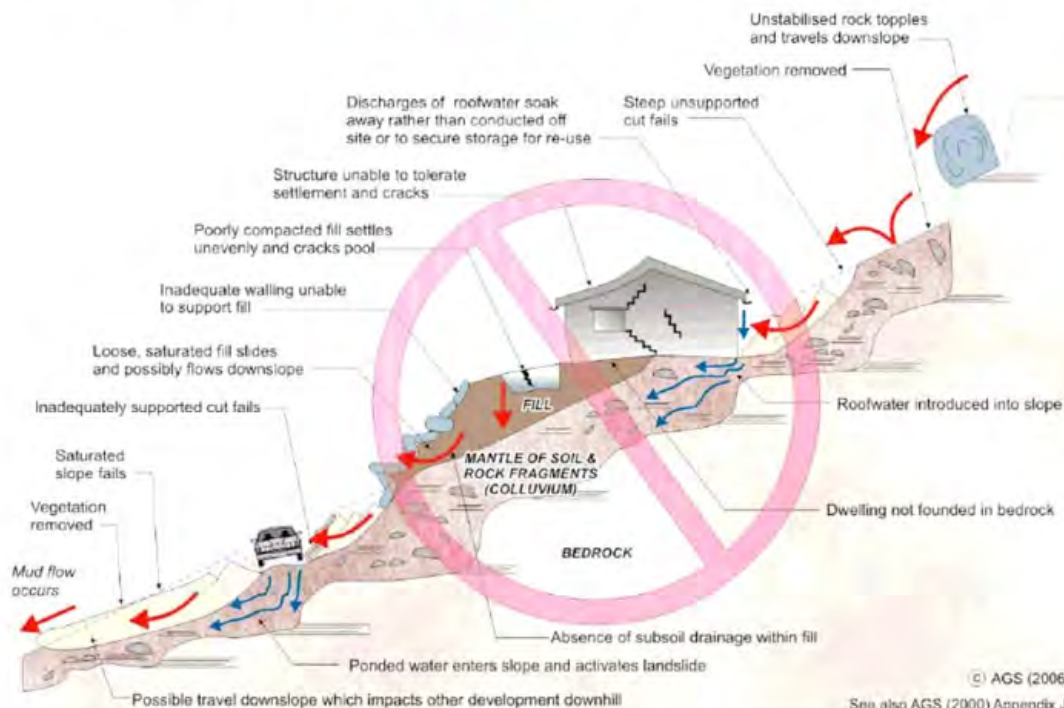
## EXAMPLES OF **POOR** HILLSIDE PRACTICE

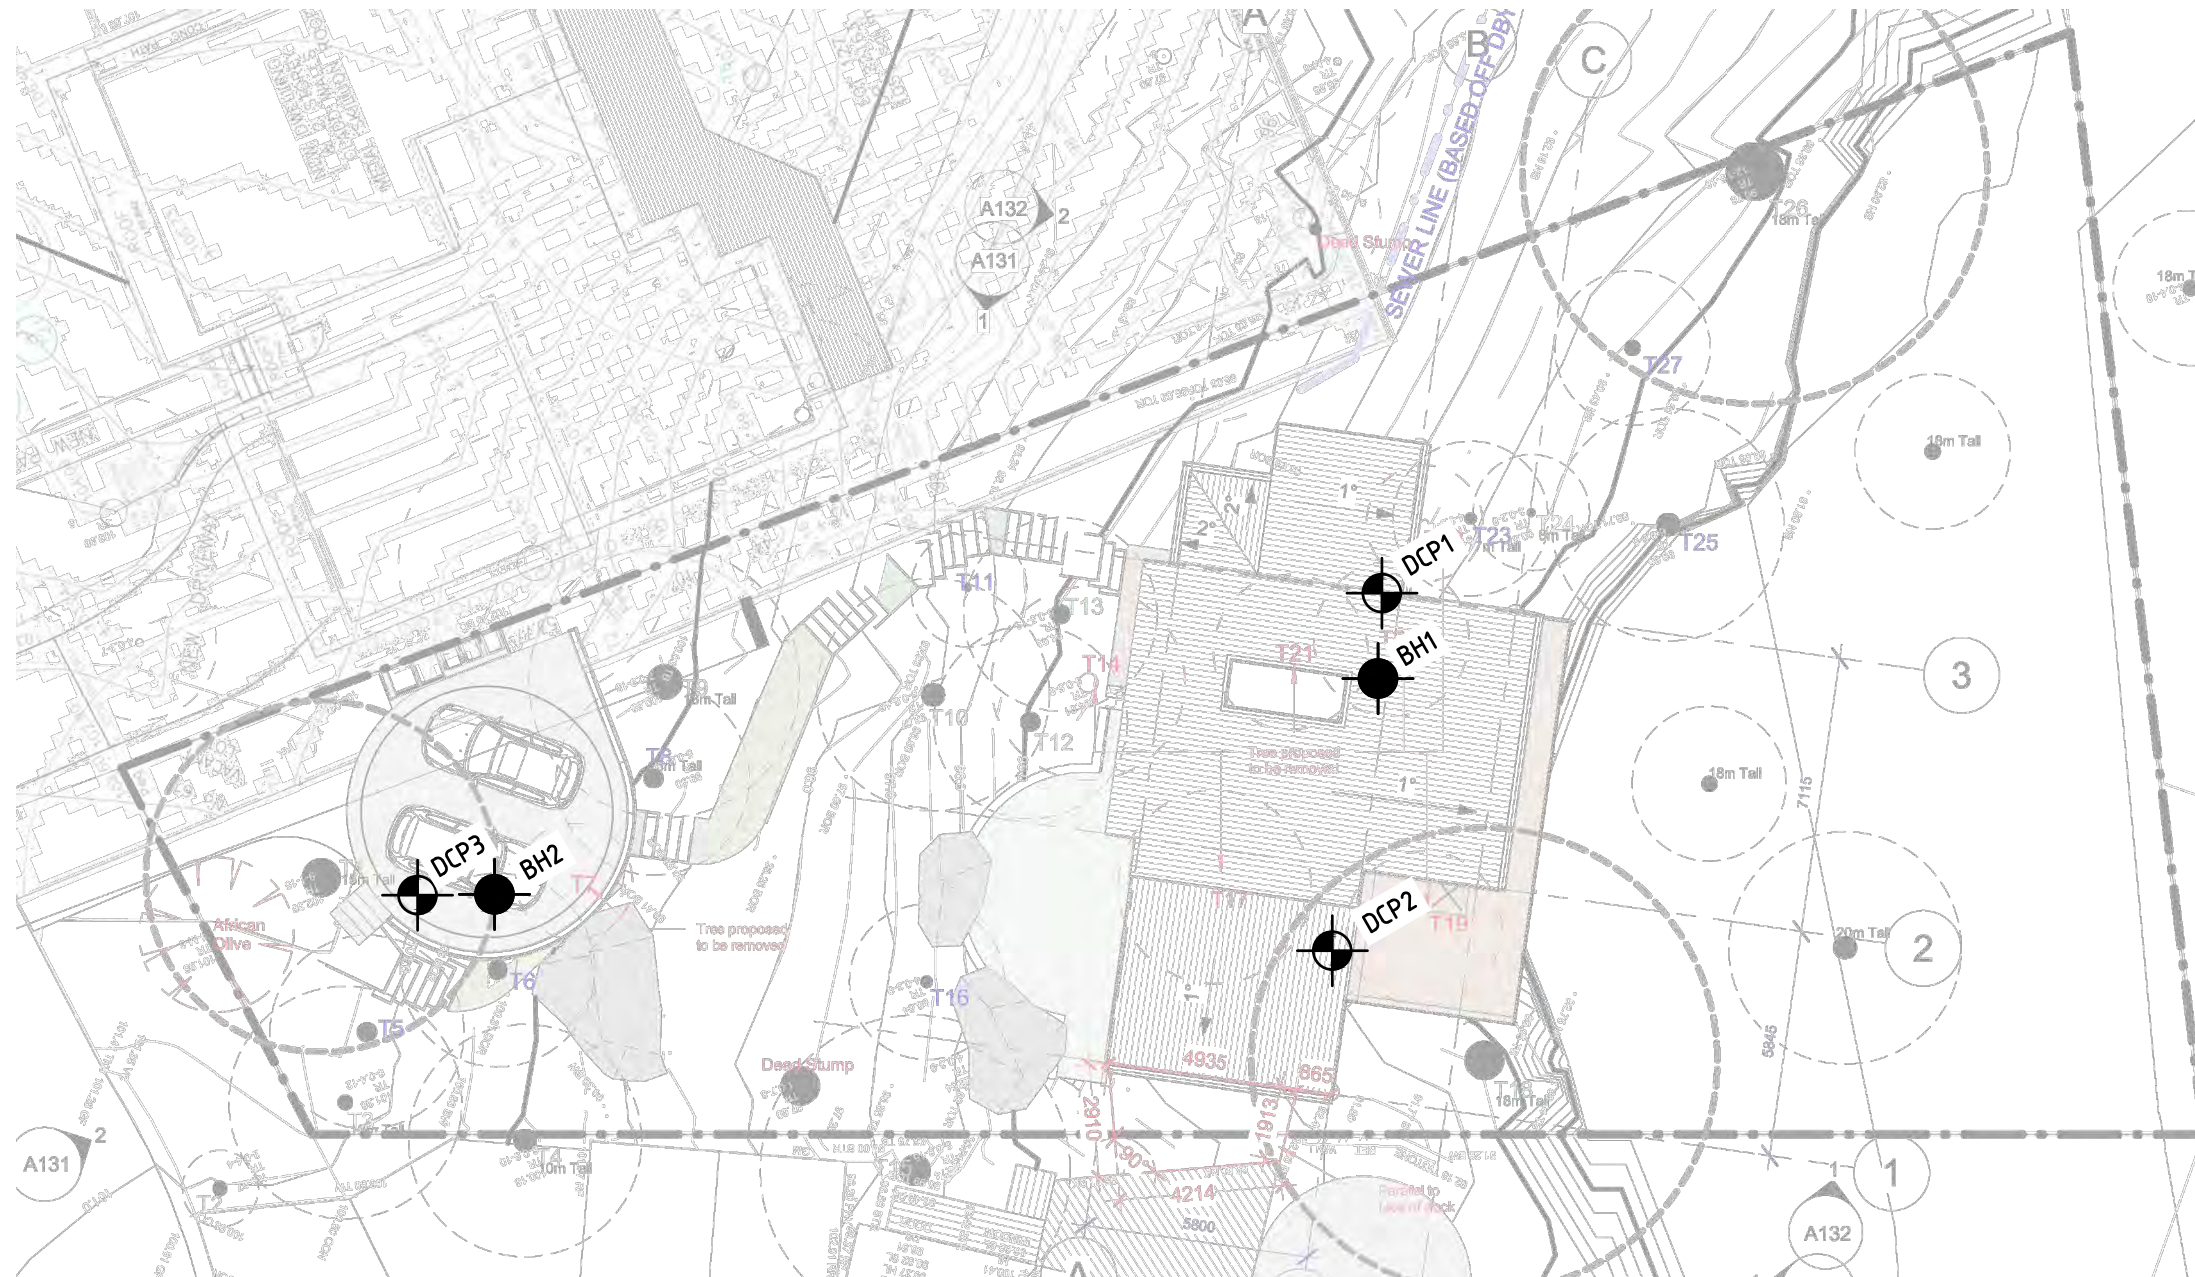
BOREHOLE LOCATIONS

**SITE PLAN/GROUND TEST LOCATIONS**  
SCALE NTS
