Jack Hodgson Consultants Pty Limited

MQ 30040 14th May, 2015 Page 1

PRELIMINARY GEOTECHNICAL ASSESSMENT FOR PROPOSED ADDITIONS AND ALTERATIONS AT 24 LINCOLN AVENUE COLLAROY

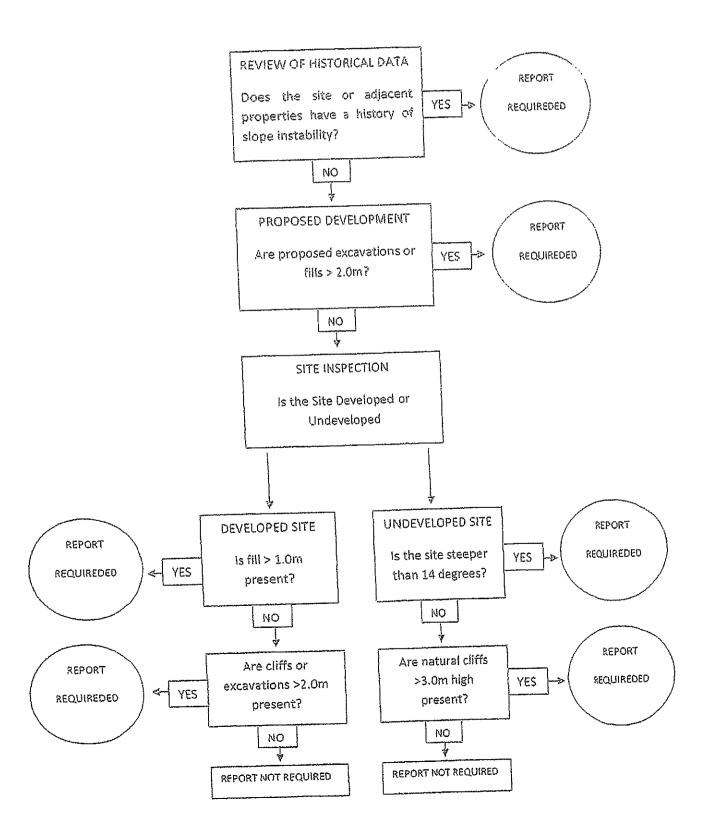
PRELIMINARY GEOTECHNICAL ASSESSMENT FLOW CHART WARRINGAH COUNCIL

The proposed building alterations and existing site conditions were considered and applied to the Council Flow Chart for class D areas as contained within Clause E10 of Warringah DCP and the WLEP. Based on this preliminary assessment, the proposed development works would be considered satisfactory from a Geotechnical and landslip perspective subject to the application of good engineering practice for the structural design and construction methods. No geotechnical report required.
