## Preliminary Geotechnical Assessment

**Project:** Alterations & Additions

13 Coniston Street, Wheeler Heights NSW

**Ref:** AG 22502

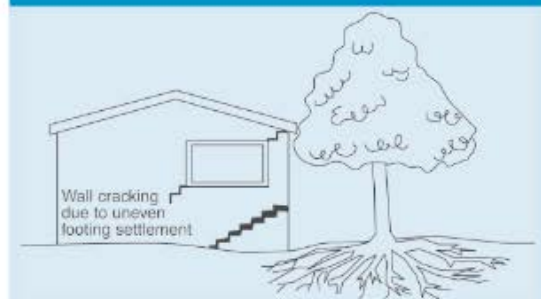
#### Trees can cause shrinkage and damage

As the weather pattern changes and the soil begins to dry out, the external footings will be first affected, beginning with the locations where the sun's effect is strongest. This has the effect of lowering the external footings. The doming is accentuated and cracking reduces or disappears where it occurred because of dishing, but other cracks open up. The roof lines may become convex.
