## **Geotechnical Assessment**

**Project:** Alterations & Additions  
4 Cabarita Road, Avalon Beach NSW

**Ref:** AG 19067  
14 April 2022

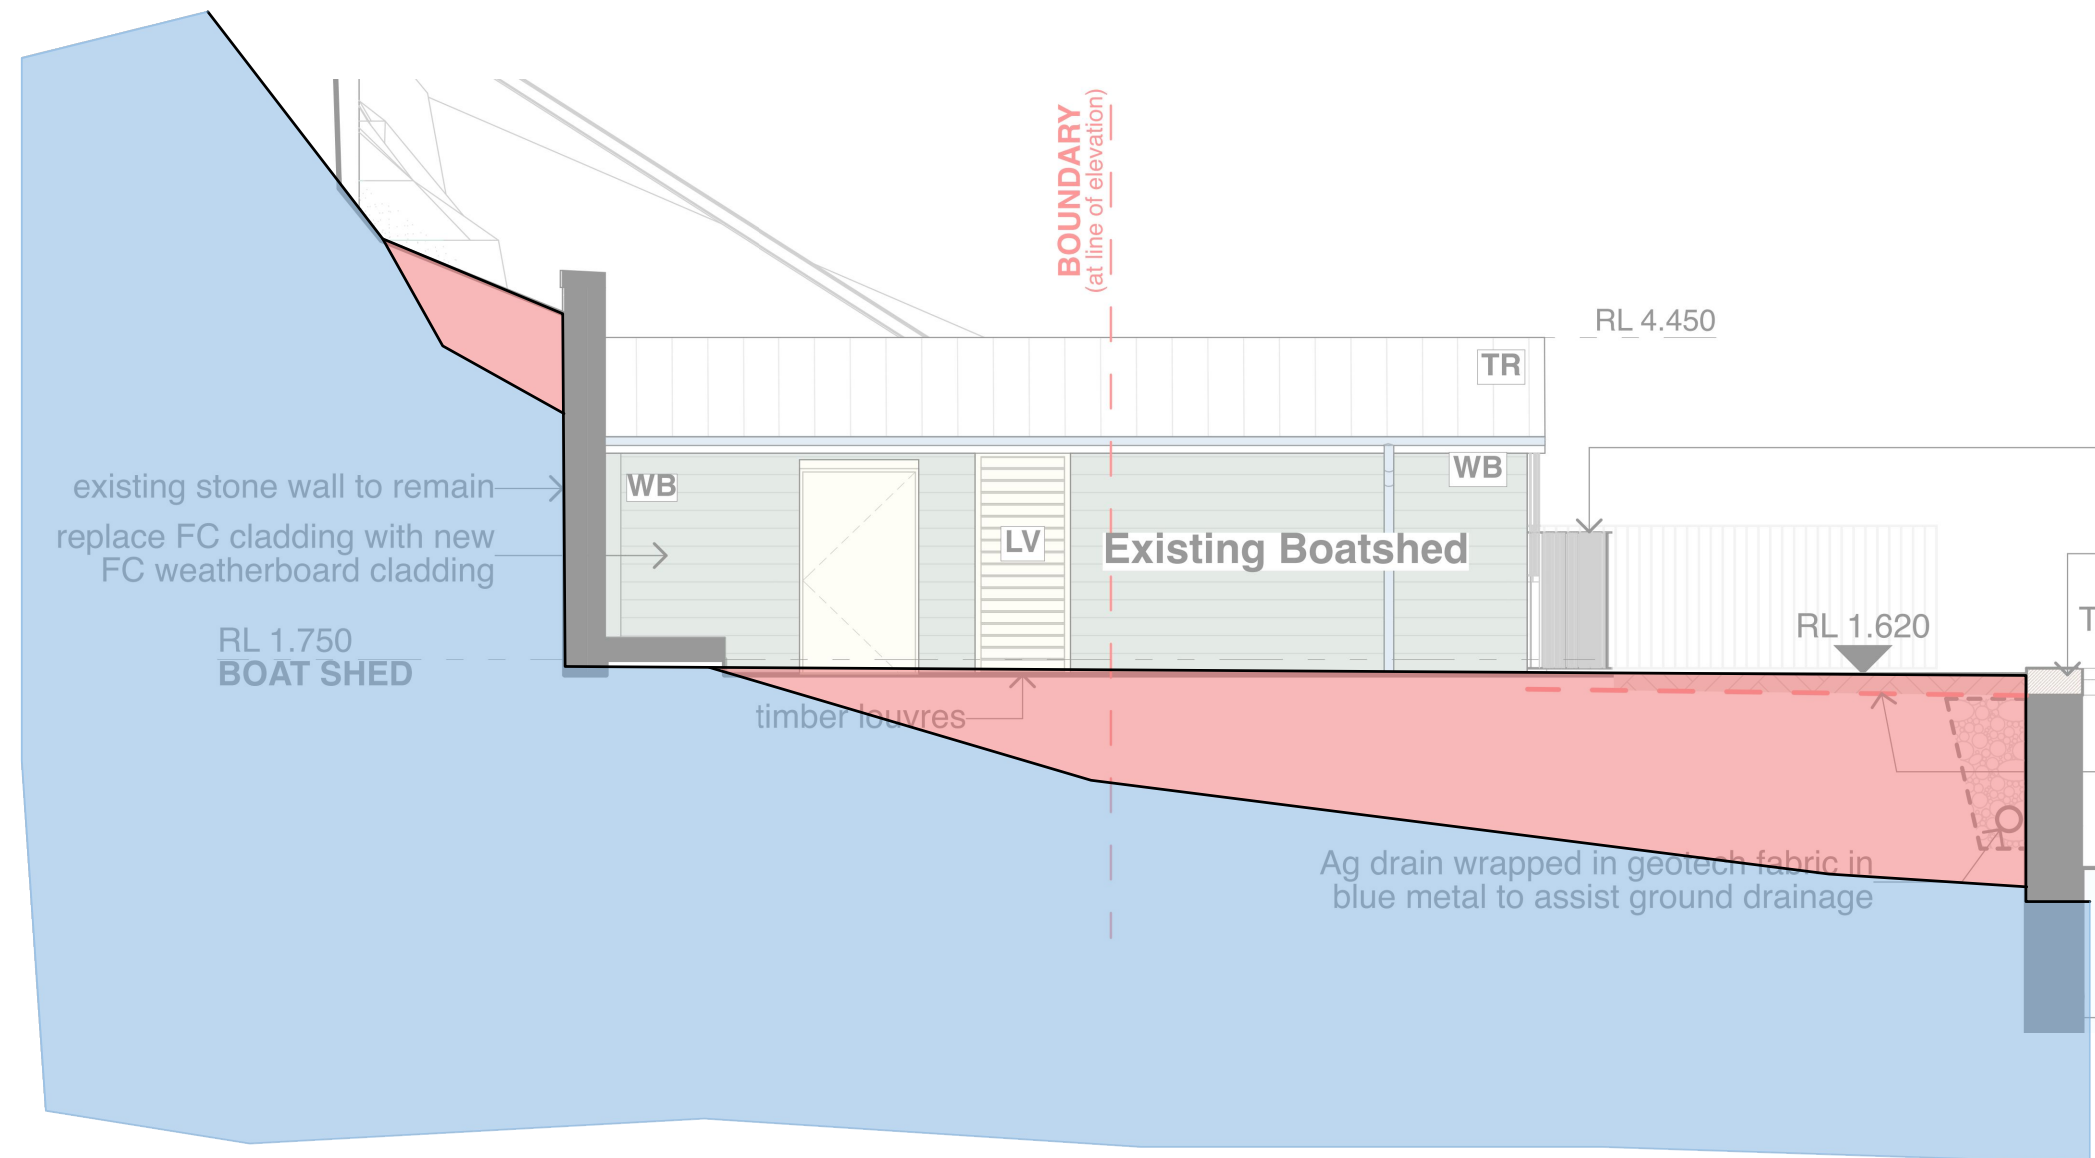
INTERPRETED SUBSURFACE SECTION ONLY.  
ACTUAL GROUND CONDITIONS MAY VARY.

**INFERRED GEOLOGICAL SECTION**  
SCALE NTS
