# Preliminary Geotechnical Assessment

**Project:** Alterations & Additions  
31 Coreen Avenue, Terrey Hills NSW

**Ref:** AG 25238  
3 June 2025

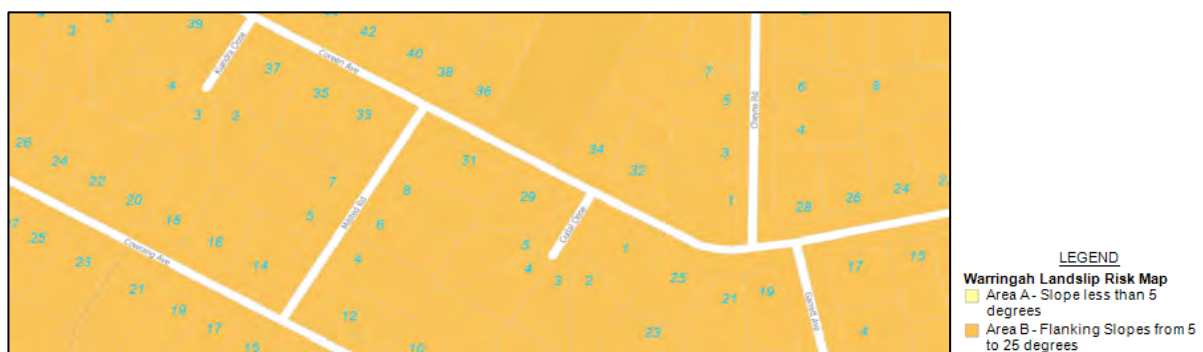
**Figure 1.** Warringah Landslip Risk Map: 31 Coreen Avenue, Terrey Hills NSW (© NBC Maps)

The site is mapped as **Area B** subject to specific landslip risk/geotechnical hazard mapping with reference to the Warringah (WLEP) Landslip Risk Map, Northern Beaches Council (**Image 1**).
