# Geotechnical Assessment

**Project:** Proposed Swimming Pool & Associated Works  
46 Gondola Road, North Narrabeen NSW

**Ref:** AG 24198  
20 May 2024

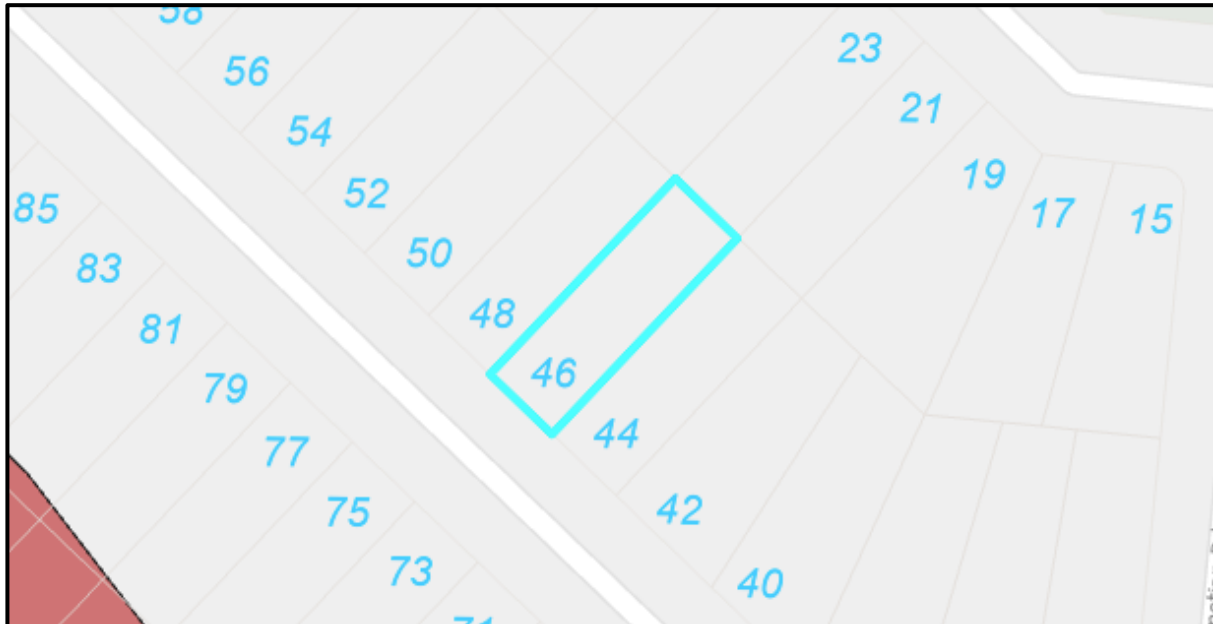
Based on reference to the plan entitled 'Geotechnical Hazard Mapping' (Ref. P21DCP-BC-MDCP2002, dated 2007) prepared by GHD LONGMAC on behalf of Pittwater Council, the site is not mapped as a **Geotechnical Hazard Zone**.

**Image 1.** Pittwater Geotechnical Hazard Risk Map:  
46 Gondola Road, North Narrabeen NSW (© NBC Maps)
