1187 Barrenjoey Road, Palm Beach

Minor Works

A Geotechnical Site Inspection was carried out on the 25th February 2016.

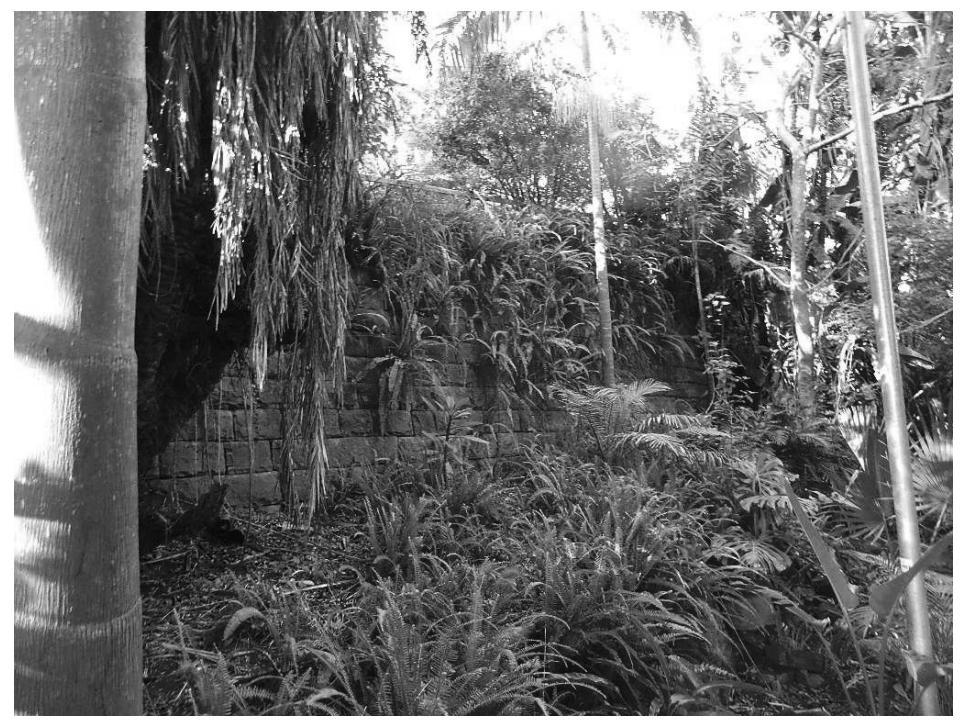
Photo 1

HAZARDS	Hazard One
ТҮРЕ	The large, dimensioned sandstone block retaining wall that supports the fill batter for Barrenjoey collapsing and impacting on the existing house and proposed works (Photo 1 & 2).
LIKELIHOOD	'Unlikely' (10 ⁻⁴)
CONSEQUENCES TO PROPERTY	'Medium' (25%)
RISK TO PROPERTY	'Low' (2 x 10 ⁻⁵)
RISK TO LIFE	4.3 x 10 ⁻⁷ /annum
COMMENTS	'Acceptable' level of risk.
