PRELIMINARY ARBORICULTURAL ASSESSMENT REPORT

Manly Village Public School NSW

REVISON B 26th of May 2022

Prepared for NBRS

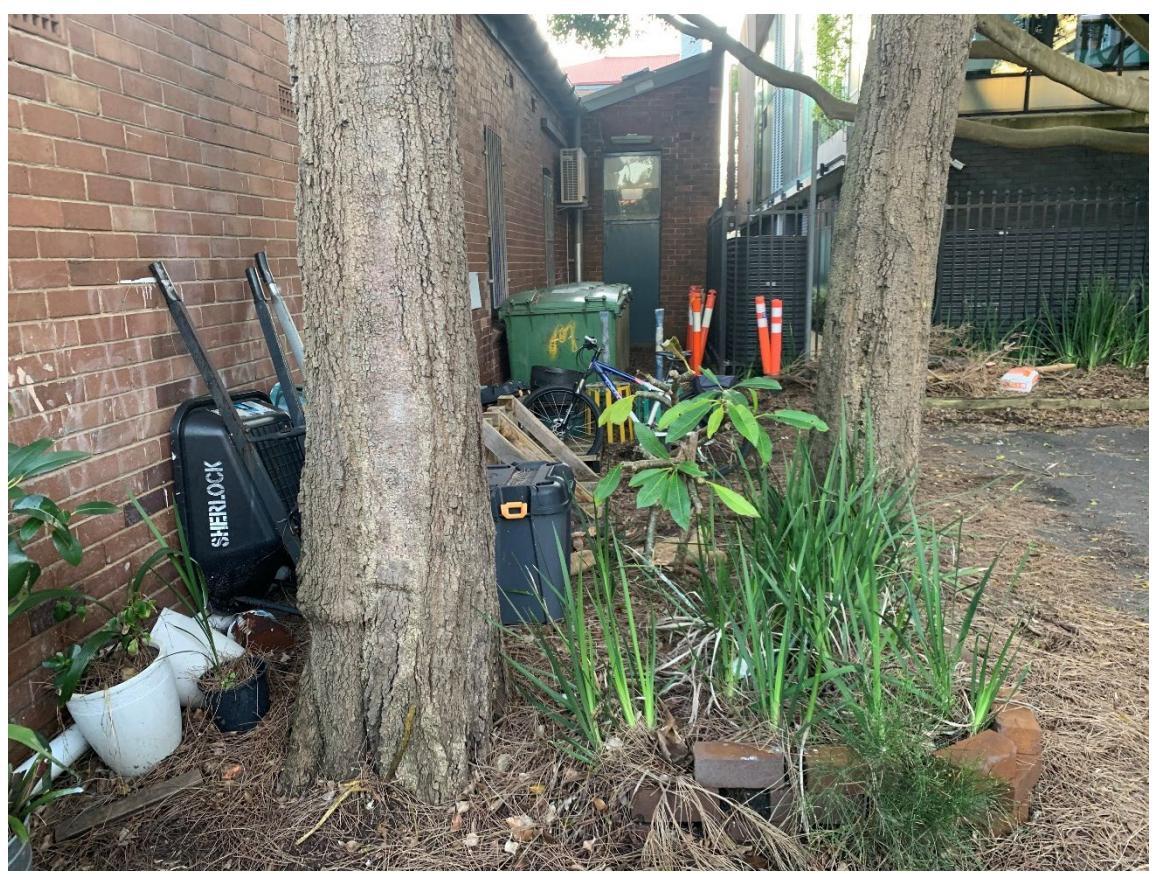
The site is relatively flat. Refer to detailed survey for detailed levels. The subject trees are within 3m of the existing school buildings. Tree 1 is approximately 1.5m from the building and Tree 2 is approximately 2.5m away from the building.

Figure 1 - Trees 1 and 2 proximity to existing buildings

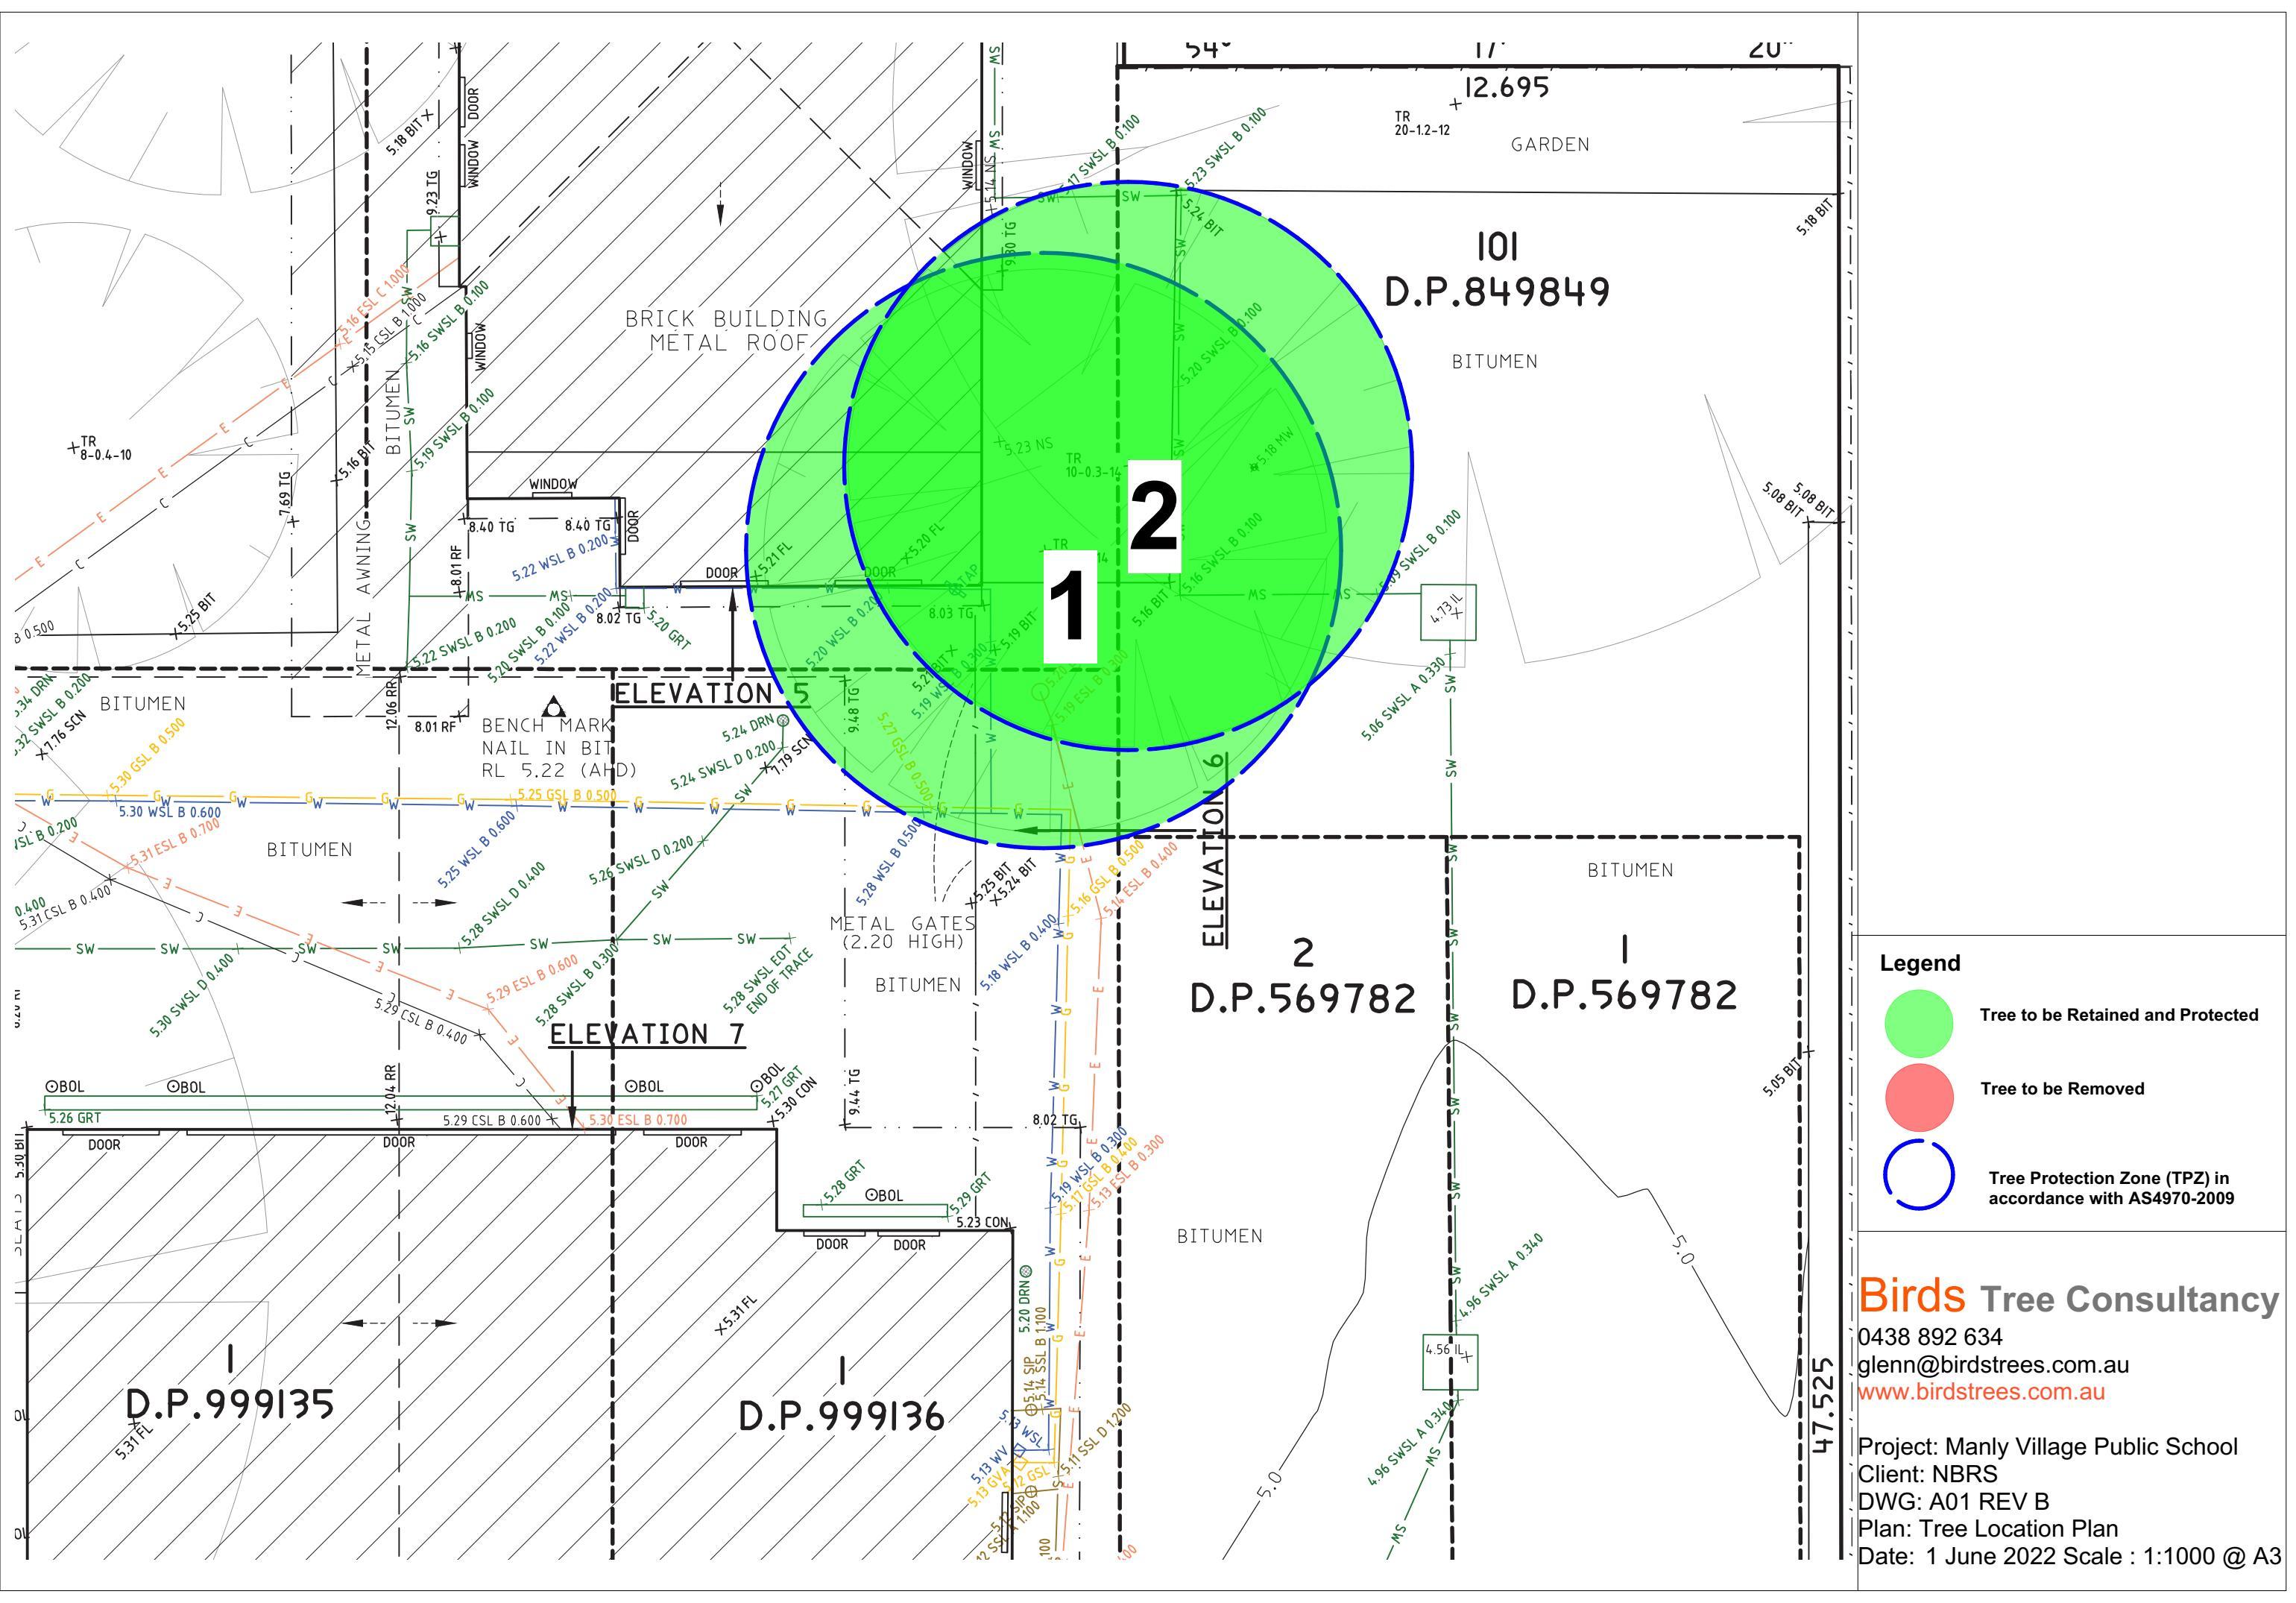
Appendix D - Tree Location Plan

Trees are as identified in the attached inspection forms in Appendix C and shown in Tree location Plan A01 in Appendix D.
