102 OLD PITTWATER ROAD, BROOKVALE ARBORICULTURAL IMPACT ASSESSMENT

PREPARED FOR:

OLANI PROPERTY GROUP

Executive Summary

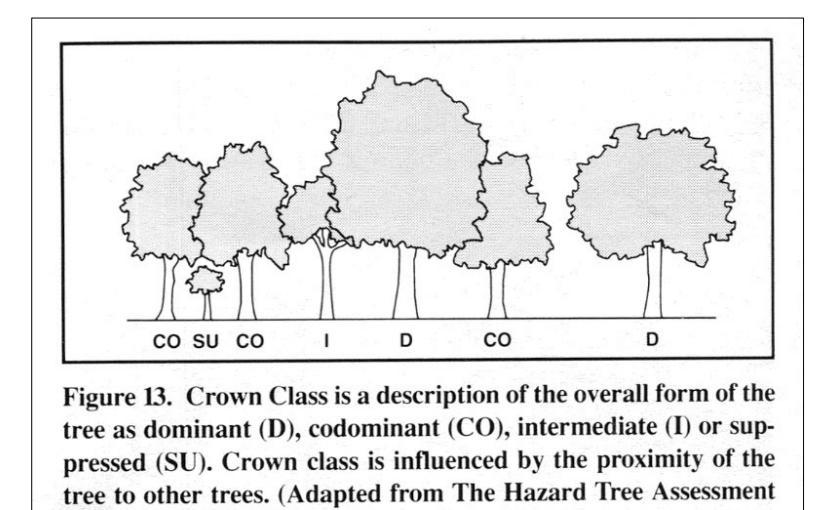
The form, structure or shape of each tree is assessed and recorded as either one or a combination of several of the below terms:

Forest forms (F) ²⁰: Dominant; Codominant; Intermediate; Suppressed. For sites that contain remnant native vegetation.

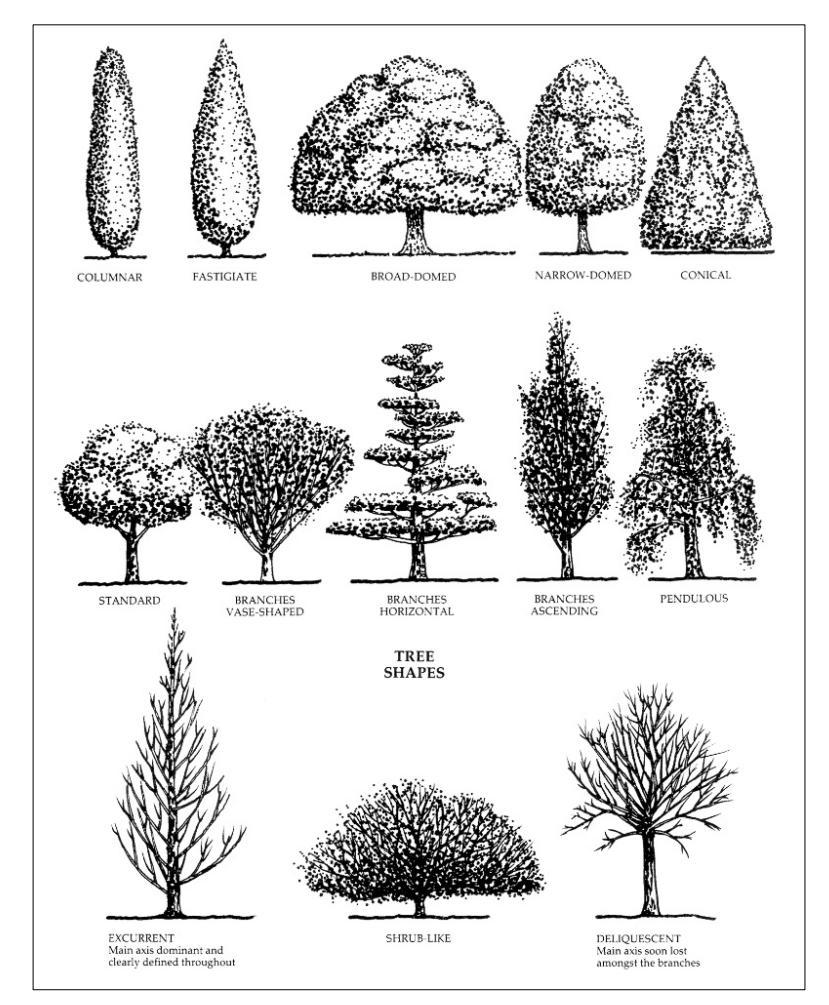
Urban Tree forms (U) ²⁹: Columnar; Fastigiate; Broad-domed; Narrowdomed; Conical; Standard; Branches Vase-shaped; Branches Horizontal; Branches Ascending; Pendulous' Excurrent; Shrub-like; Deliquescent. For sites that mainly contain Urban trees.

Modifiers: Bias Crown/Asymmetry (**BC**); Crown Shy (**CS**) (also referenced is the adjacent dominant tree canopy i.e. **T4**); Palm (**P**), Leaning (**L**); Basal Multi Trunked/stump sprout (**BM**); Emergent (**E**), the crown emerges from a lower canopy formed by other dominant or codominant crowns.

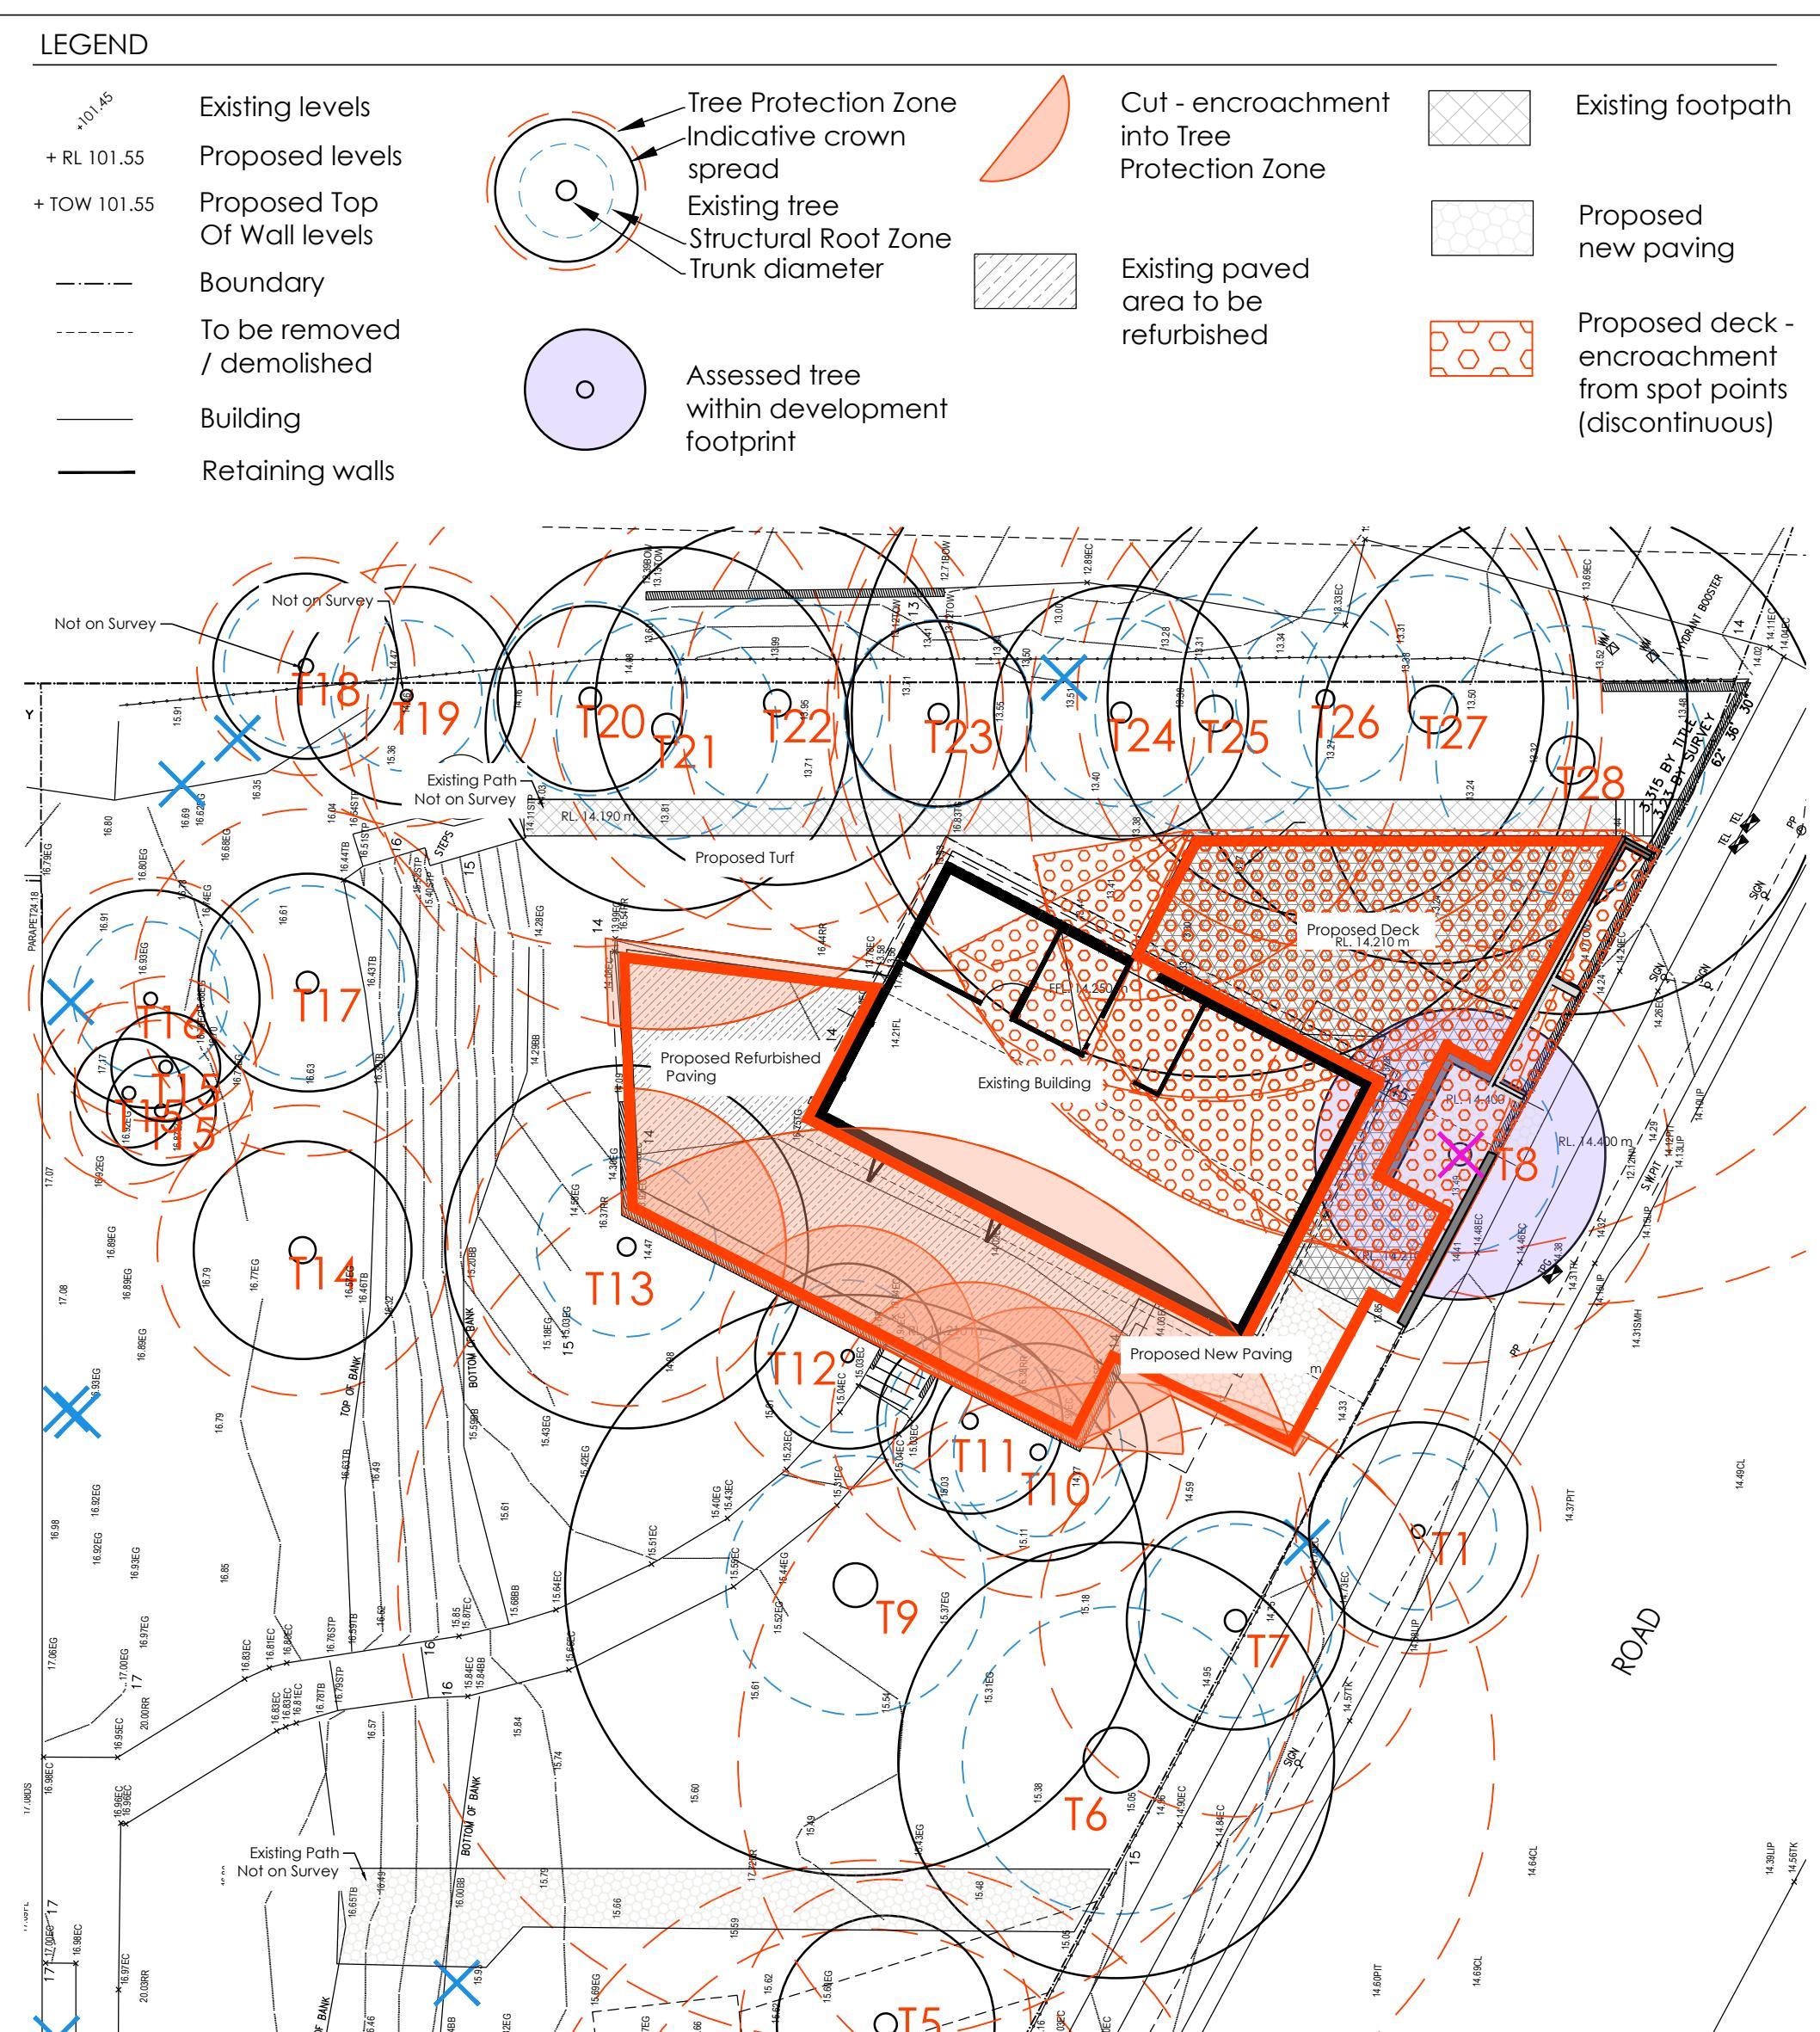
9. Tree Location Plan

Generally the site's vegetation was observed to have a majority native tree canopy, with an exotic shrub mid storey and a turf groundcover layer. The existing surveyed trees are shown at **9. Tree Location Plan** (page 22).

The physical data for tree locations, crown width and DRB is schematically described in **9. Tree** Location Plan (page 22).

The proposed development will involve the alterations and additions to an existing building with associated paving. This will involve the demolition of existing structures and regrading site levels through excavation, cutting and filling of soil on site. The extent of site works is also illustrated at **9**. **Tree Location Plan** (page 22).
