GEOTECHNICAL ASSESSMENT (In Accordance with Pittwater Council Risk Management Policy)

FOR PROPOSED ALTERATION AND ADDITIONS

AT 140A CRESCENT ROAD, NEWPORT, NSW

Date: 23 April 2020 Ref: 22486Z4rpt

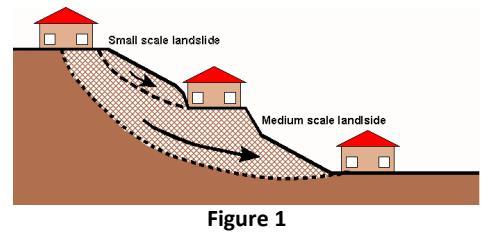
Rotational or circular slip failures (Figure 1) - can occur on moderate to very steep soil and weathered rock slopes (Table 1). The sliding surface of the moving mass tends to be deep seated. Tension cracks may open at the top of the slope and bulging may occur at the toe. The ground may move in discrete "steps" separated by long periods without movement. More rapid movement may occur after heavy rain.

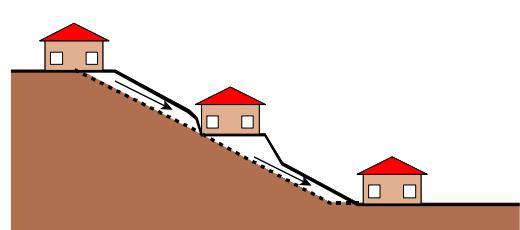
Translational slip failures (Figure 2) - tend to occur on moderate to very steep slopes (Table 1) where soil, or weak rock, overlies stronger strata. The sliding mass is often relatively shallow. It can move, or deform slowly (creep) over long periods of time. Extensive linear cracks and hummocks sometimes form along the contours. The sliding mass may accelerate after heavy rain.

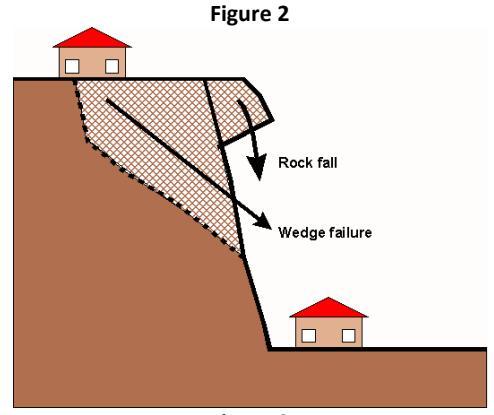
Figure 3

Wedge failures (Figure 3) - normally only occur on extreme slopes, or cliffs (Table 1), where discontinuities in the rock are inclined steeply downwards out of the face.

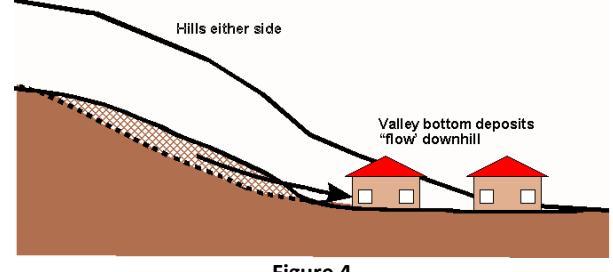
Figure 4

Debris flows and mud slides (Figure 4) - may occur in the foothills of ranges, where erosion has formed valleys which slope down to the plains below. The valley bottoms are often lined with loose eroded material (debris) which can "flow" if it becomes saturated during and after heavy rain. Debris flows are likely to occur with little warning; they travel a long way and often involve large volumes of soil. The consequences can be devastating.
