### **RE: PROPOSED BOARDING HOUSE DEVELOPMENT 255 CONDAMINE STREET MANLY VALE** NSW – RESPONSE TO NATURAL ENVIRONMENT AND WATER MANAGEMENT OFFICER COMMENTS

### ATTACHMENT A - ADDITIONAL FLOODING INFORMATION MAPSET

255 Condamine Street, Manly Vale, NSW Proposed Boarding House Development Response to Council Comments Sub-Project MY Manly Vale Pty Ltd

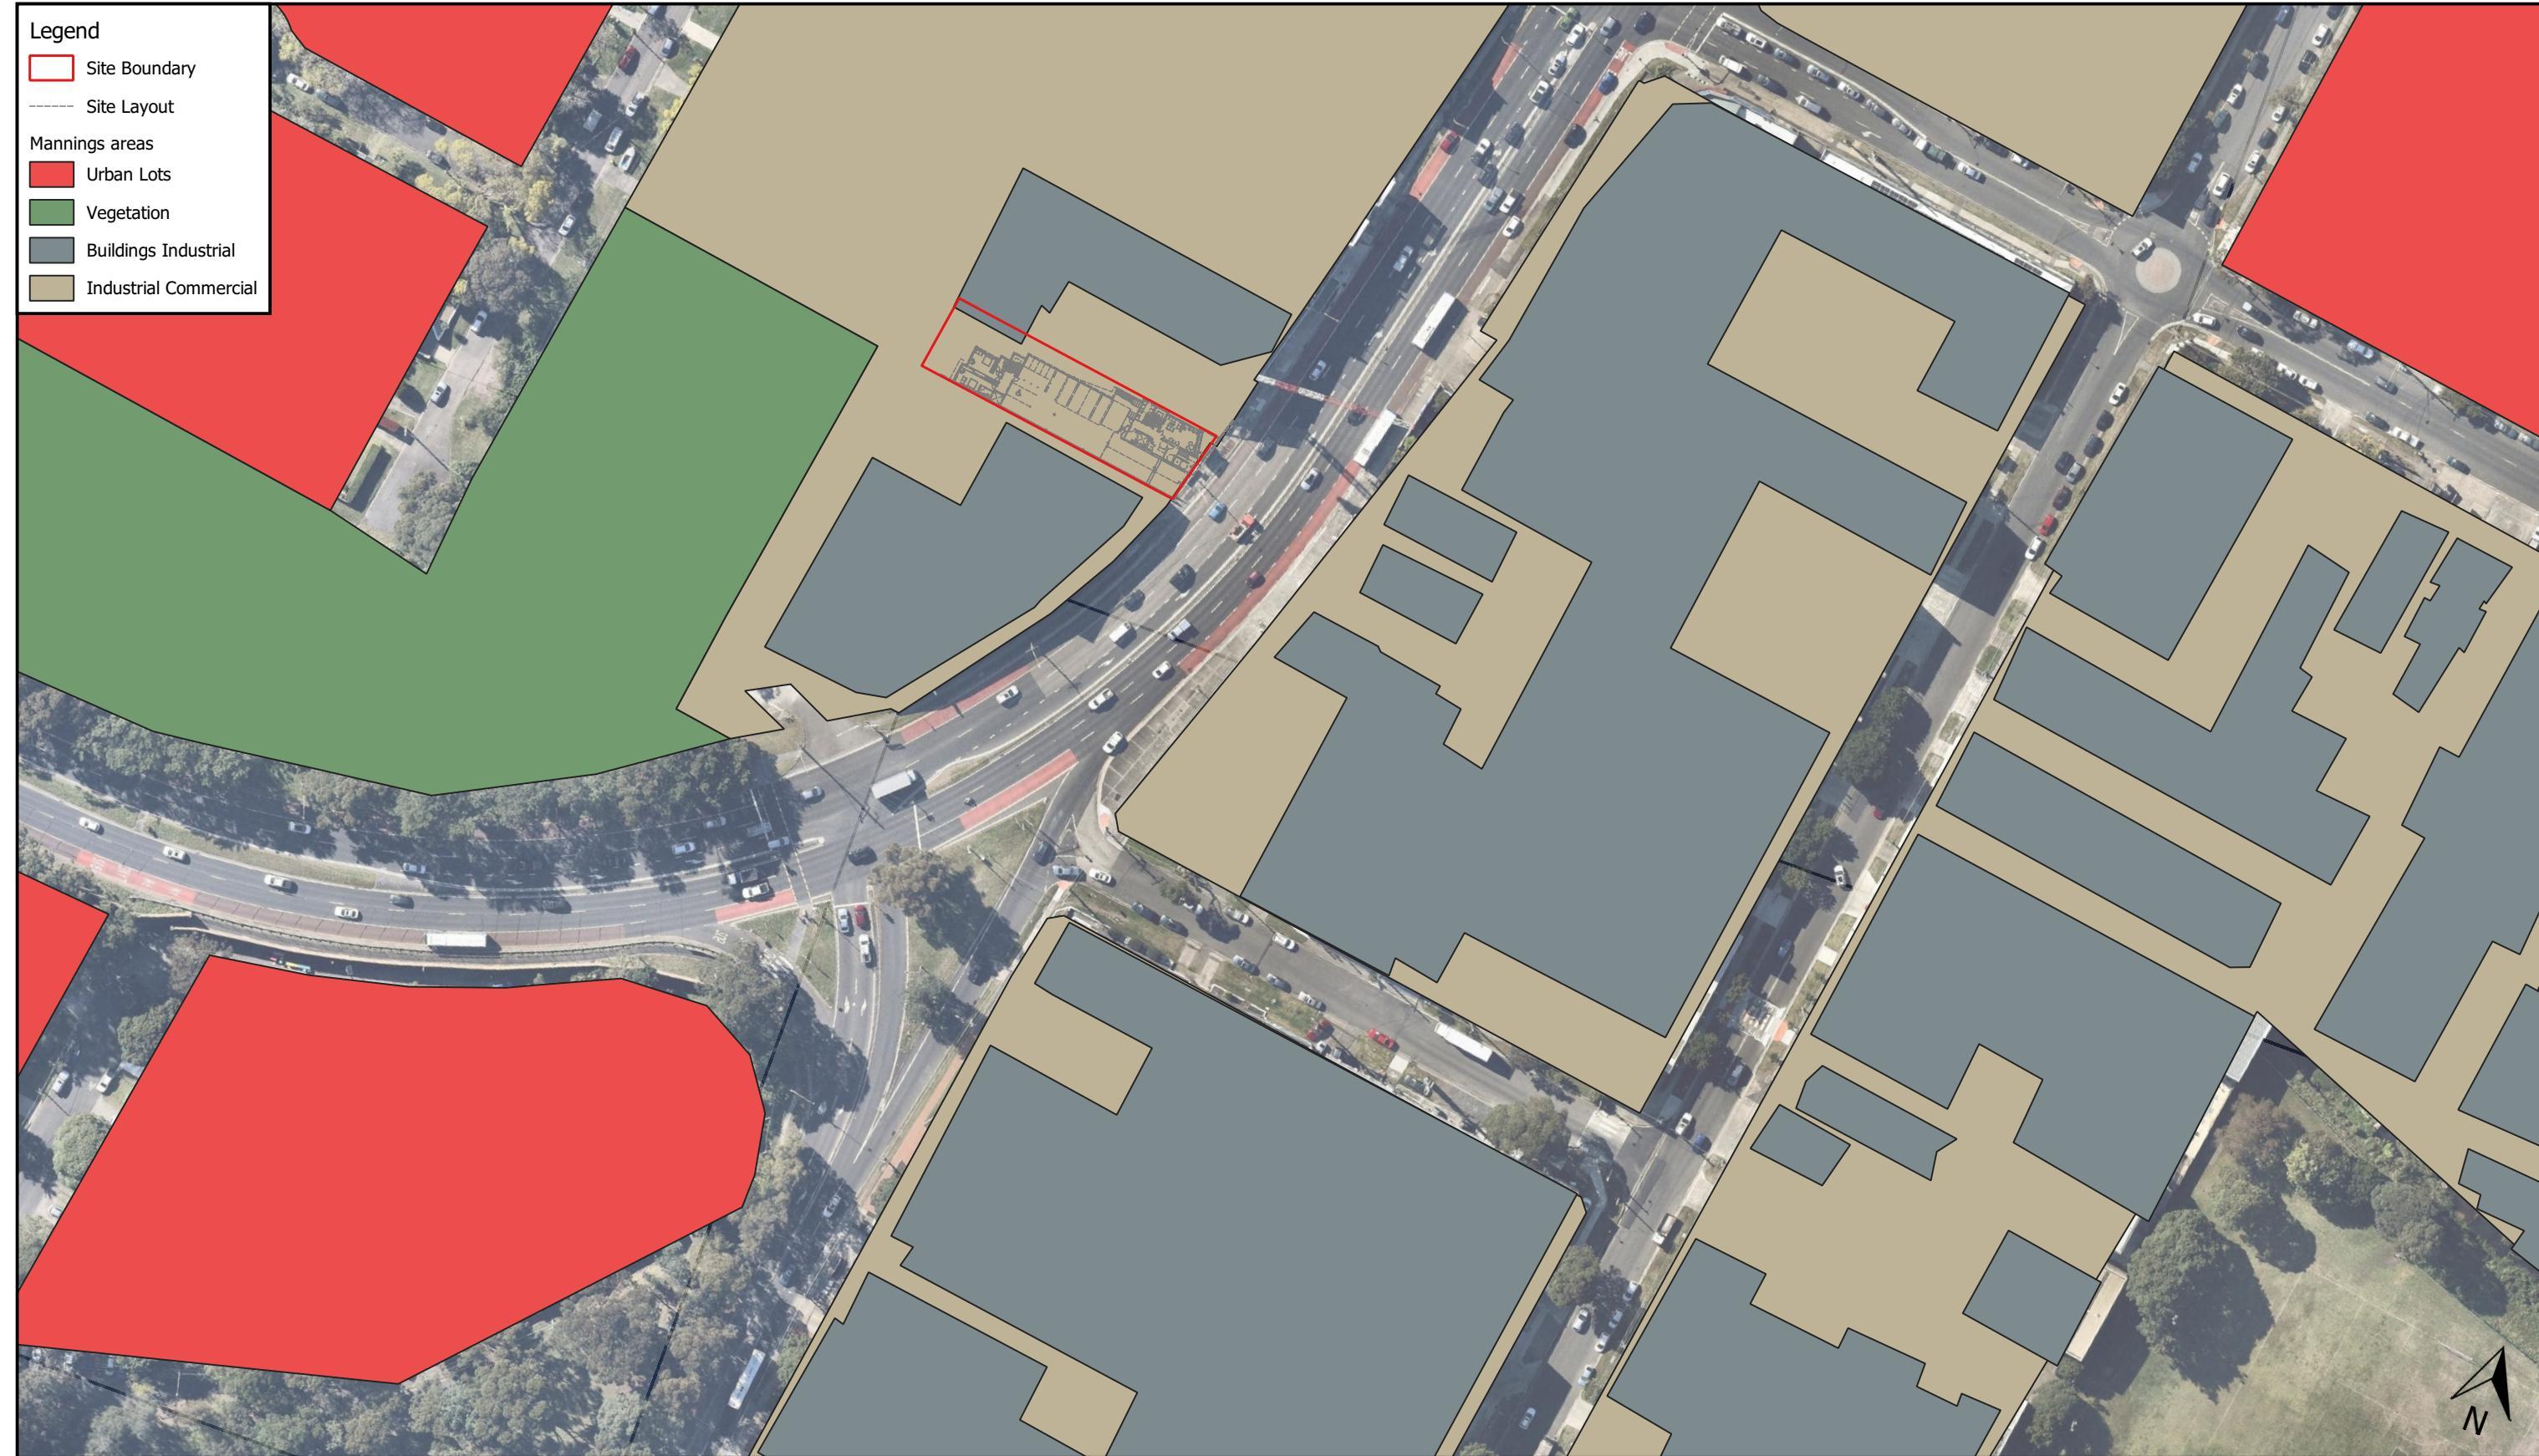
### Map 01

Natural Environment	More information is required to show the flood model set up, this includes how existing buildings have been modelled in the lots to the north and south of the subject site. It appears the modelling conducted by the flood consultant does not include neighbouring existing buildings in the model. The flood impact assessment for the development should factor in buildings in the assessment.	Model setup is consistent with Council's Manly Lagoon Flood Model (2013) in relation to building setup. Buildings are modelled with a Manning's roughness of 2.0. Refer to Attachment A Map 1.
Referral Response – Flood		The building to the north of the site (259 Condamine Street) is suspended over Burnt Bridge Creek and is modelled as a layered flow constriction. Refer to Attachment A Map 12.
	1% AEP and PMF Water Level and Velocity afflux mapping must be provided for a greater area around the site (extent of 100-150m upstream and downstream of the site to shown proposed flood impacts on surrounding properties).	Refer to Attachment A Maps 3 – 5. We note that there is a general trend of water levels dropping in the proximity of the site. This is due to the extra conveyance and storage provided by the cut under the building.

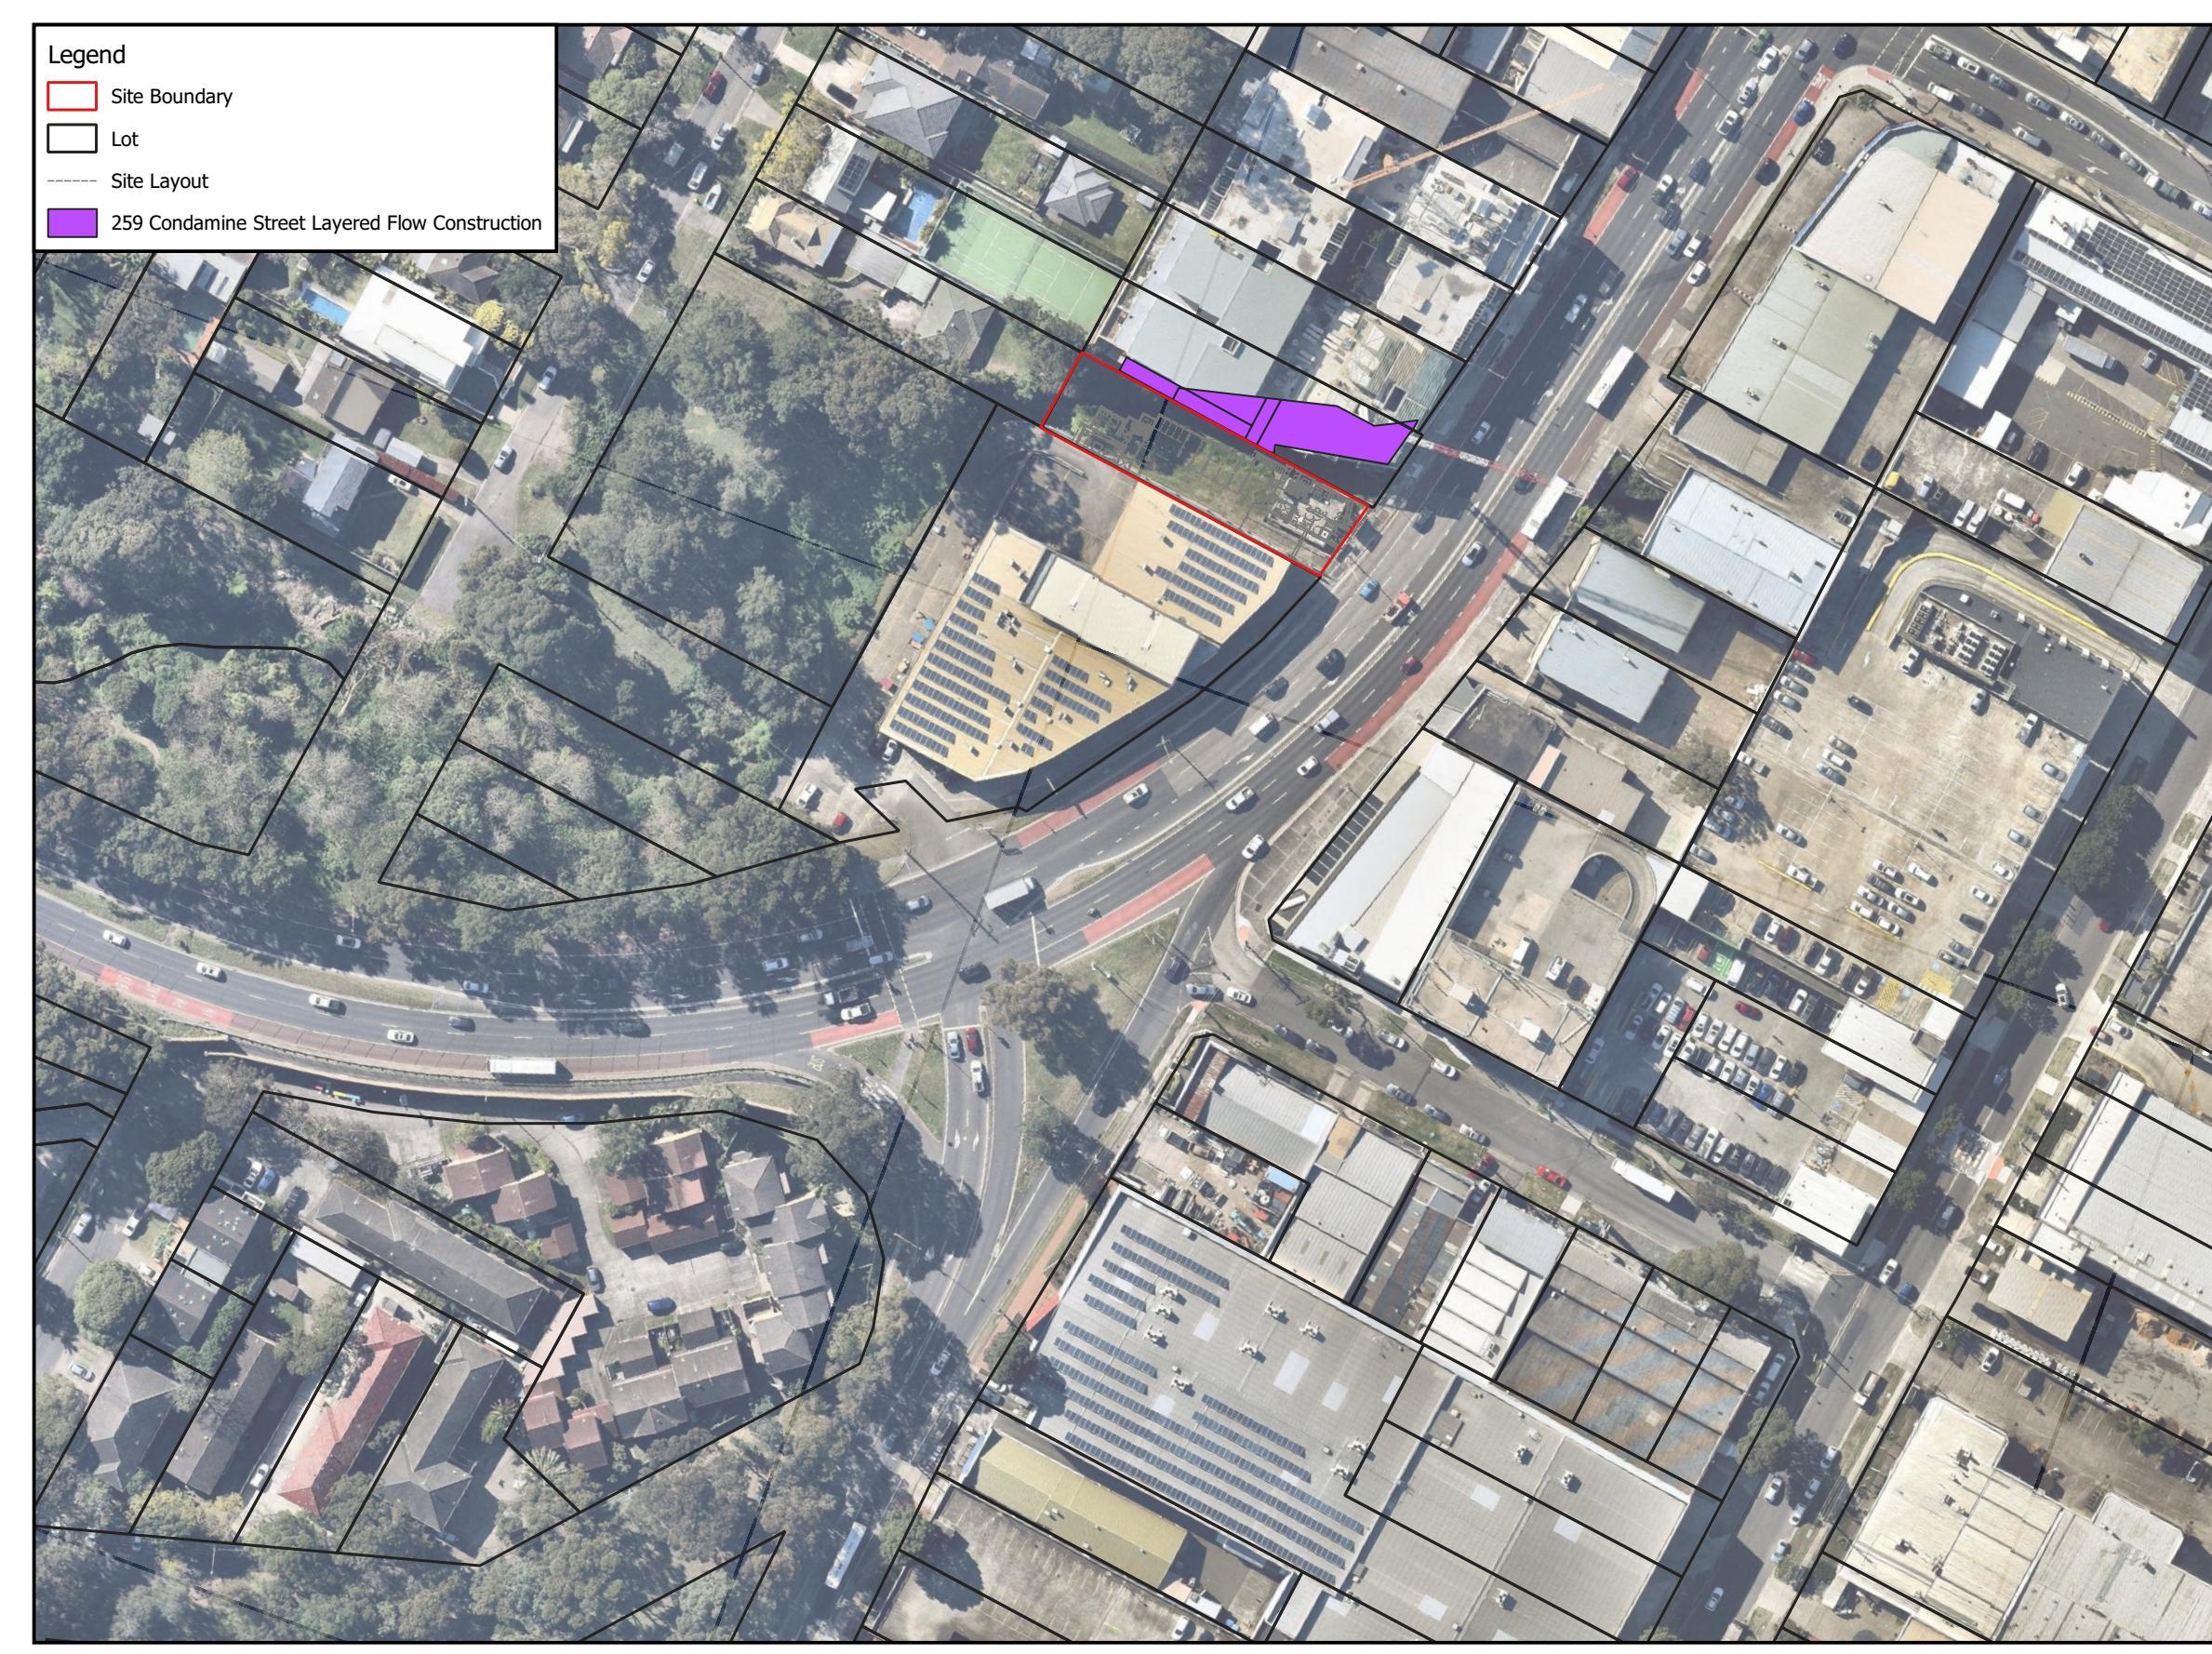
Map 02

Map Title / Figure: Model Setup - 259 Condamine Street Layered Flow Constriction

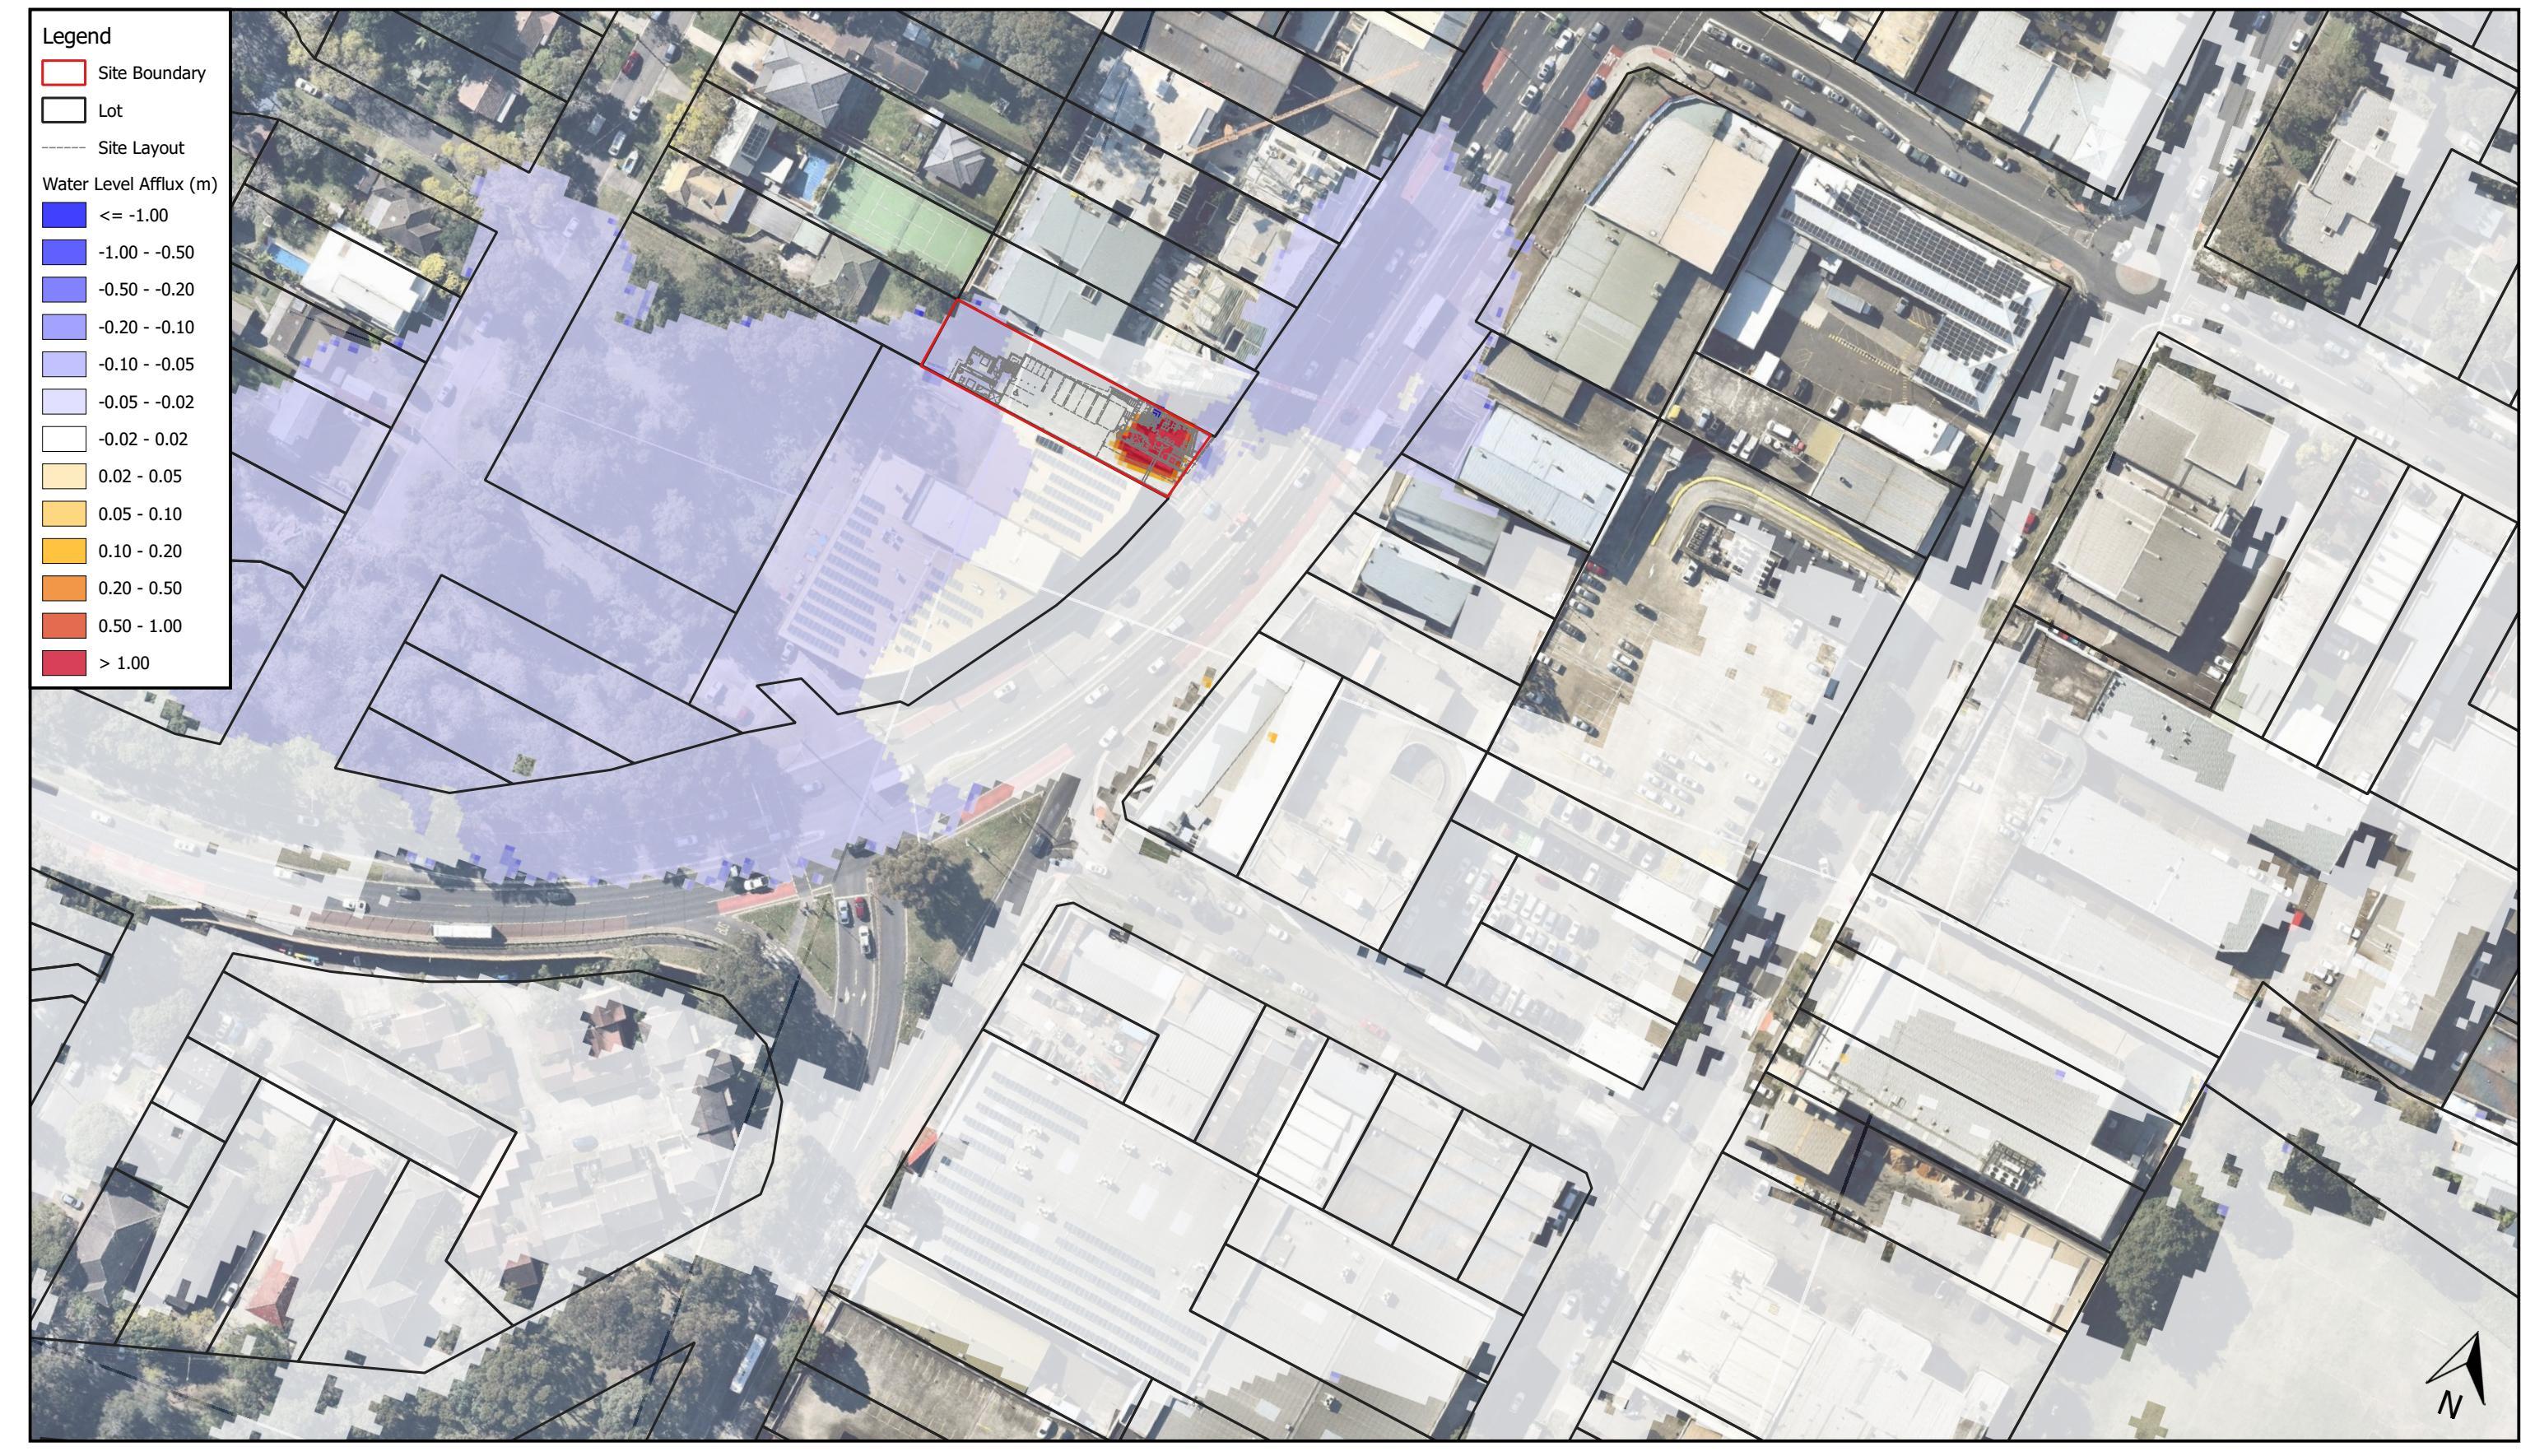
### Map 03

Notes: Areas coloured white represent negligible change. Areas coloured blue represent water level reduction. Areas coloured yellow/red represent water level increase.

### Map Title / Figure: Proposed Conditions 1% AEP Event Water Level Afflux (m)

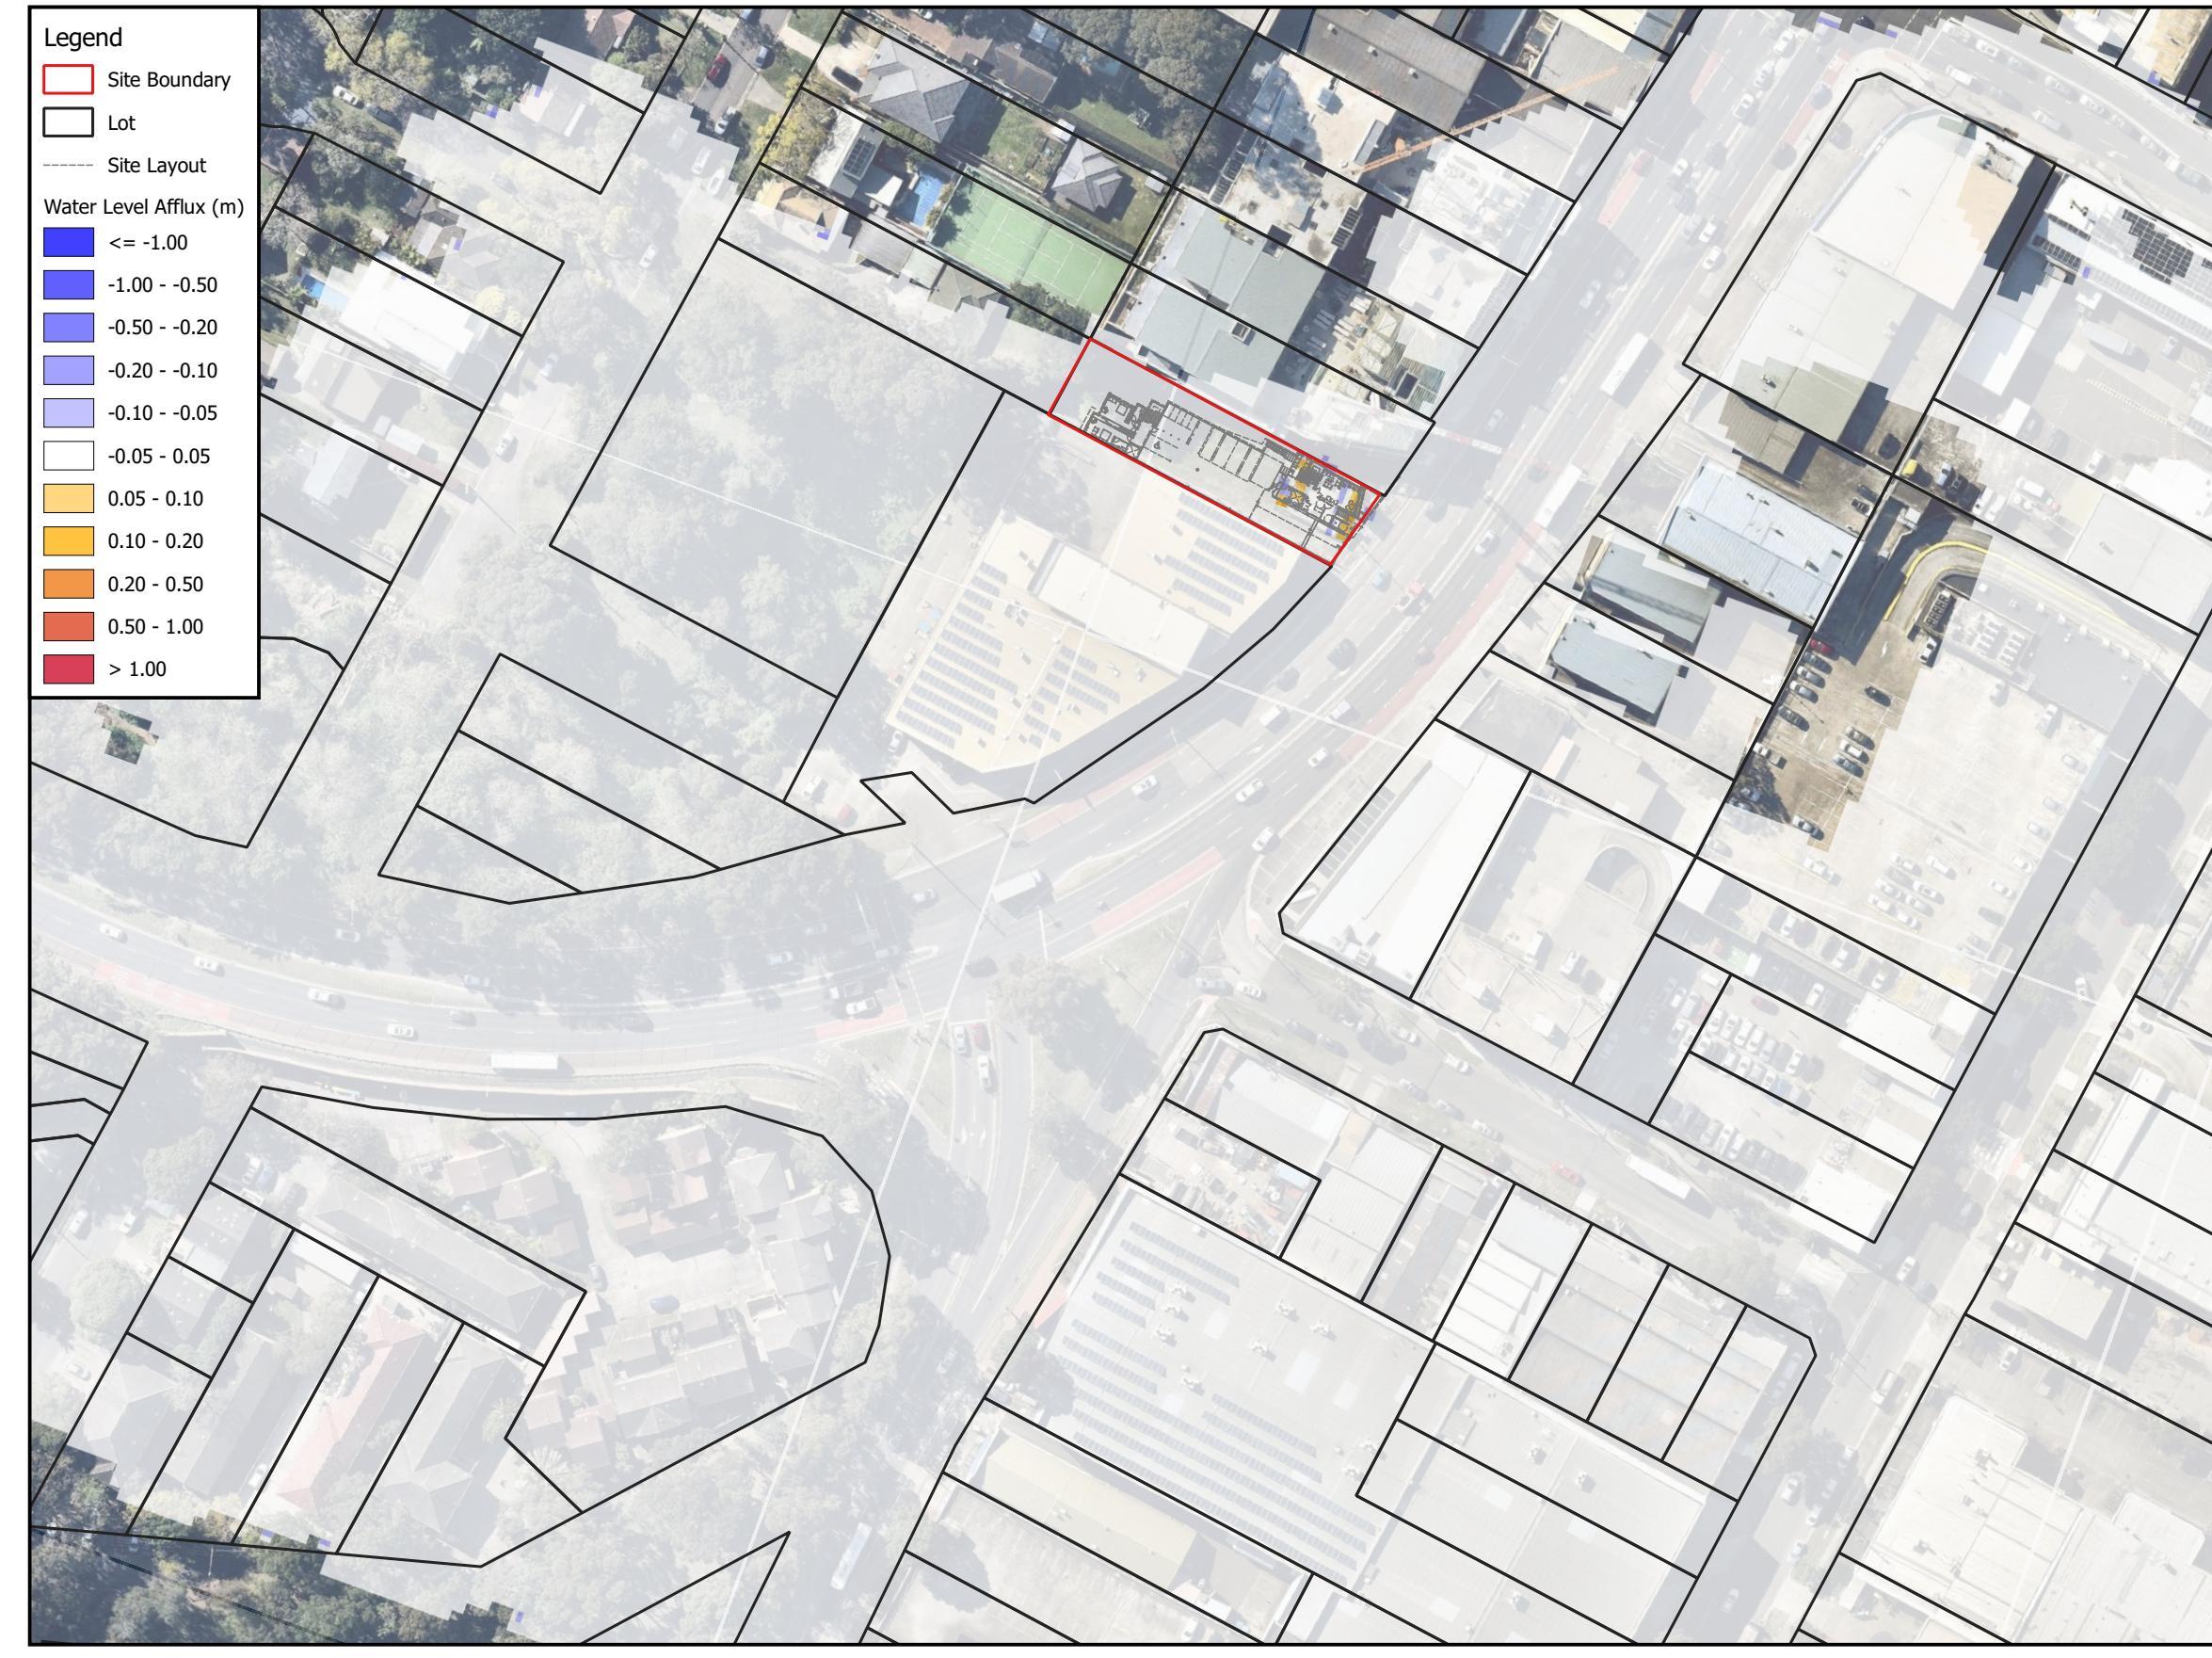
### Map 04

Notes: Areas coloured white represent negligible change. Areas coloured blue represent water level reduction. Areas coloured yellow/red represent water level increase.

## Map Title / Figure: Proposed Conditions PMF Event Water Level Afflux (m)

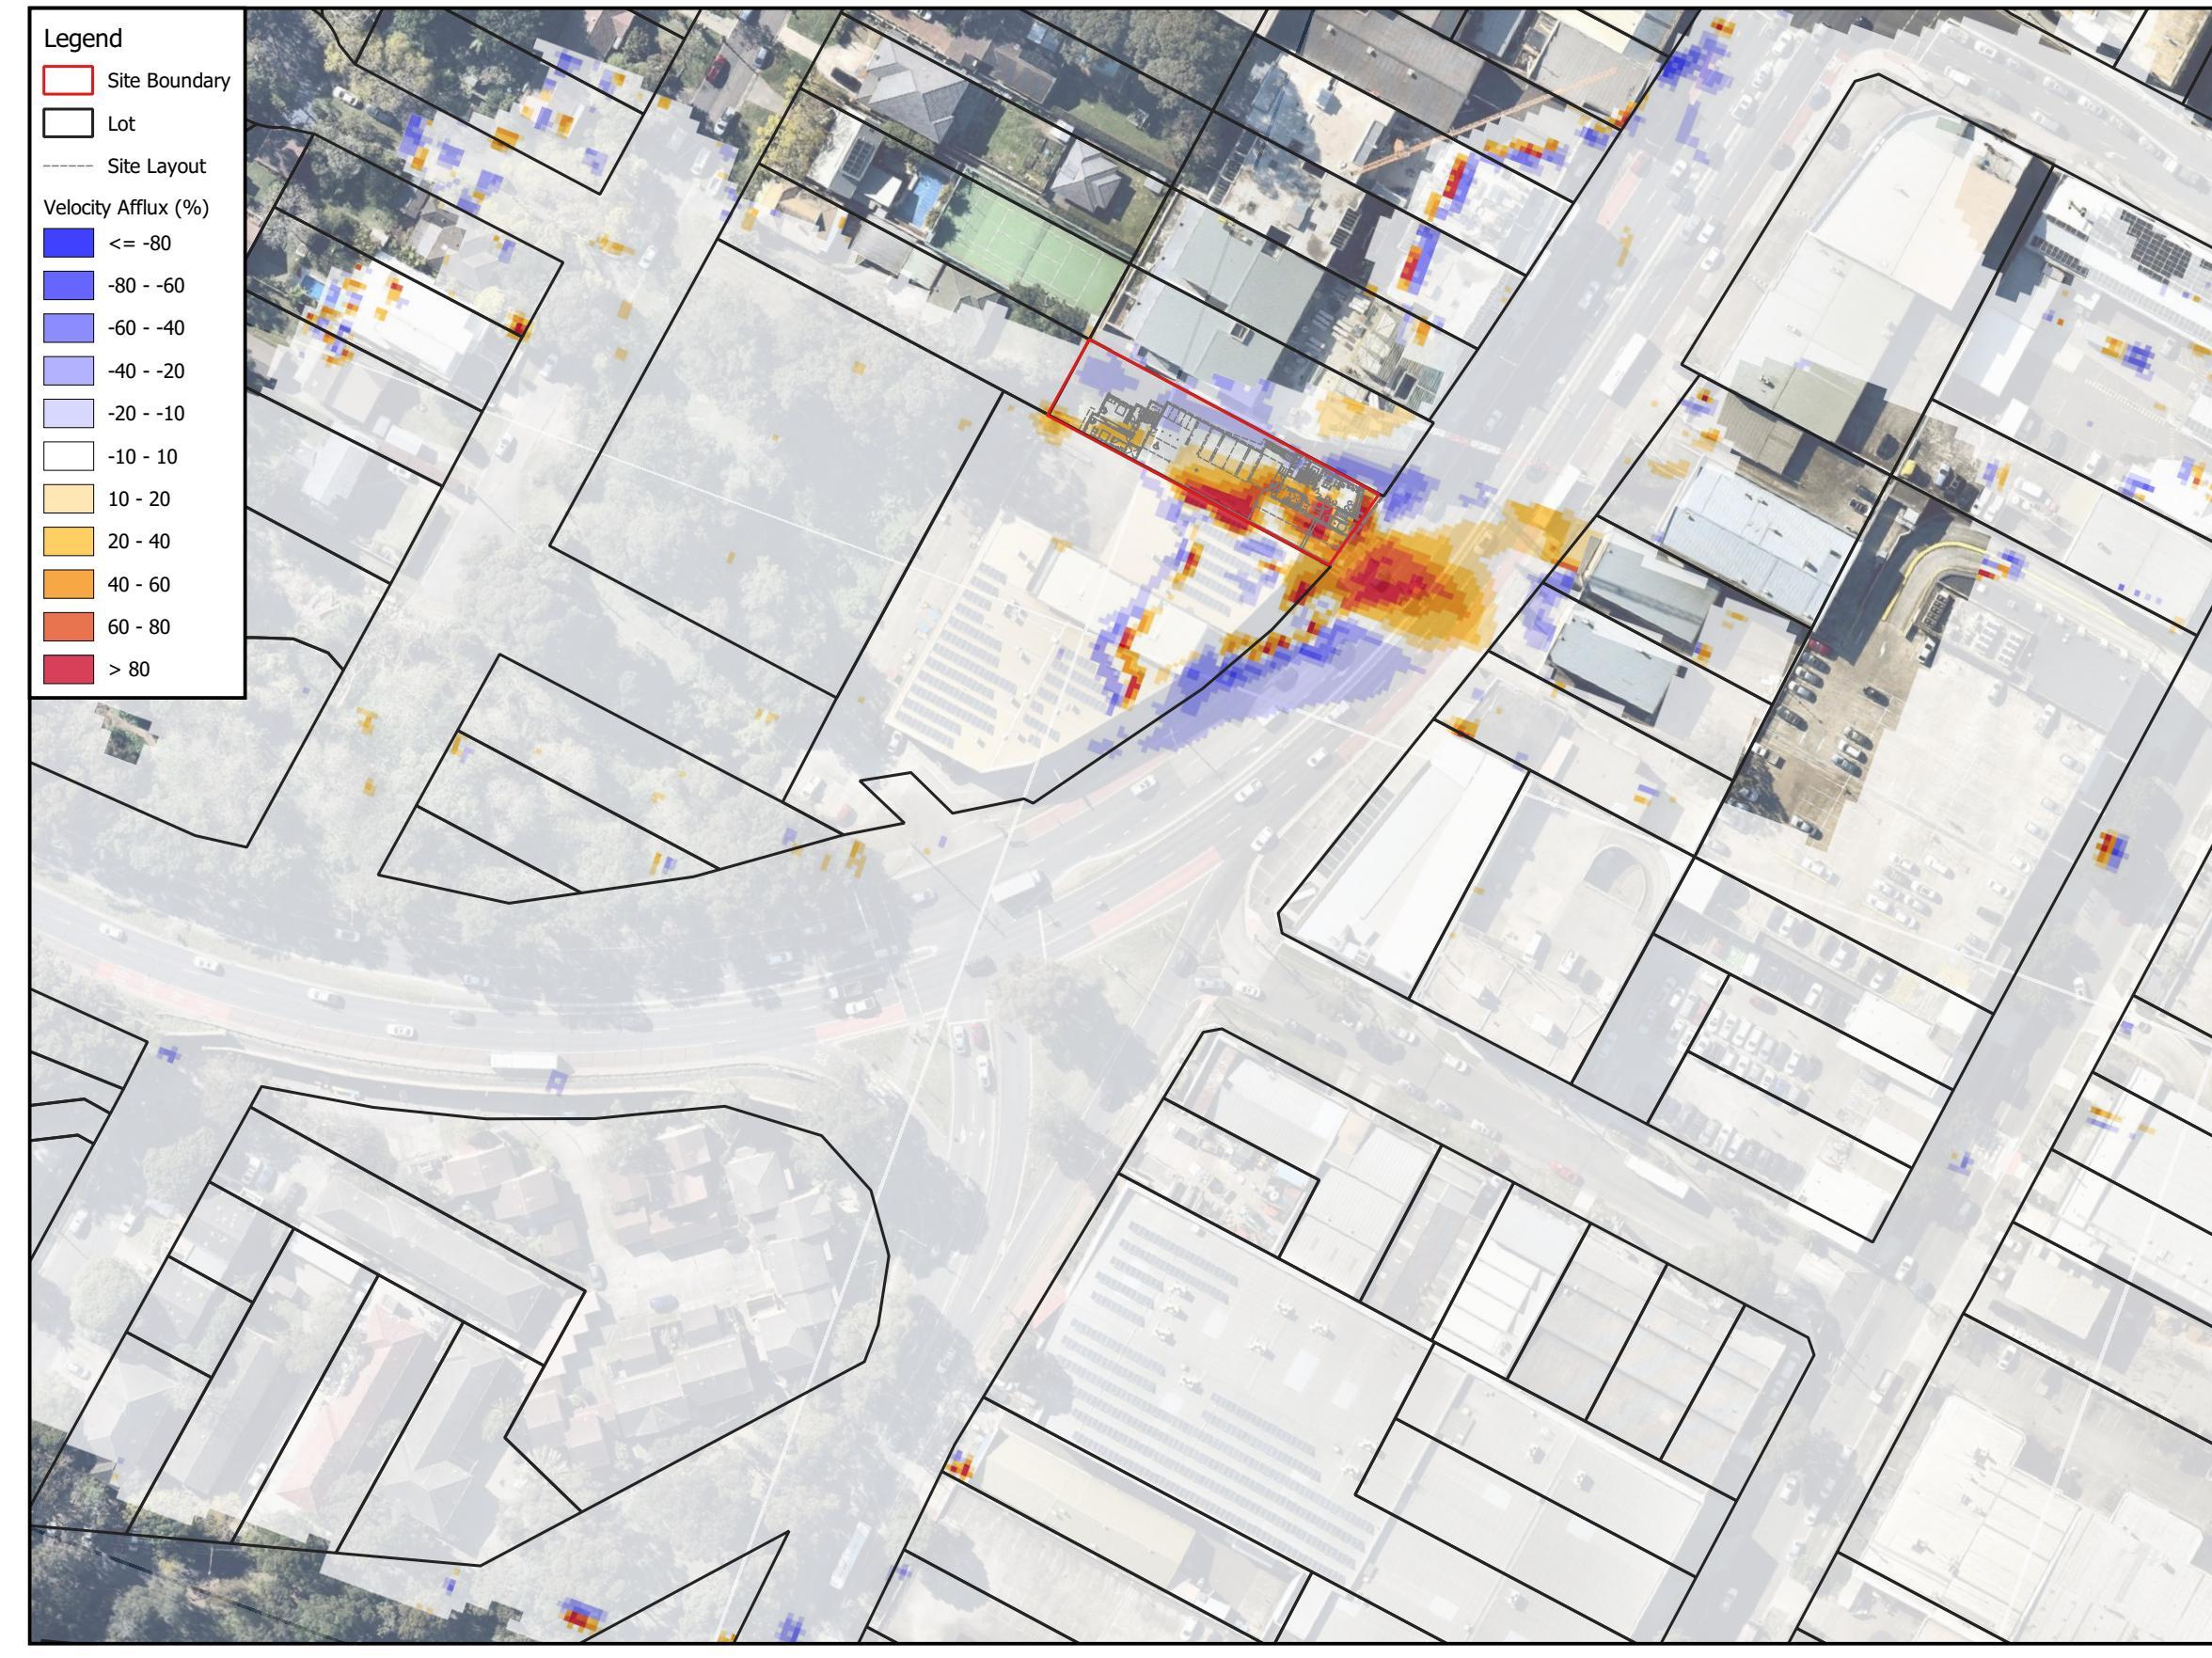
### Map 05

Notes: Areas coloured white represent negligible change. Areas coloured blue represent velocity reduction. Areas coloured yellow/red represent velocity increase.

# Map Title / Figure: Proposed Conditions PMF Event Velocity Impact (%)

Reference	Issue Raised	Response
	The proposed development is for a multi-level boarding house. The flood modelling output, specifically Map 16 of the Attachment F in the Flood Assessment Report shows post-development increases in the PMF velocities on private property (lot to the south of the subject site) of greater than 10%. The development cannot result in potential adverse flood impacts of more than 10% increase of PMF velocity on private land.	PMF velocity increases in excess of 10% are generally confined to the main road (where these do not result in unacceptable velocities or scour), or are the result of very minor absolute velocity increases (velocity increase from 0.05 m/s to 0.08 m/s to the south of the site, and from 0.2 m/s to 0.4 m/s to the east). As none of these increases result in unacceptable erosion risks, combined with the rarity of the PMF event, we note these velocity increases are acceptable despite them exceeding the arbitrary 10% threshold.
