## **McCarrs Creek Road Church Point**

06 March 2024

Report File Name	Prepared	Reviewed	Issued	Date	Issued to
P5737.003R McCarrs Creek Road Church Point RSA Report (Updated Design)				06/03/2024	Email:

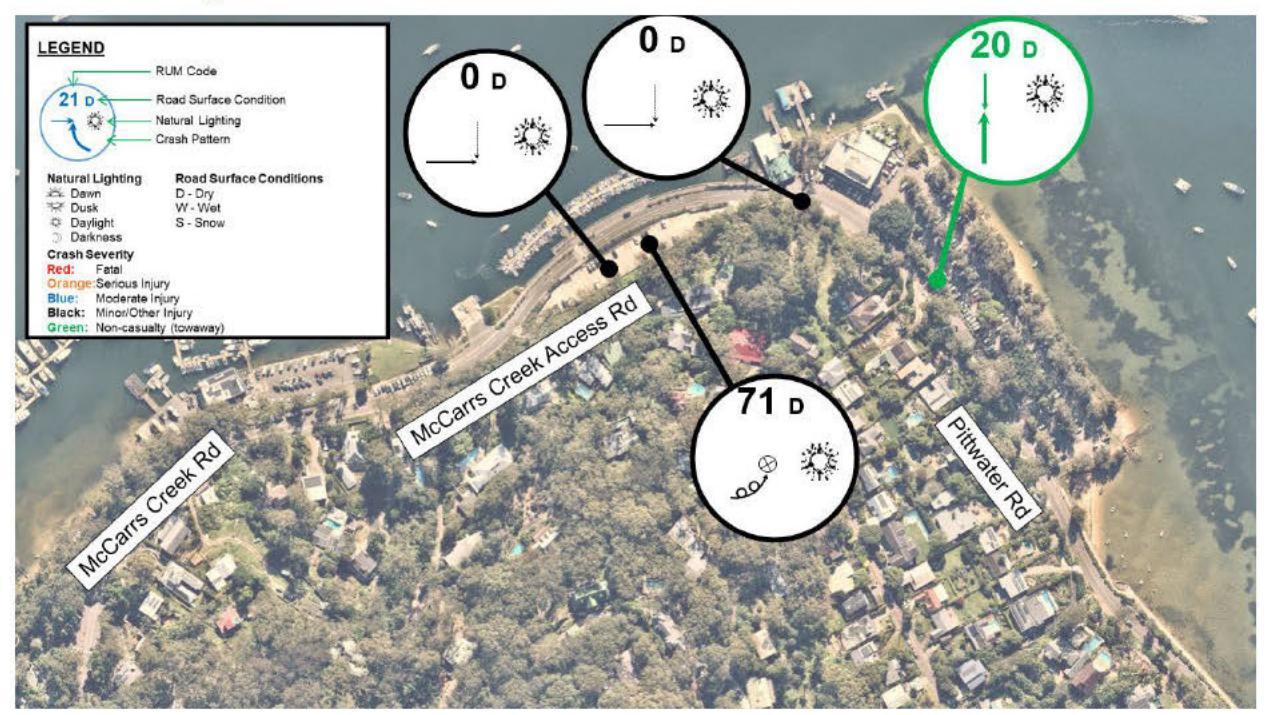
Figure 3.1: Crash Map Diagram

Between 2018-2022, four (4) crashes were recorded within the study area along the frontages of the retail premises and within the off-street car park. Details and location of the recorded crashes are illustrated in Figure 3.1.

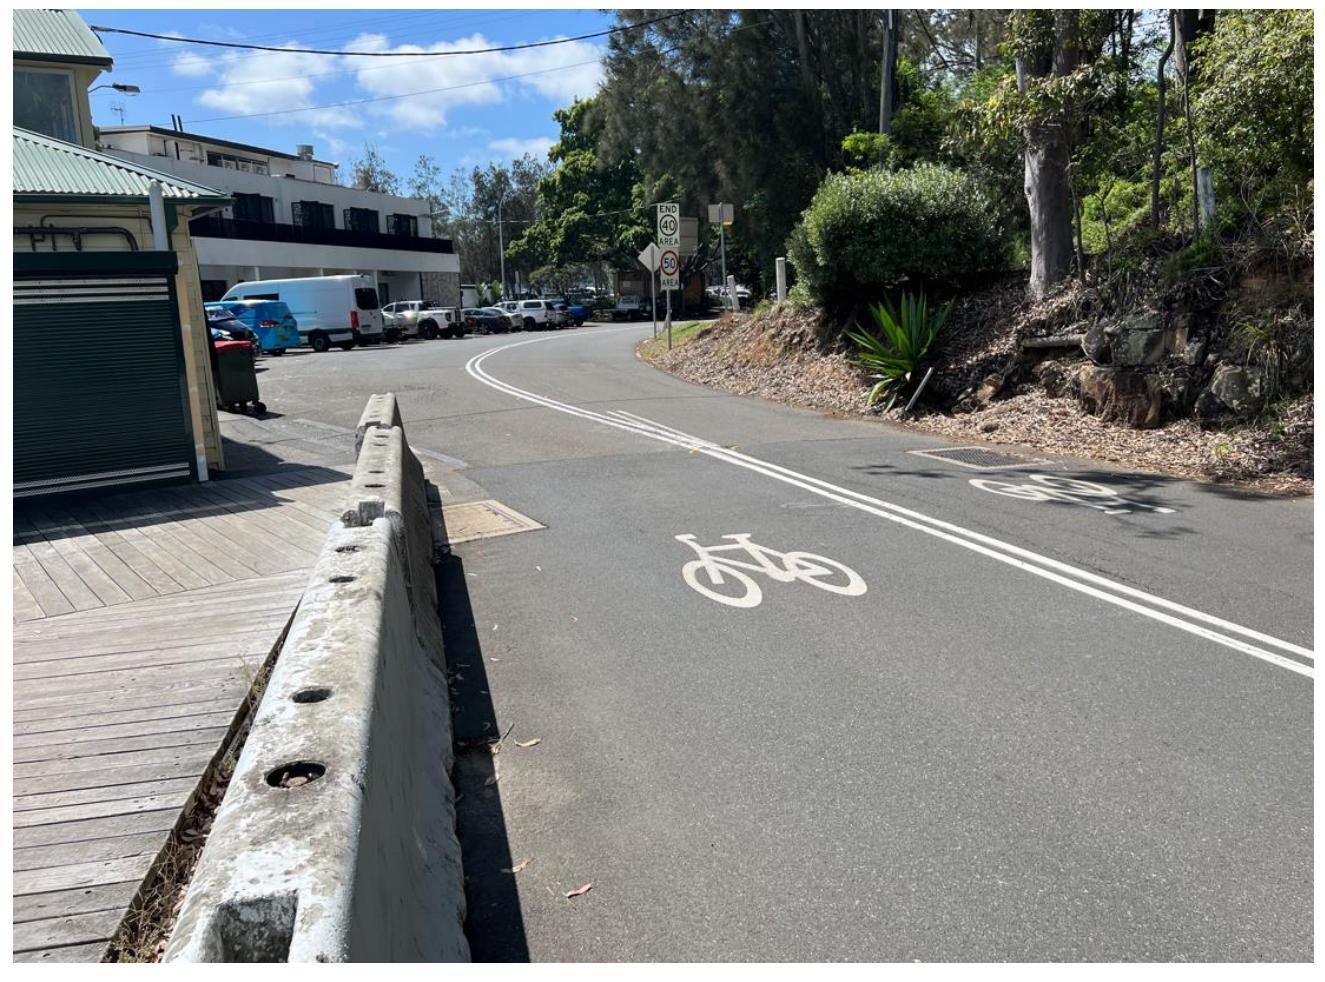
Figure 3.2: Site Photo – McCarrs Creek Road and Pittwater Road Corridor (Looking East)

- The weather was sunny with dry surface condition
- Low traffic demand was observed along the road corridor
- Few cyclists were observed along the road corridor
- Pedestrians observed travelling between parked vehicles and the retail premises and crossing McCarrs Creek Road in front of retail premises
- Poor sight distances, narrow road width at the bend of McCarrs Creek Road and Pittwater Road with some eastbound drivers cutting the corner over the bend
- Faded delineation along McCarrs Creek Road has been renewed since the last site visit.

Figure 3.2 illustrates the McCarrs Creek Road and Pittwater Road corridor.
